## **Appendix A: 2019 Site Visits**

# Summary Report of WOTS Requested Site Visit for the Papillion Creek Watershed Stream Degradation Study

Prepared By:  
River and Reservoir Engineering Section  
Hydrologic Engineering Branch  
River & Reservoir Engineering Section  
Omaha District

## June 2019

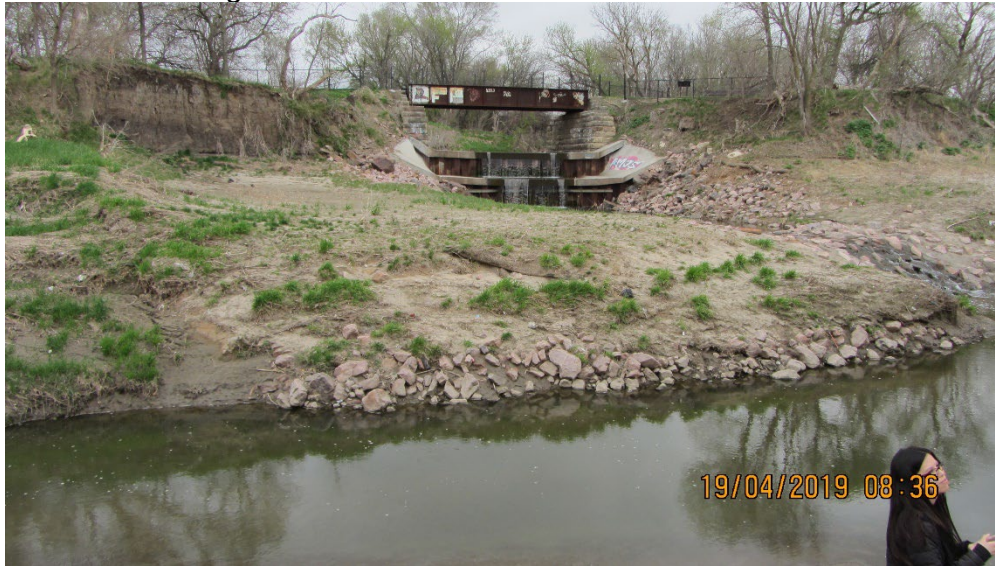
South Papillion Creek joins West Papillion Creek just upstream of the Hell Creek drop structure, just west of South 110<sup>th</sup> Street and Harry Andersen Blvd. The entire confluence area is highly degraded. The Hell Creek invert elevation has been set by a constructed drop structure to eliminate significant head cutting to the channel. Figure 1 shows the Hell Creek outlet structure.

**Figure 1. Hell Creek outlet structure**

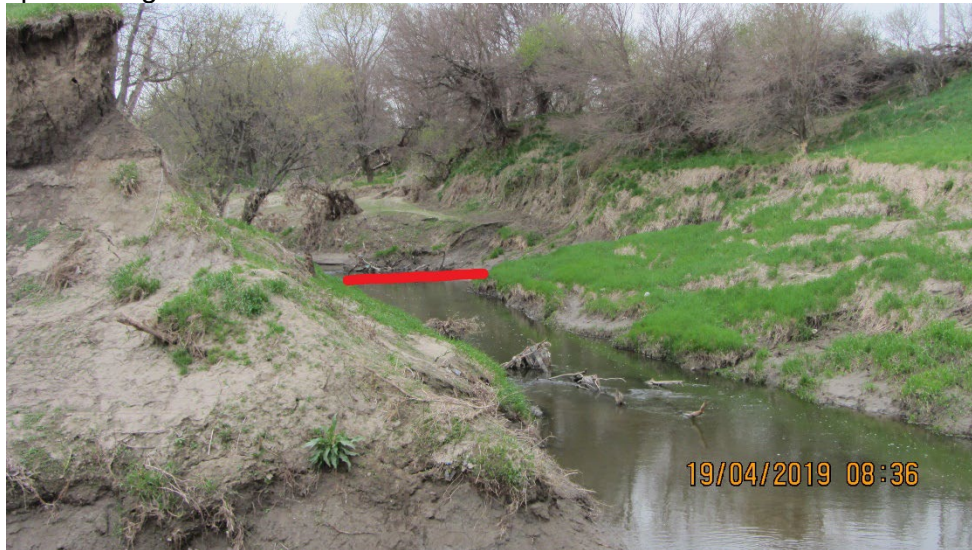
Degradation continues on the West and South Papillion Creeks in the vicinity. The city of Omaha has identified a sewer line on West Papillion Creek, approximately 200 feet upstream of the confluence that has become exposed. Figure 2. Identifies the location of the sewer line.

**Figure 2. Exposed sewer line on West Papillion Creek just above confluence with South Papillion Creek (looking upstream from the confluence). Pipe location highlighted.**

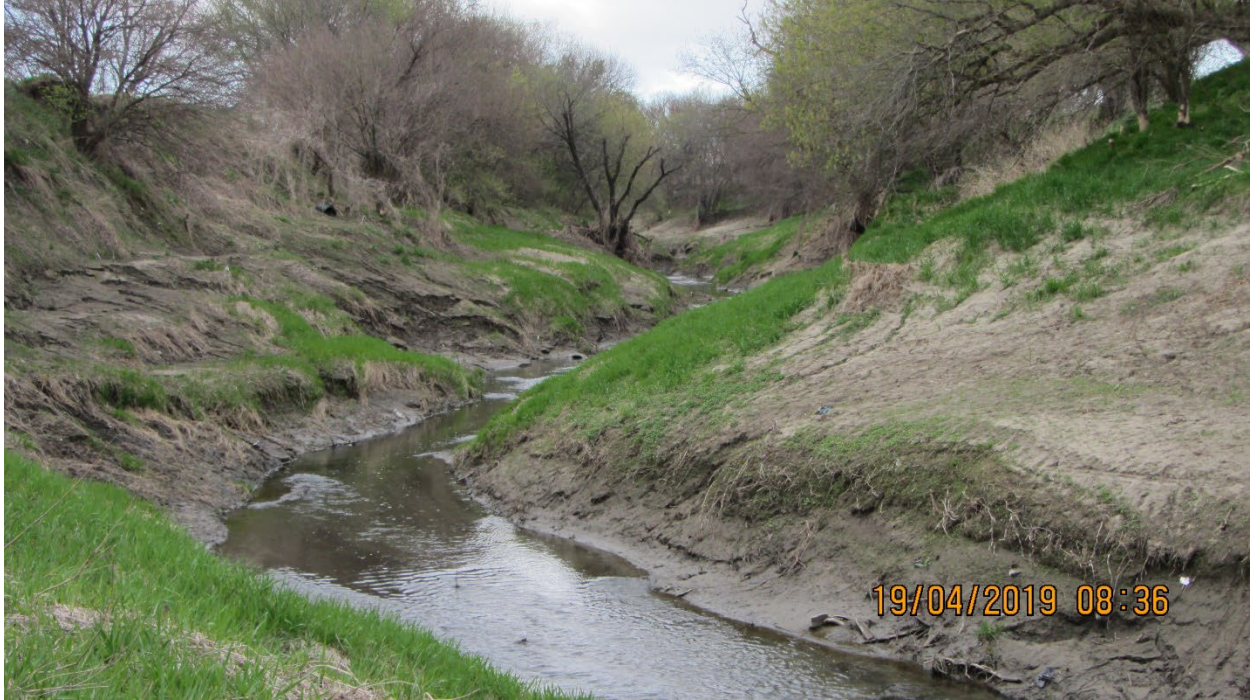
The mouth of South Papillion Creek is in a similar condition, experiencing 10-15 feet of degradation in places. Figure 3. Looks up from the mouth on South Papillion Creek.

**Figure 3. Mouth of South Papillion Creek (looking upstream)**

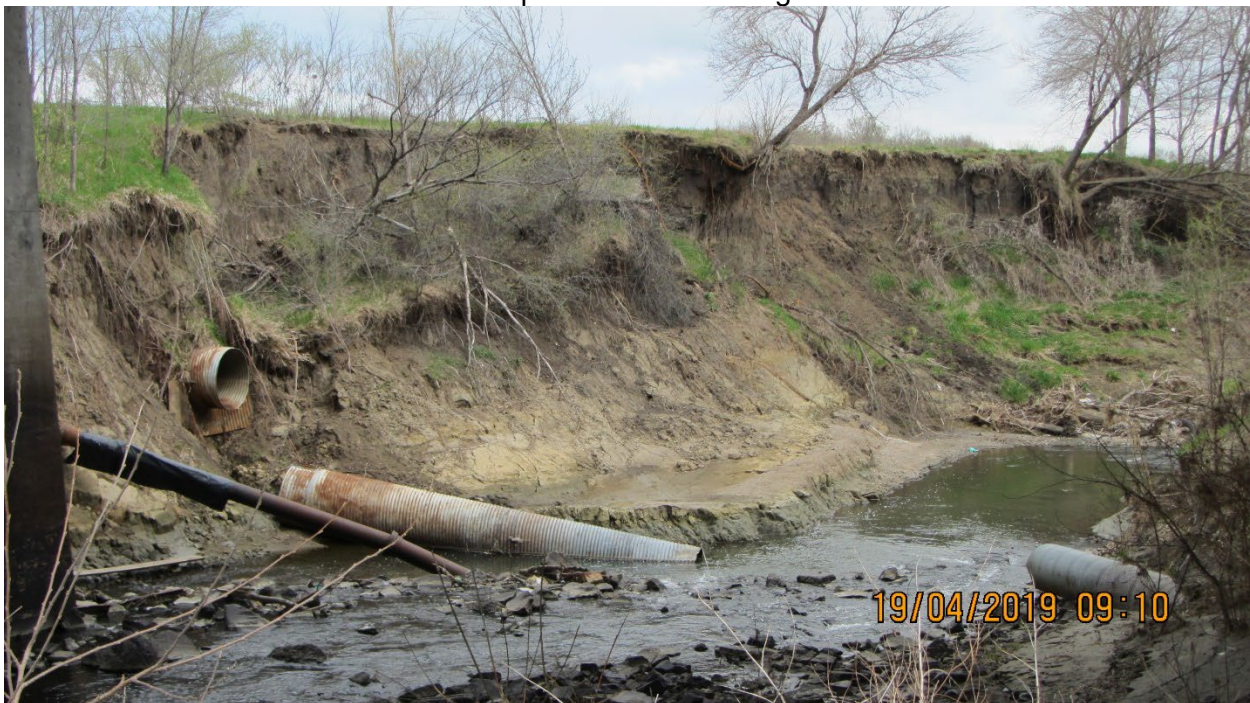
**Figure 4. South Papillion Creek channel at the downstream side of Giles Road Bridge (looking downstream)**

The channel below the bridge appears to be partially stabilized with broken slab concrete waste, however, the concrete bridge piers appear to be partially exposed at their base. Directly upstream of the bridge extreme bank erosion continues. It does not appear that in the past, the bridge has served

as grade control, although as degradation continues, additional hard material will be exposed, possibly slowing degradation.

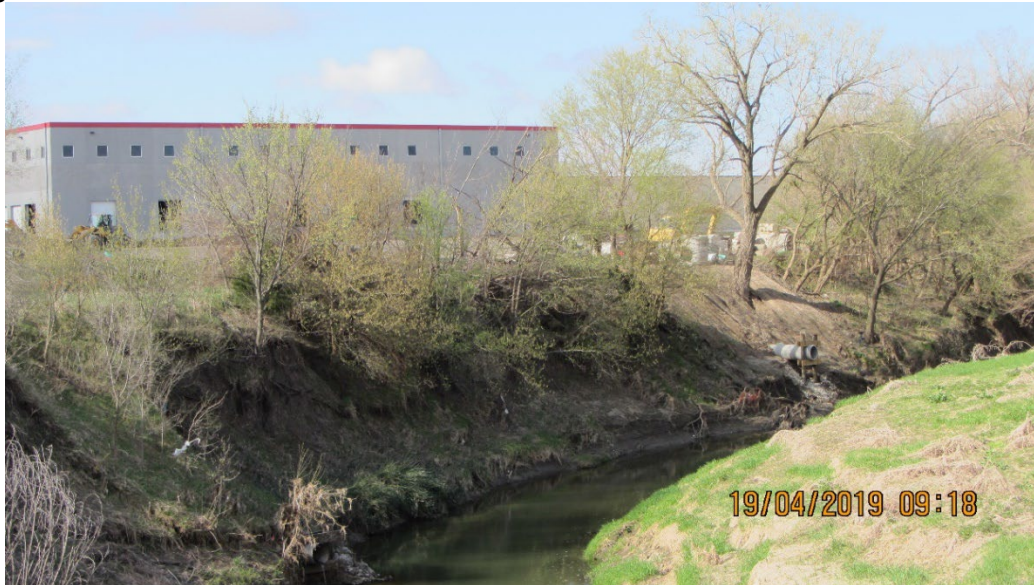
**Figure 5. Right bank erosion above the Giles Road Bridge (looking upstream)**

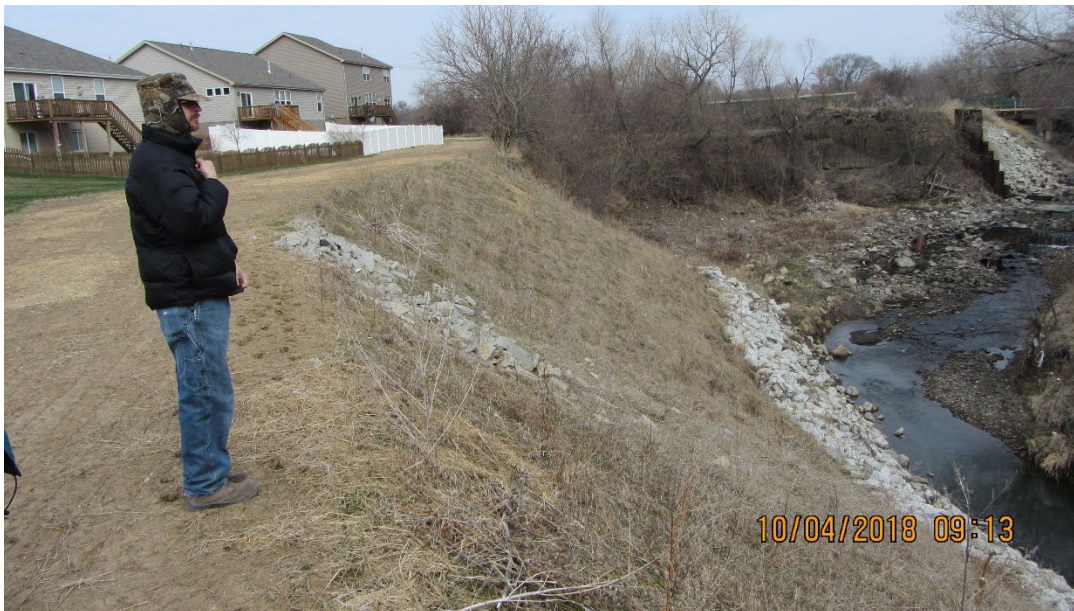
**Figure 6. Newly constructed right bank slope and toe to protect sewer line (looking upstream)**

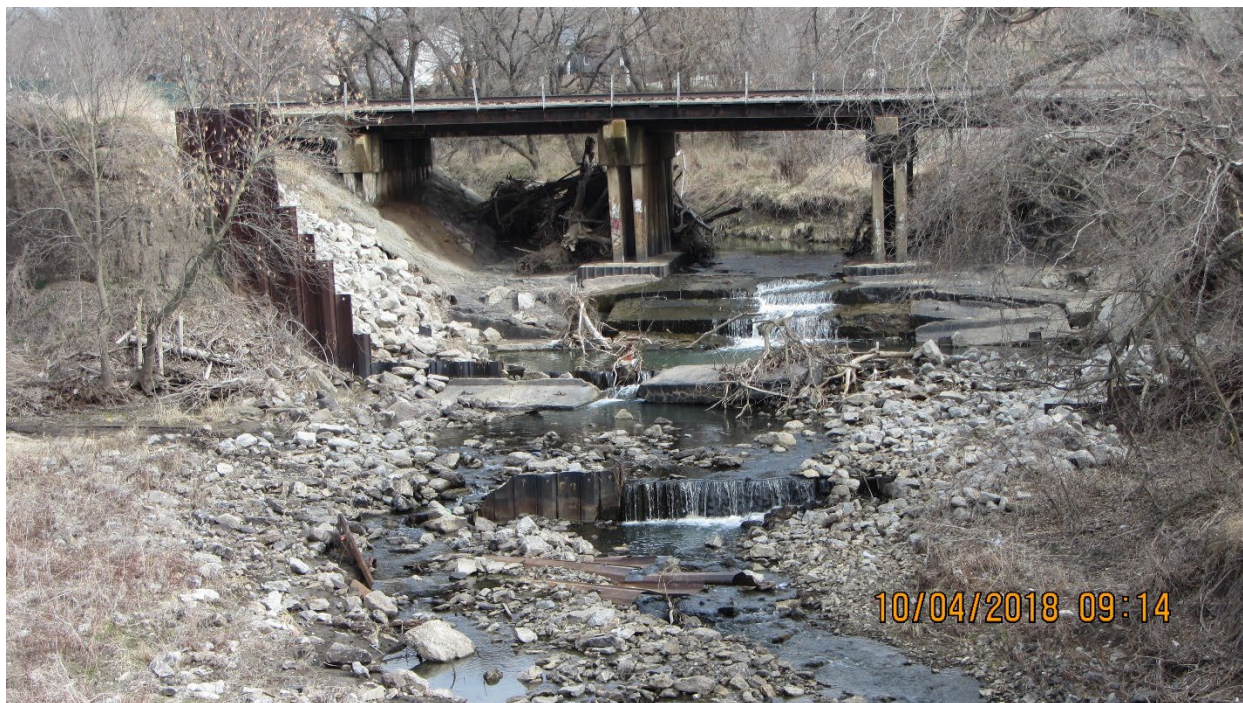
**Figure 7. Railroad Bridge just east of 156<sup>th</sup> St. (looking upstream)**

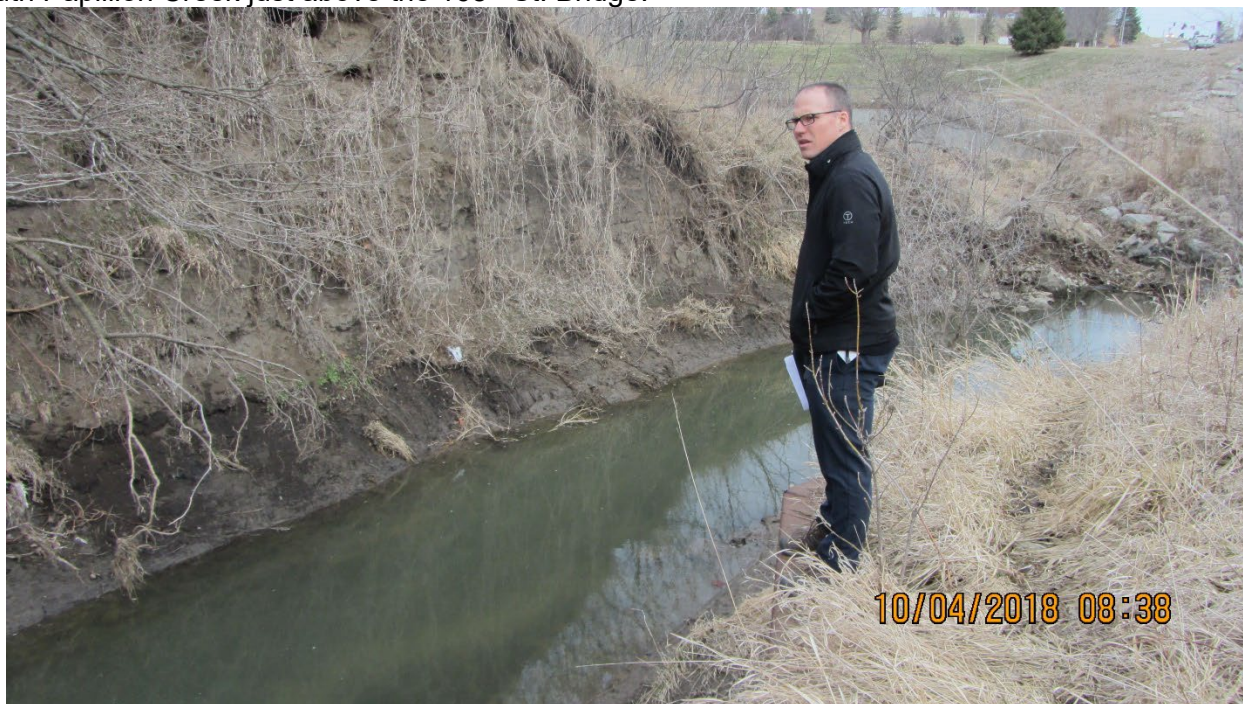
**Figure 8. Channel incision upstream of 168<sup>th</sup> St. Bridge**

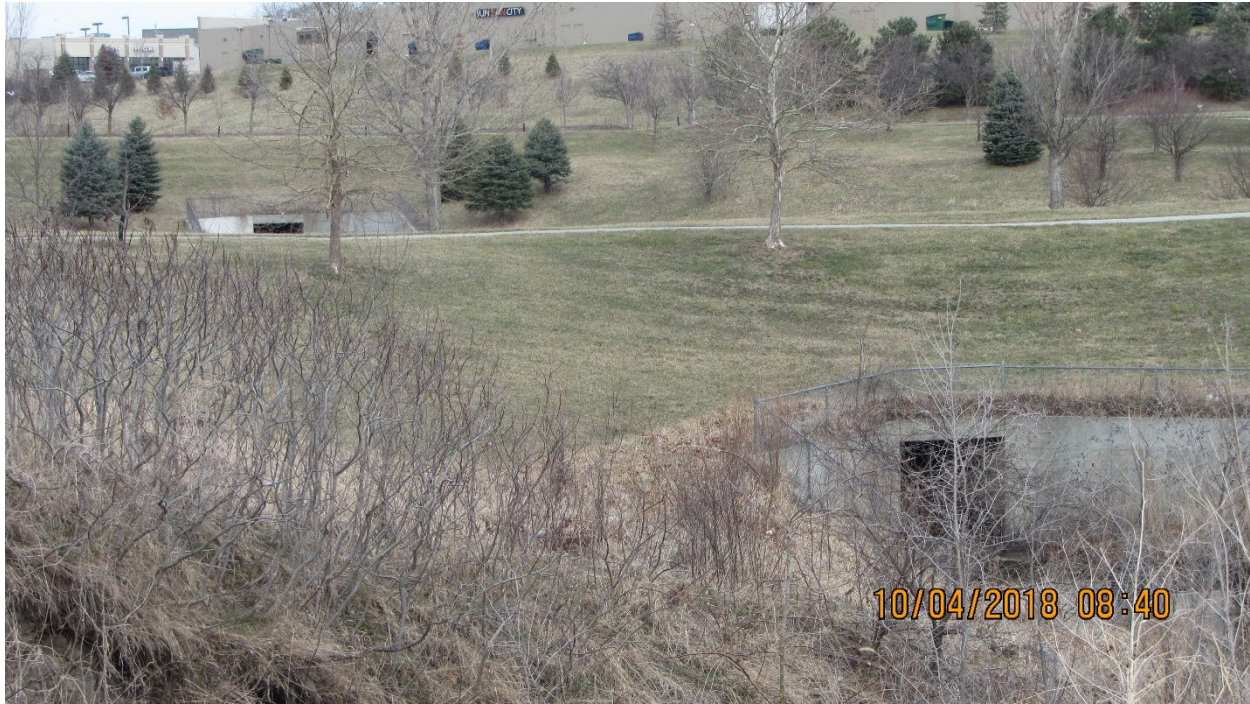
**Figure 9. NRCS designed neighborhood runoff detention structure**

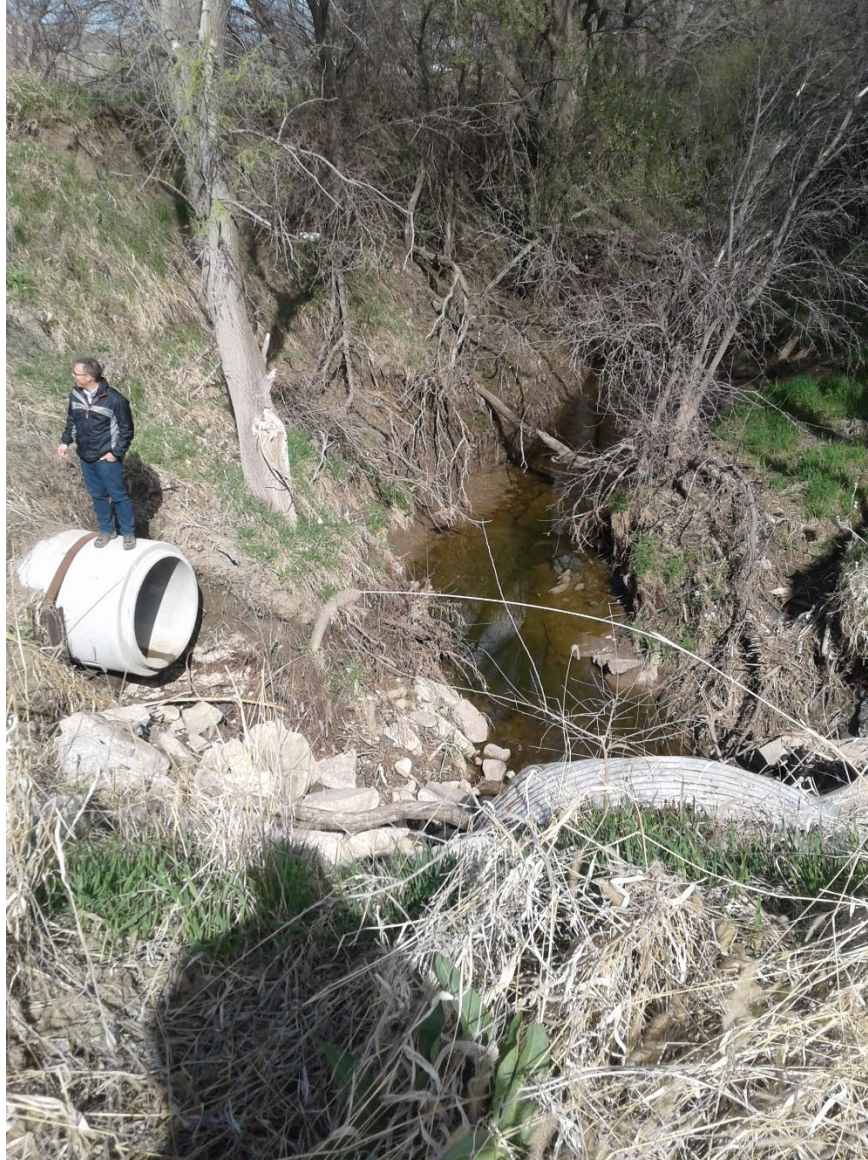
Figure 10. Upstream inlet to Beetle Creek culvert

The invert change through the culvert likely exceeds 10 feet, though not measured. The channel incision below the culvert extends down to South Papillion Creek, approximately 0.2 miles below the culvert. The culvert is actively working a grade control.

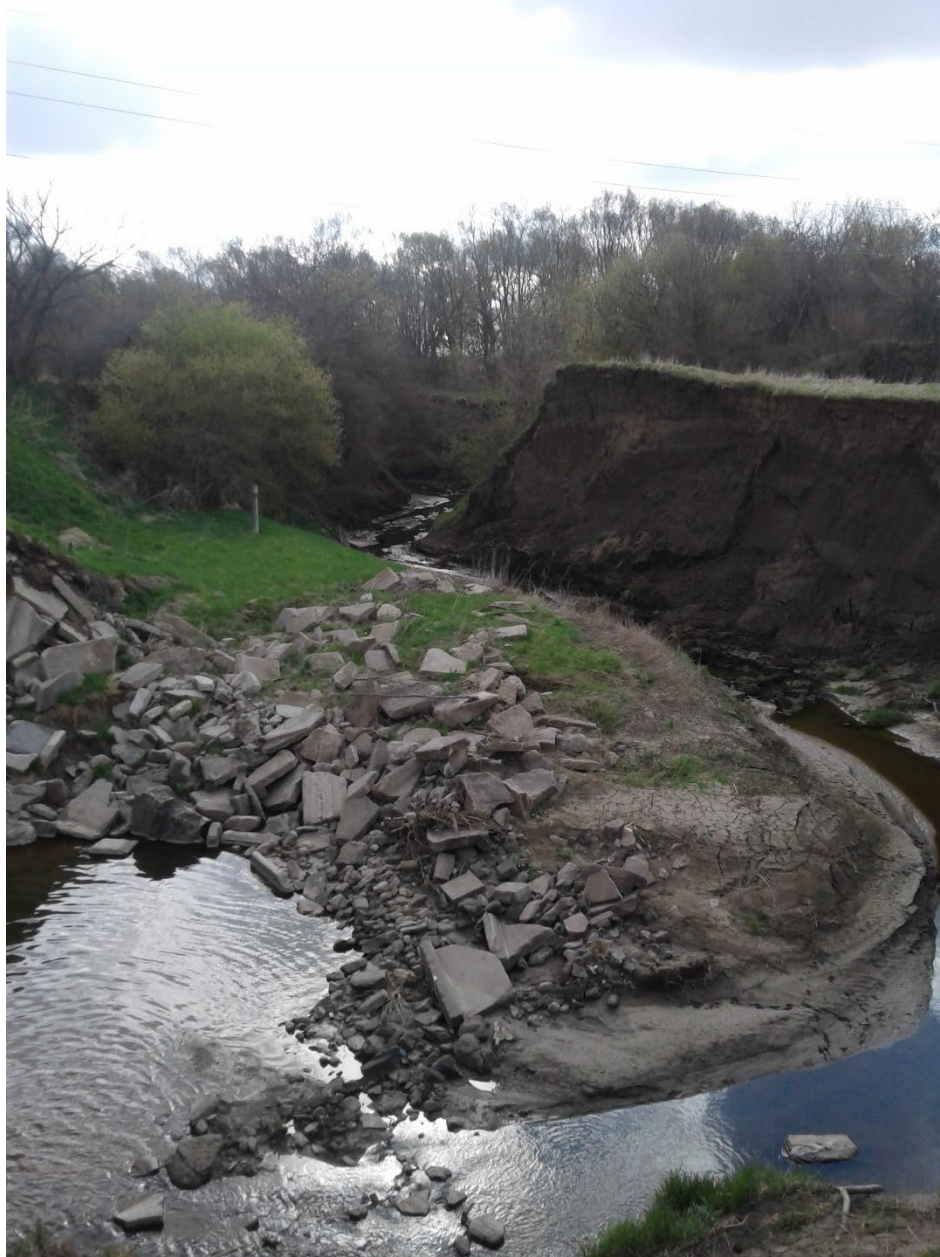
**Figure 11. Outlet of Beetle Creek culvert**

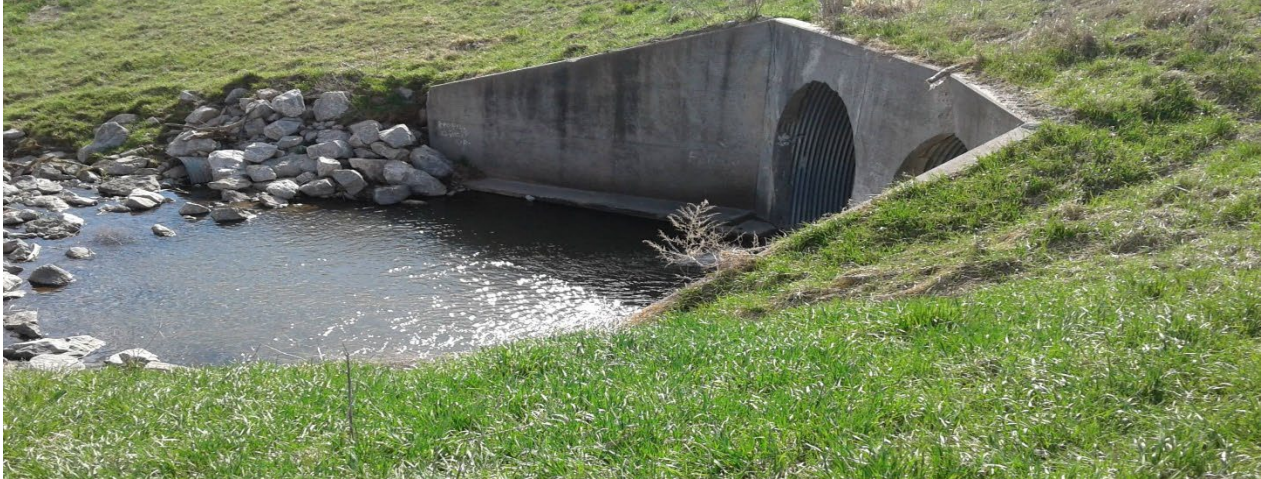
**Figure 12. Culvert structure at Giles Rd. Upstream limit of site.**

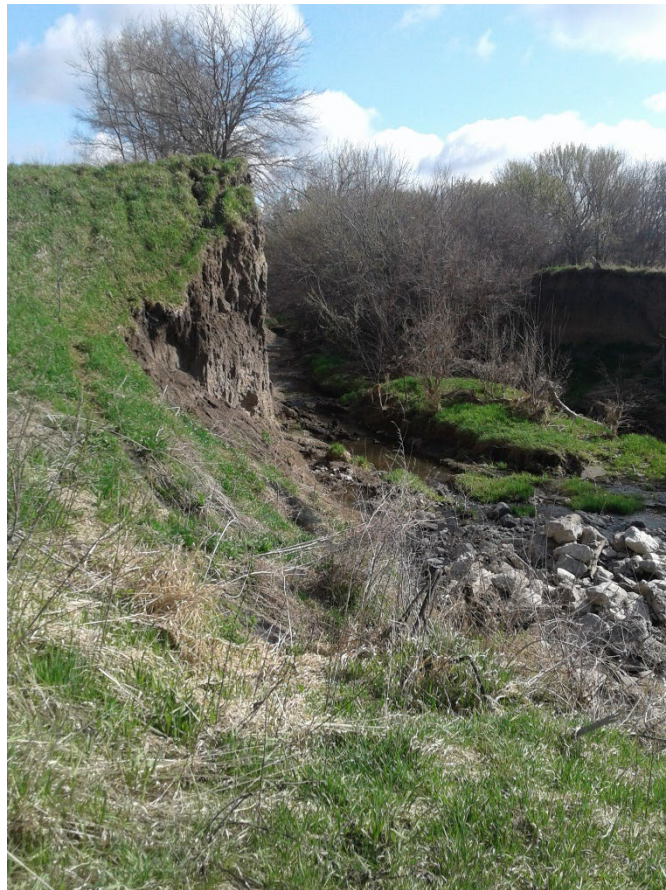
Significant bank erosion is seen below the structure and there were signs that the rock protecting the wing wall was recently placed, though not by the NRD. Figure 13. Show the bank erosion below the structure.

**Figure 13. Bank erosion below the culvert structure on Giles Rd. near 180<sup>th</sup> St.**

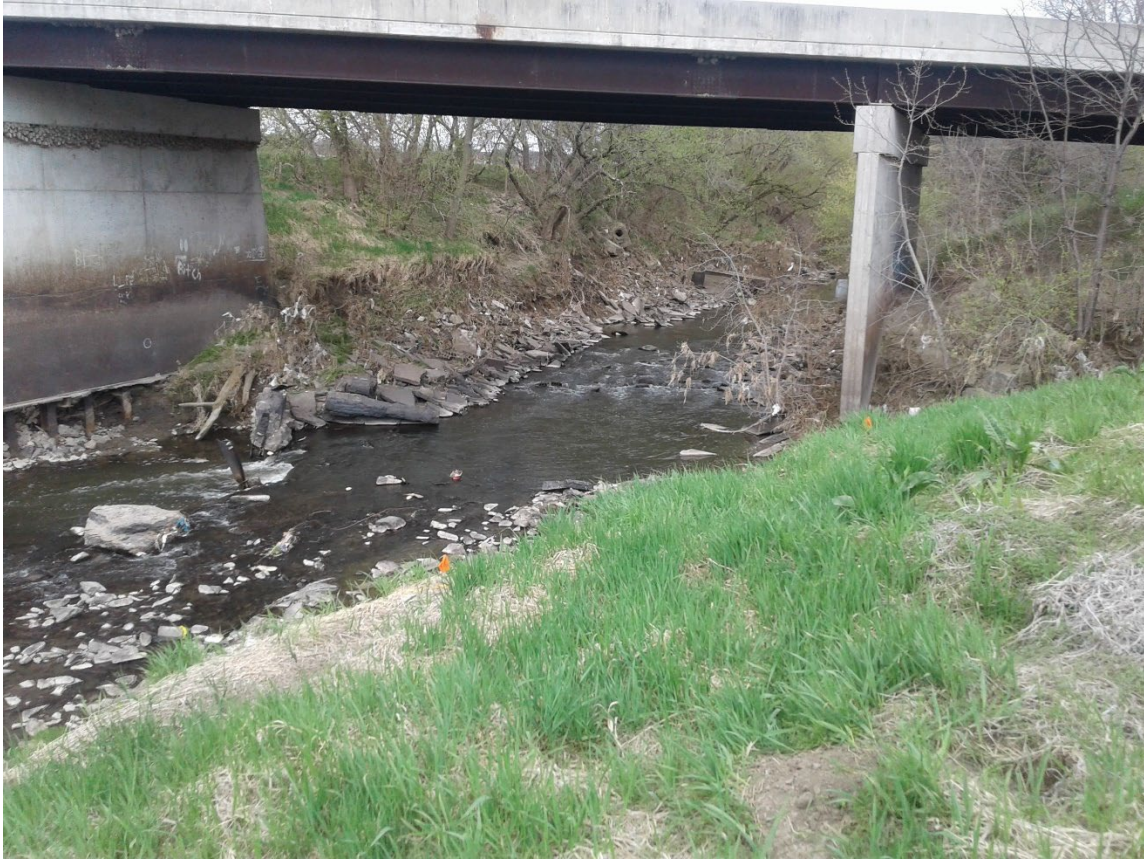
At the 132<sup>nd</sup> St. bridge location, the I-beams driven into the subsurface to support the bridge piers are exposed due to channel degradation. The condition is exacerbated by the discharge of surface runoff into the channel directly below the bridge. Due to degradation, the surface discharge is now perched 10 feet above the channel, and the momentum of the discharge carries it to the far bank, increasing bank erosion. Figure 14. Shows the bridge with surface discharge pipe delivering from the right.

**Figure 14. 132<sup>nd</sup> St. Bridge over West Papillion Creek.**

There has been some attempt to stabilize the bed of the channel by dumping concrete waste, cinder blocks, etc. in the area directly above the bridge. Some of this material appears to have moved under and below the bridge. It is unknown how effective this material is at preventing further bed degradation.

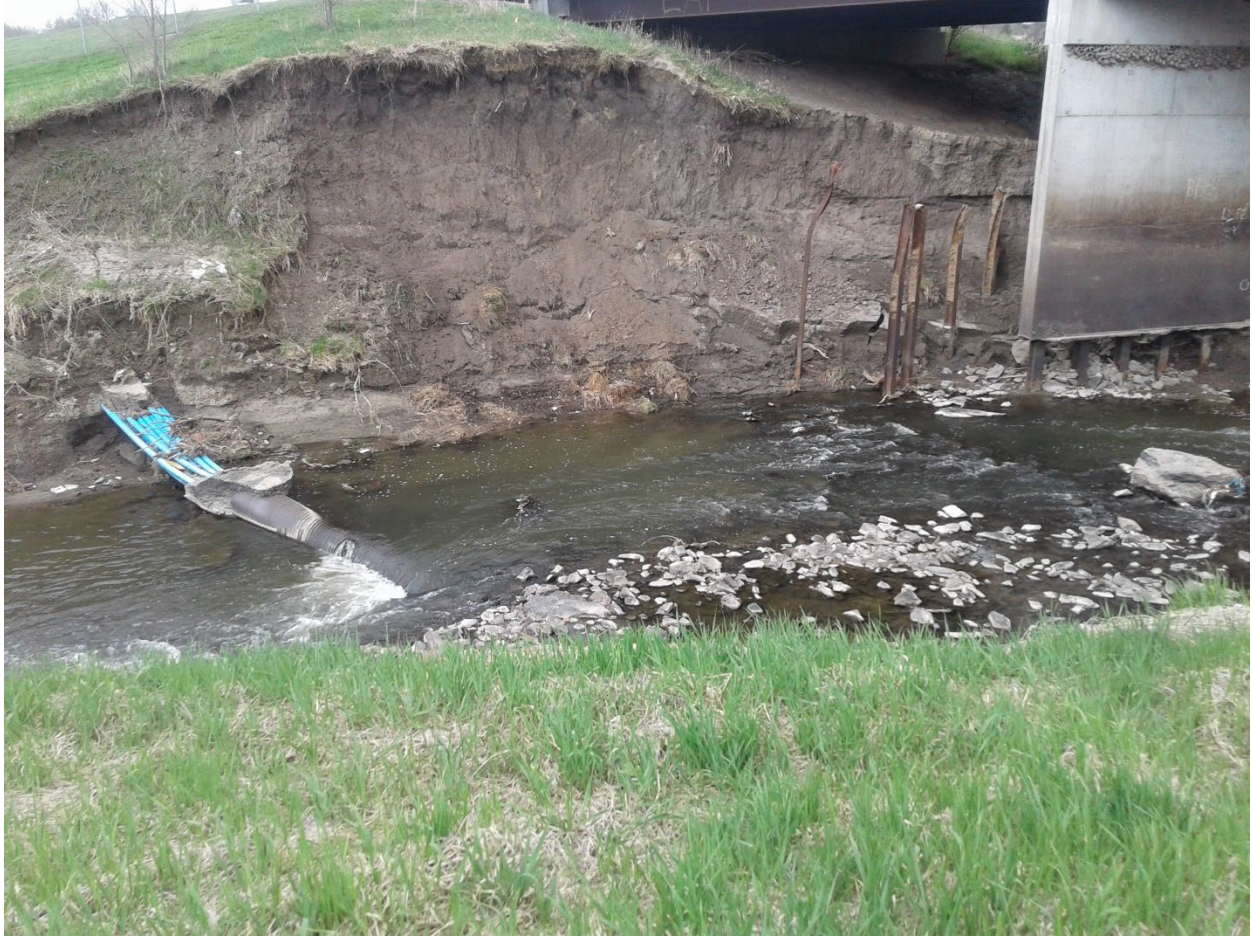
**Figure 15. Bank erosion caused by channel degradation and surface water discharge into channel perpendicular to bank. Note telecom lines exposed by erosion.**

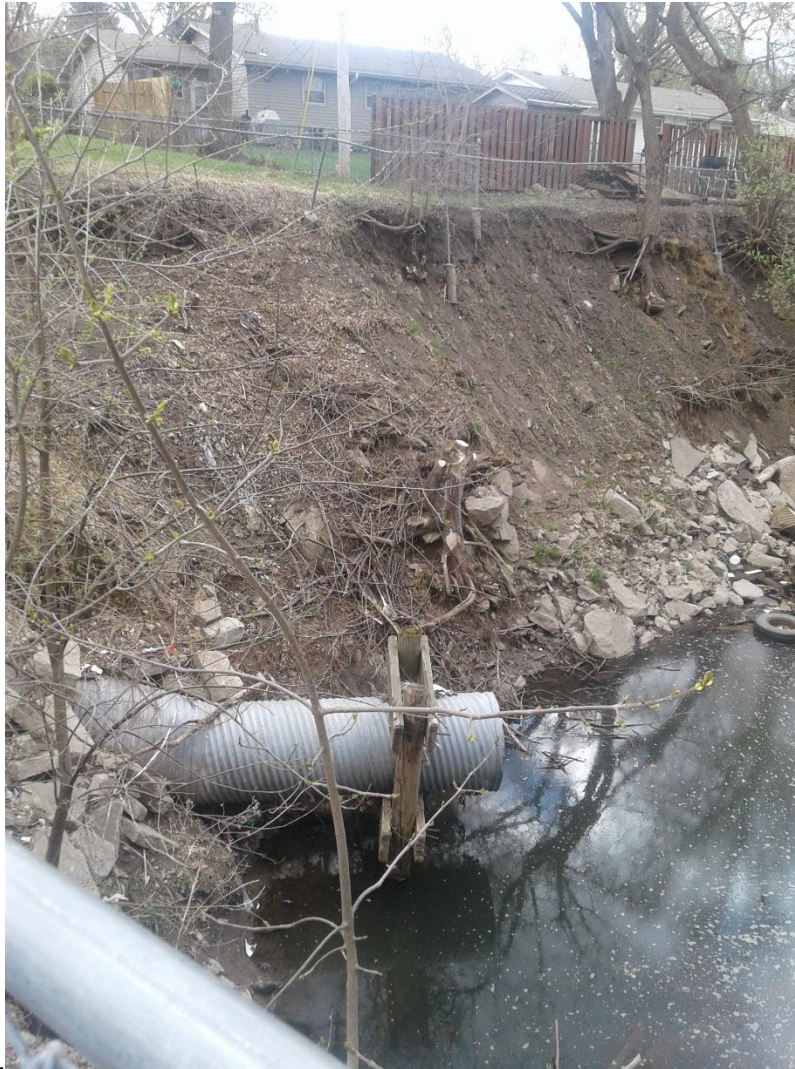
Extreme bank erosion can be observed on the left bank, resulting the fences and backyards falling into the river. Throughout the reach, the left bank averages 15-20 feet high. The reach is controlled by under-street culverts on each end. Work was done in the past to increase the capacity of the culvert to reduce localized flooding. Figure 16. Shows a fence falling into the creek, and Figure 17. Provides left bank height scale.

**Figure 16. Bank erosion along Cole Creek results in fences and trees falling into the creek.**

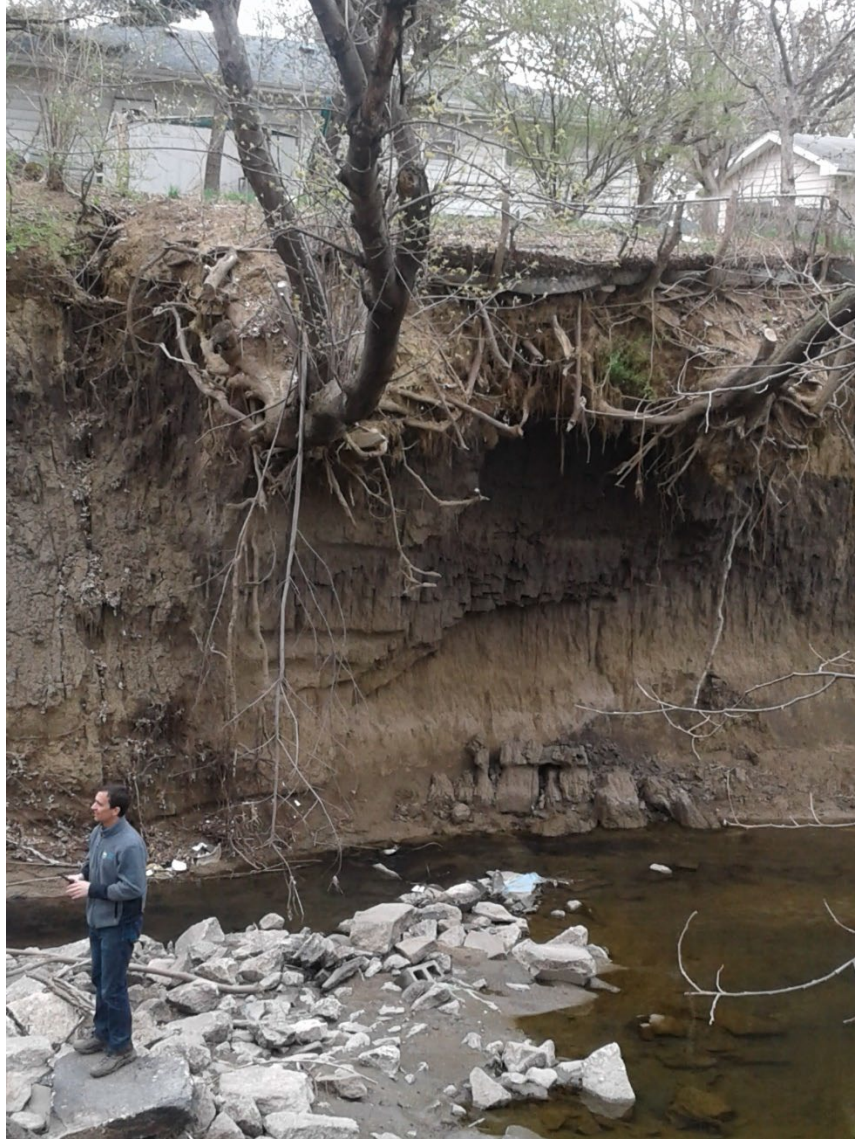
**Figure 17. Cole Creek left bank failure.**

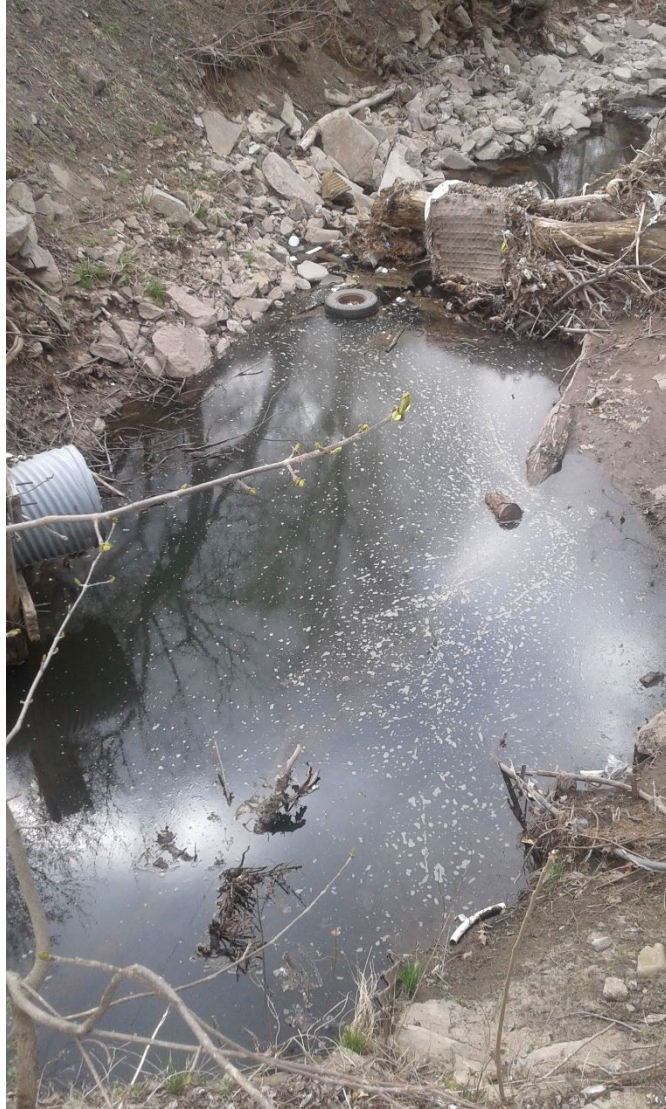
This one block reach is indicative of others in the watershed. The overall grade of the channel is controlled by the culverts at each road crossing, but channel degradation between crossings is extreme. Figure 18 shows the downstream outlet of the Hillside Drive culvert with large hole. Broken concrete makes up the majority of the bed material.

**Figure 18. Cole Creek channel below Hillside Drive culvert.**
