# **Papillion Creek Watershed**

## **Streambed Degradation Study**

### **Section 22: Planning Assistance to States**

#### **Final Report**

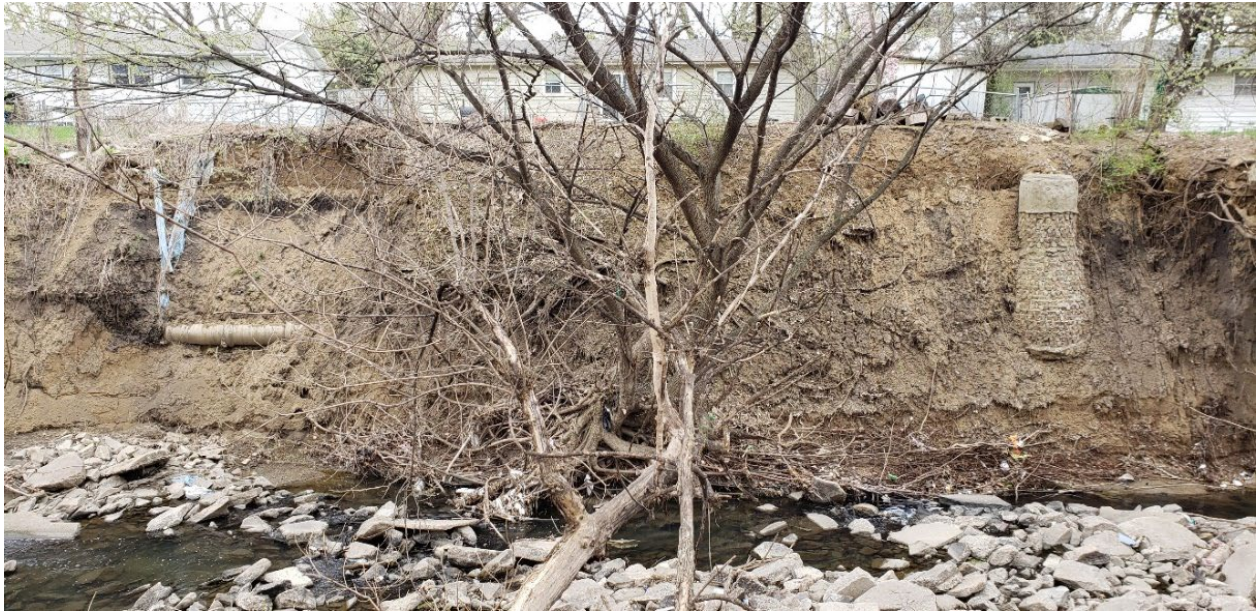
For example, during the site visit in April 2019, the channel section in Figure 4-6 illustrates a large quantity of broken concrete and rubble that is typical in many areas within Cole Creek. The concrete rubble mostly lines the center of the channel and does not provide bank protection. This type of protection is not consistent but does provide limited benefits for channel stabilization; however, the concrete rubble also lines the center of the channel and directs flow into the channel banks that are already eroding. In many cases, the streambanks are vertical and very susceptible to extreme slumping and mass bank failure.

**Figure 4-6: Cole Creek Channel and Bankline Showing Riprap Rubble**

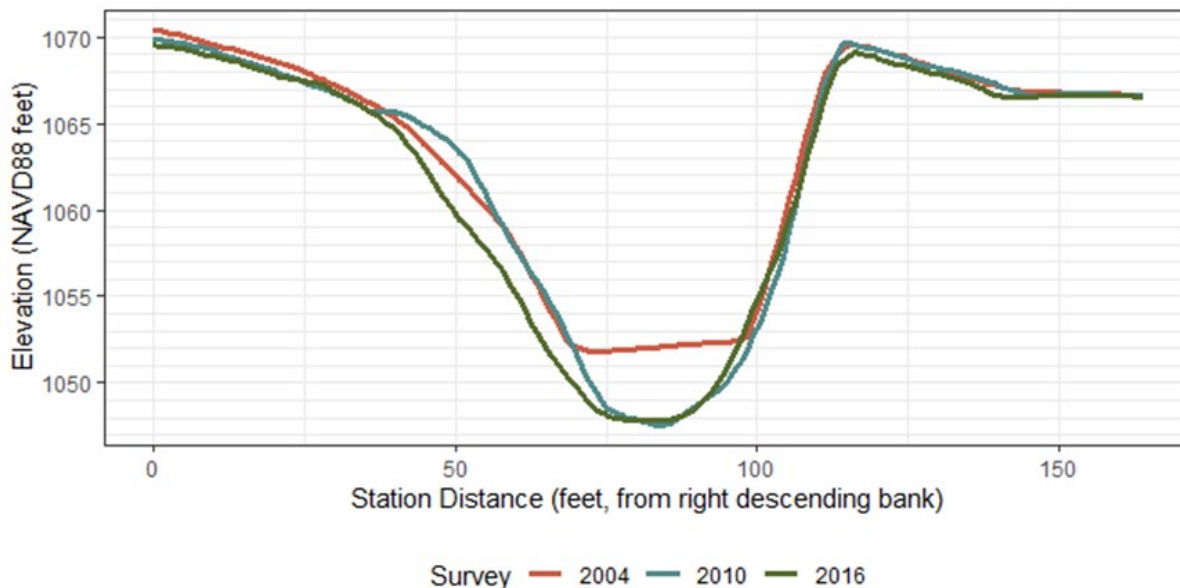
The Western Avenue culvert was replaced prior to the LiDAR data collection in 2004 and there are possible bed changes (lower by degradation; Figure 4-12 is associated with that change upstream of the crossing). There was also a change to the Seward Street crossing between 2004 and 2010 (Figure 4-13). Further investigation into the causes of local bed and bank erosion issues is warranted. The culvert inverts and sizing designs should be reviewed to determine what channel changes may have occurred as a result of the culverts being replaced.

**Figure 4-12: Cross-section 84 Illustrating Bed Changes Between 2004 and 2016**

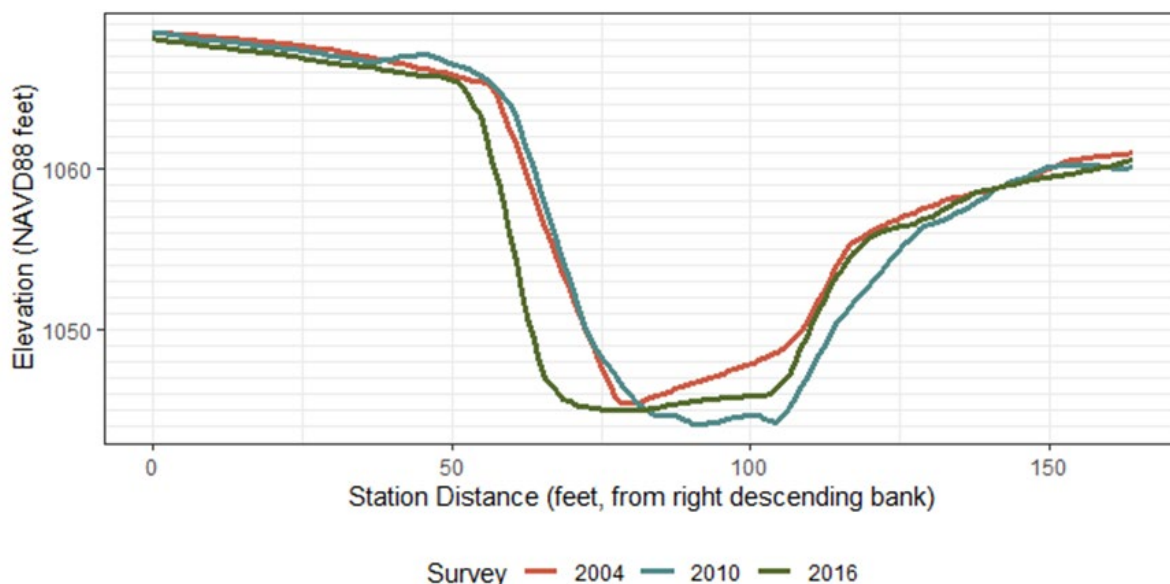
Associated with the bed degradation, there is also lateral bank erosion which is expected in incised channels (Figure 4-13). The channel has eroded the bed approximately two-to-three feet (Figure 4-12) and eroded laterally eight-to-ten feet (Figure 4-13) in two locations.

**Figure 4-13: Cross-section 113 Illustrating Left Bank Lateral Erosion**

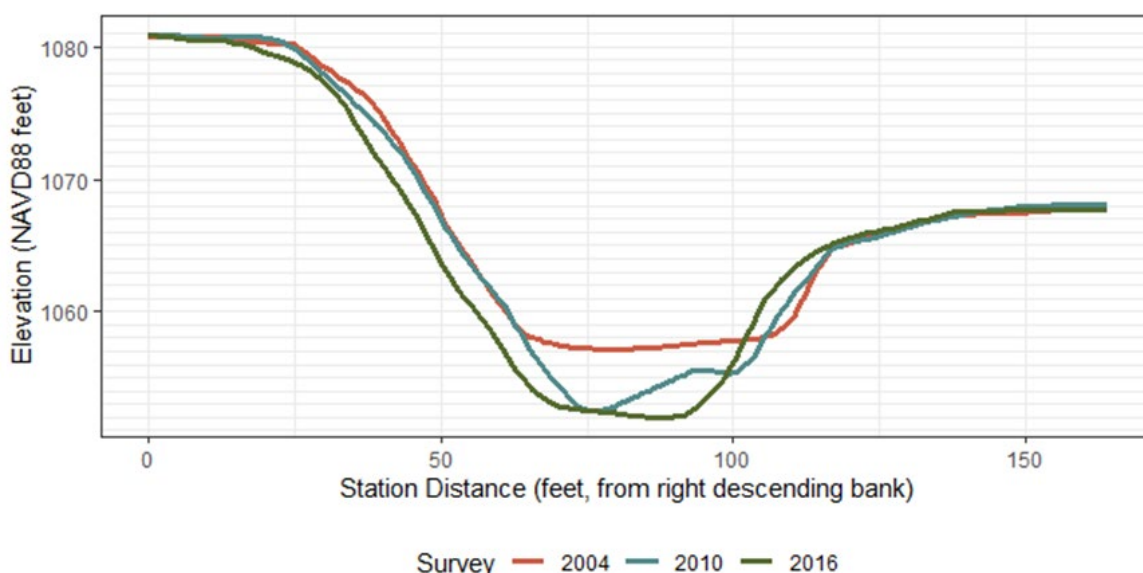
The water surface profiles show a trend of channel degradation in the downstream section of the reach (cross-sections 1-26) from Blondo Street to approximately station 1800. The bed lowering was likely caused by the culvert changes downstream in the upper section of Reach 1. The middle section of Reach 2 (cross-sections 27-57) approximately station 1800 to the Maple Street culvert is not as incised. This sub-reach has much lower bank heights, eight to 10 feet, with some access to active floodplains. Figure 4-17 illustrates potential channel degradation as the channel appears to deepen and widen at this cross-section location. Figure 4-18 shows channel migration with no associated degradation.

**Figure 4-17: Reach 2 – Cross-section 7 Depicting Potential Channel Degradation**

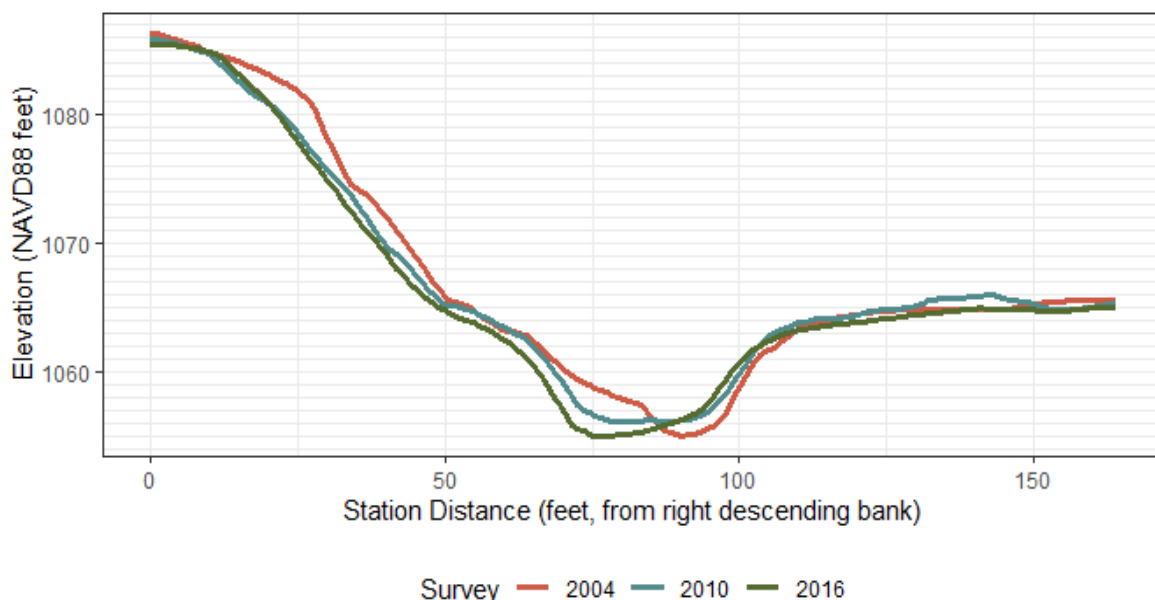
**Figure 4-18: Reach 2 – Cross-section 38 Illustrating Channel Migration**

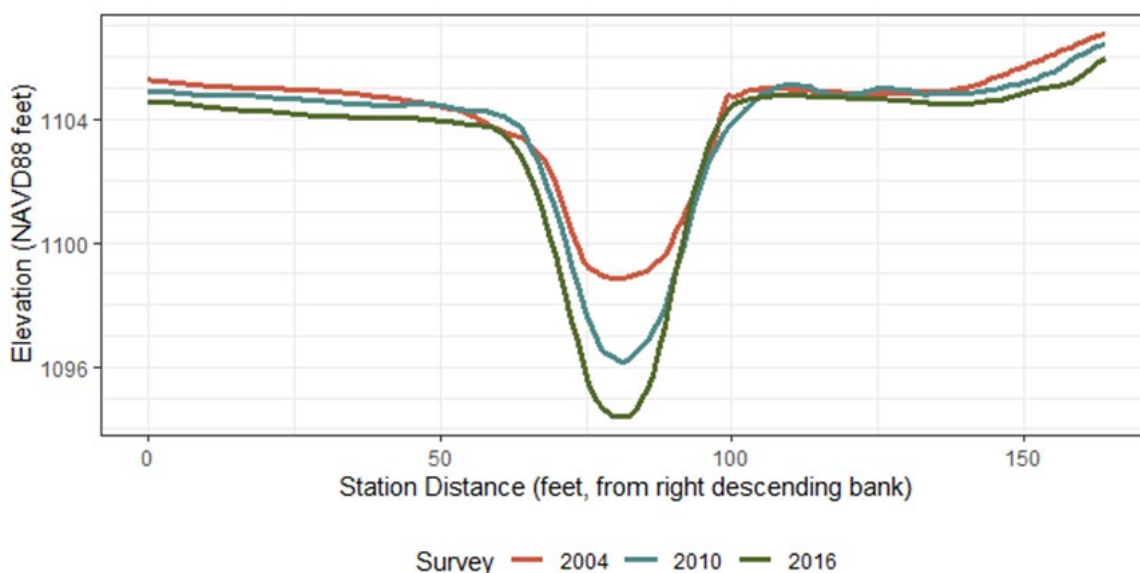
The water surface profiles indicate a trend of channel degradation ranging from approximately two to four feet. The incised channel locations are located on the downstream section of the reach as indicated by the bank heights. The channel bed lowering is more significant in the downstream section (Figure 4-28) of the reach than in the upstream section (Figure 4-29). There are larger slope breaks in the downstream section of the reach where there are riprap Grade Control Structures (GCS) (Figure 4-27). There is also local bank protection that has occurred throughout the reach.

**Figure 4-28: Reach 4 – Cross-section 12 Illustrating Bed Changes Between 2004 and 2016**

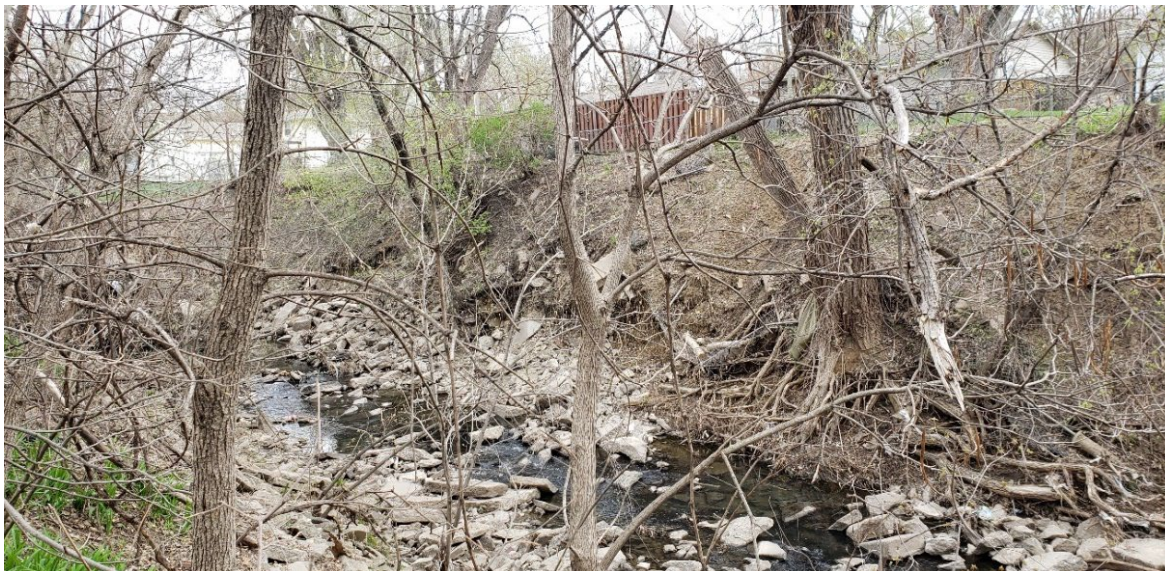
- Reach 1 was visited in 2019. The Level I analysis predicts low W/D and ERs for the section of the reach in Figure 4-40. The Hillsdale Drive culvert is scheduled to be replaced just upstream of the photo. As is typical in urban watersheds, there are large amounts of concrete rubble within the incised channel. In some cases, the rubble is directing flows into the incised channel banks, further destabilizing the streambanks. It would be possible to shape some of the existing concrete rubble and protect the highly erodible streambanks. This could also promote floodplain berm building within the channel margins, if that would be an appropriate option based on hydraulic modeling. A series of GCSs in the reaches would provide added stability and would supplement local bank protection alternatives. Figure 4-41 shows the current conditions in the reach.

**Figure 4-41: Cole Creek Downstream of Hillside Drive**

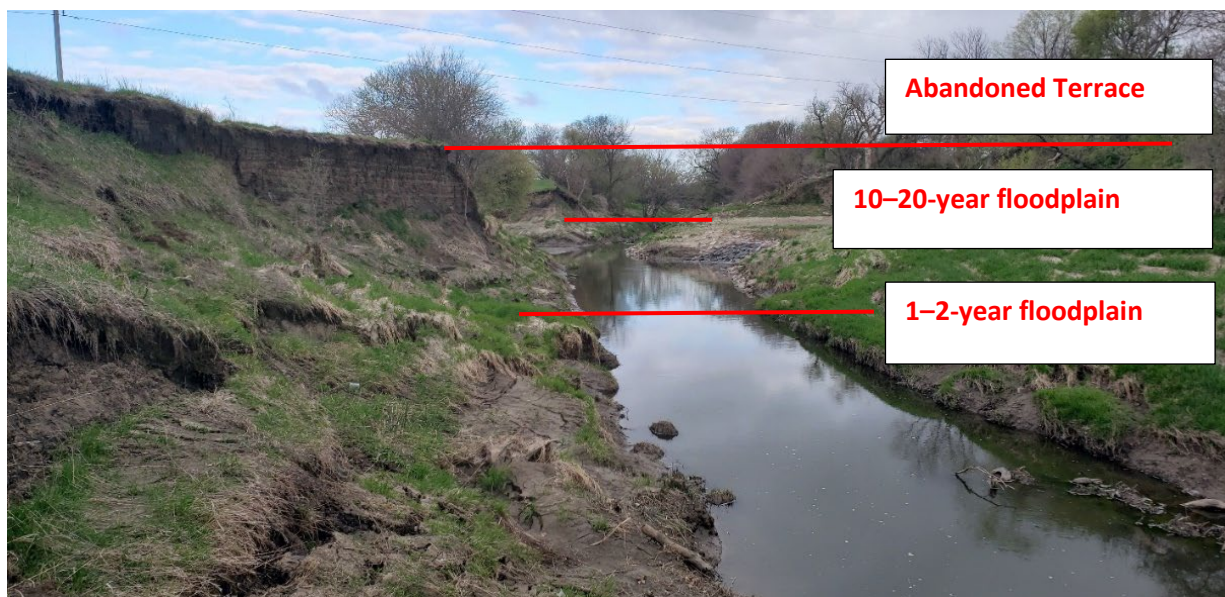
There have been wide-scale changes in land-use in the South Papillion Creek watershed and they are continuing today. The changes include stream channelization, agricultural and urban development, and public infrastructure encroachments in the form of bridges, roadways, and utilities. The changes impact soil infiltration and runoff rates changing the characteristic delivery of sediment and hydrologic discharge regimes throughout the watershed. The changes lead to a process of channel bed incision followed by widening and floodplain redevelopment. The presence of multiple terrace and floodplain levels illustrates the geomorphic channel evolution (Figure 4-52) providing evidence of the process.

**Figure 4-52: Papillion Creek Channel Facing Upstream with South Papillion Creek Mouth to Left and Hell Creek Grade Control Structure (GCS) on the Right**

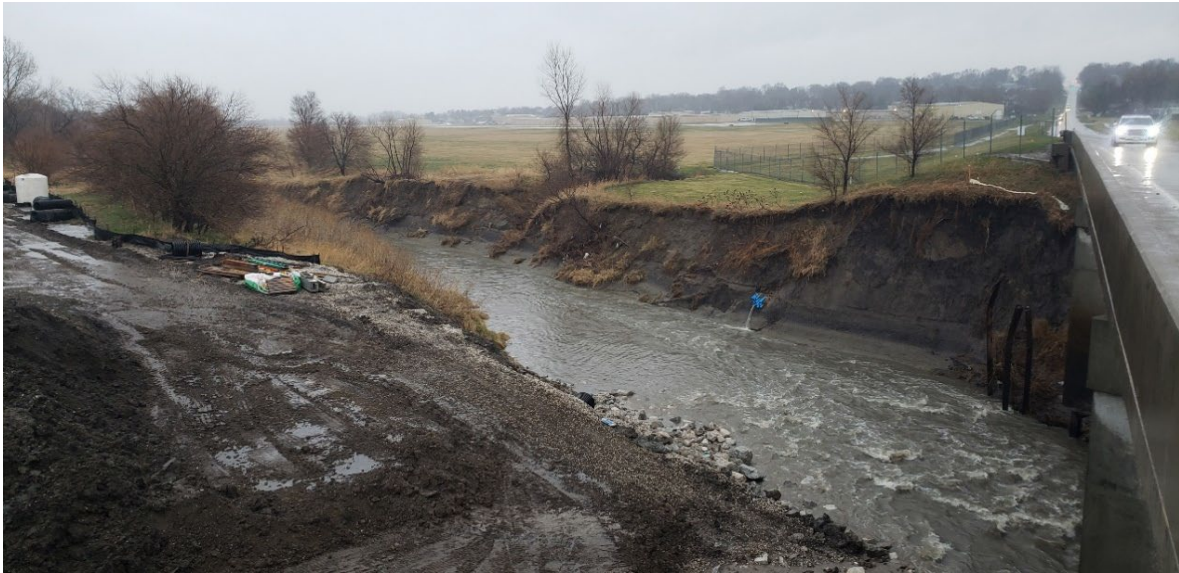
**Figure 7-2: FG Reach 5 – Right Bank Erosion Downstream of 132<sup>nd</sup> Street Bridge, West Papillion Creek**

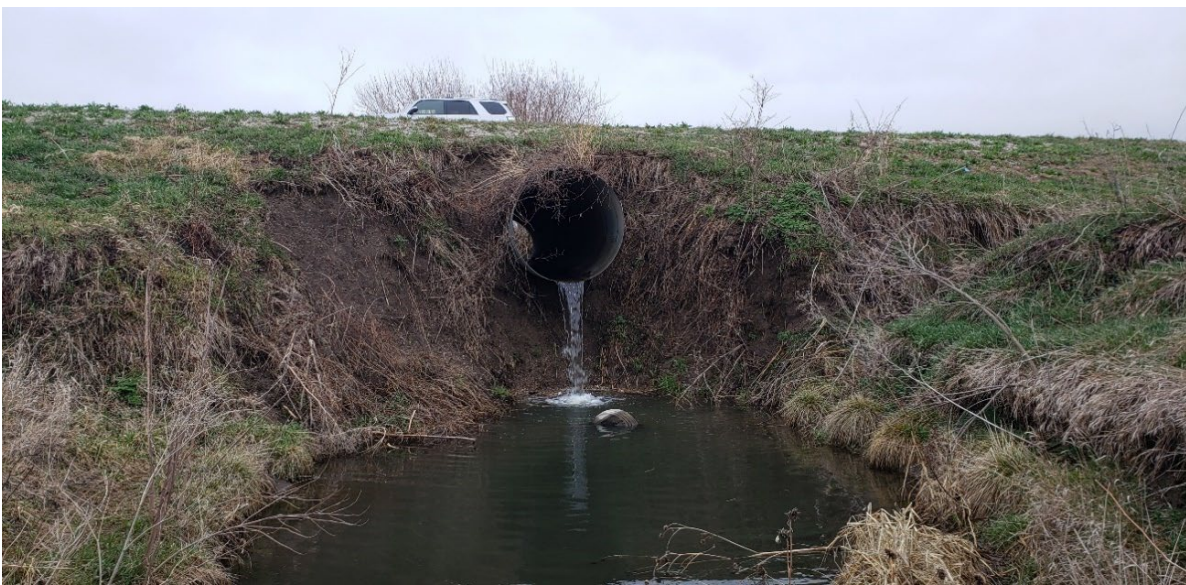
**Figure 8-5: South Papillion Creek FG, Reach 9 – Downstream Terminus of Reach 9, Illustrating a Perched Culvert at South 216<sup>th</sup> Street**

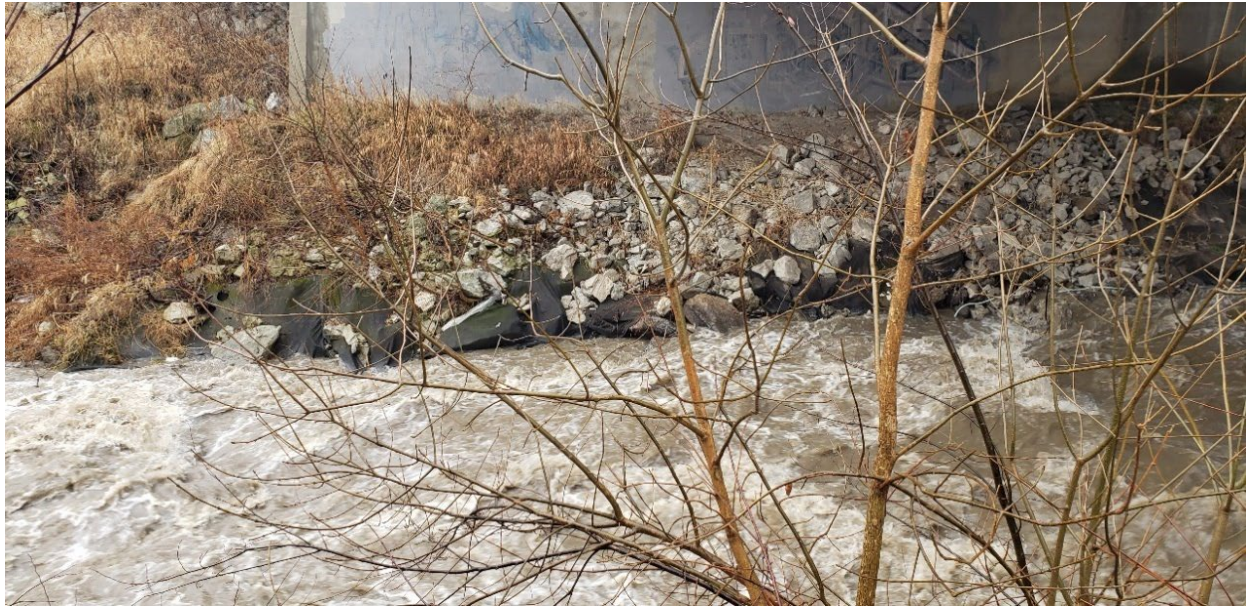
**Figure 8-6: FG Reach 2b –South Papillion Creek: Existing Riprap Forming GCS Under South 126<sup>th</sup> Street Bridge**

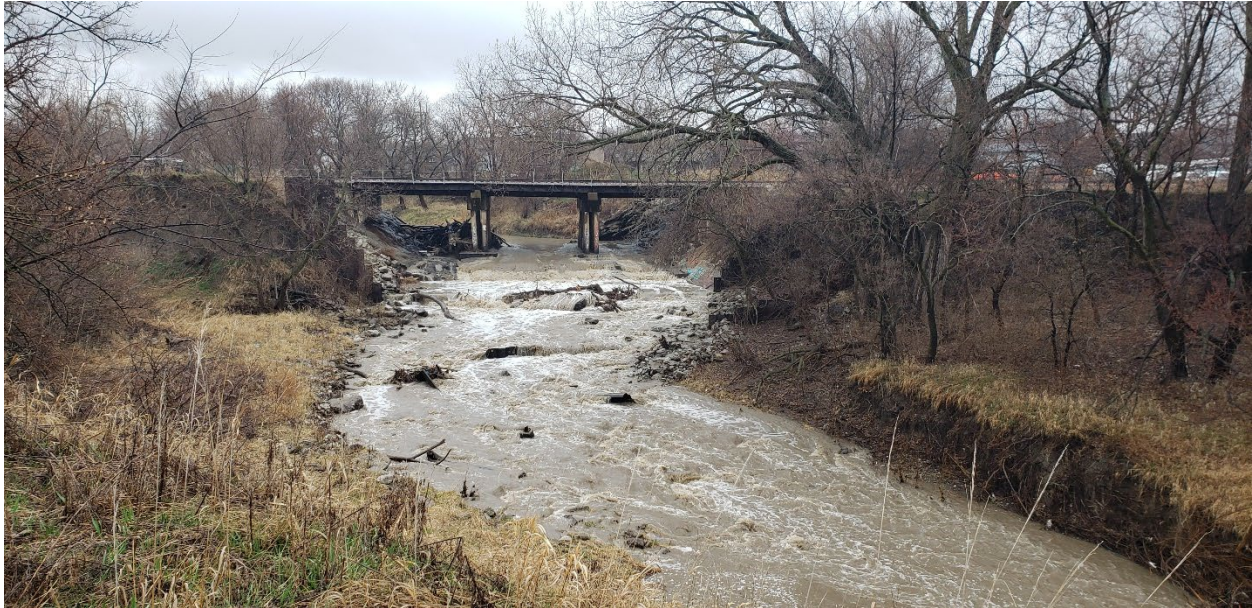
**Figure 8-8: FG Reach 3, South Papillion Creek – Illustrating Railroad Bridge GCS**

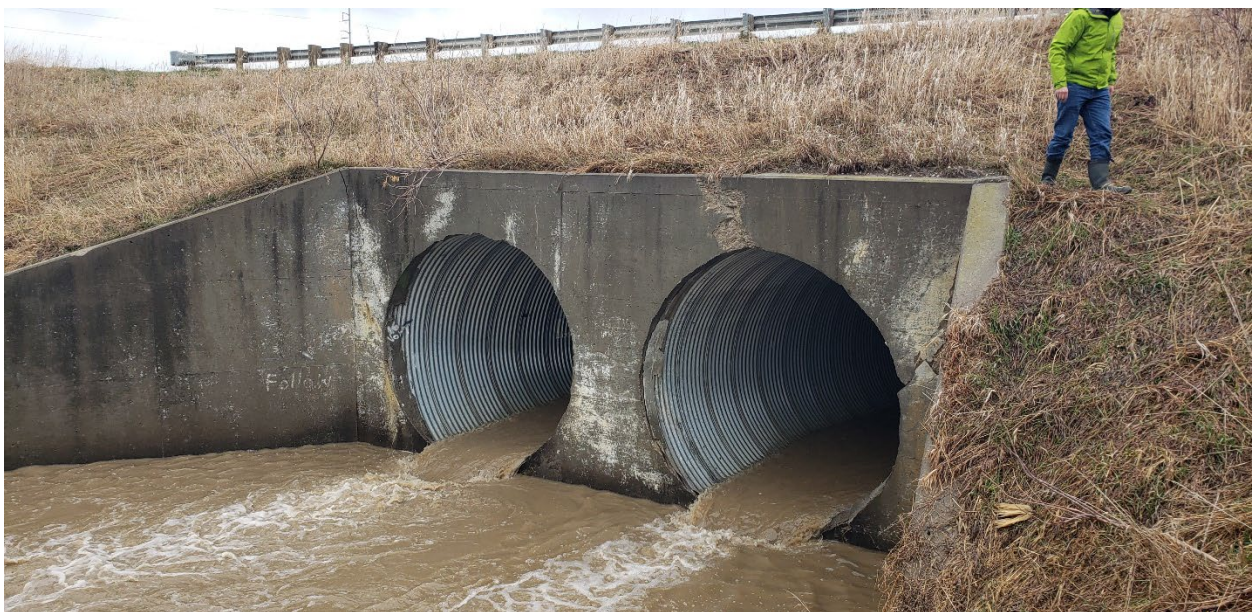
**Figure 8-9: FG Reach 6, South Papillion Creek – Giles Road Culverts**

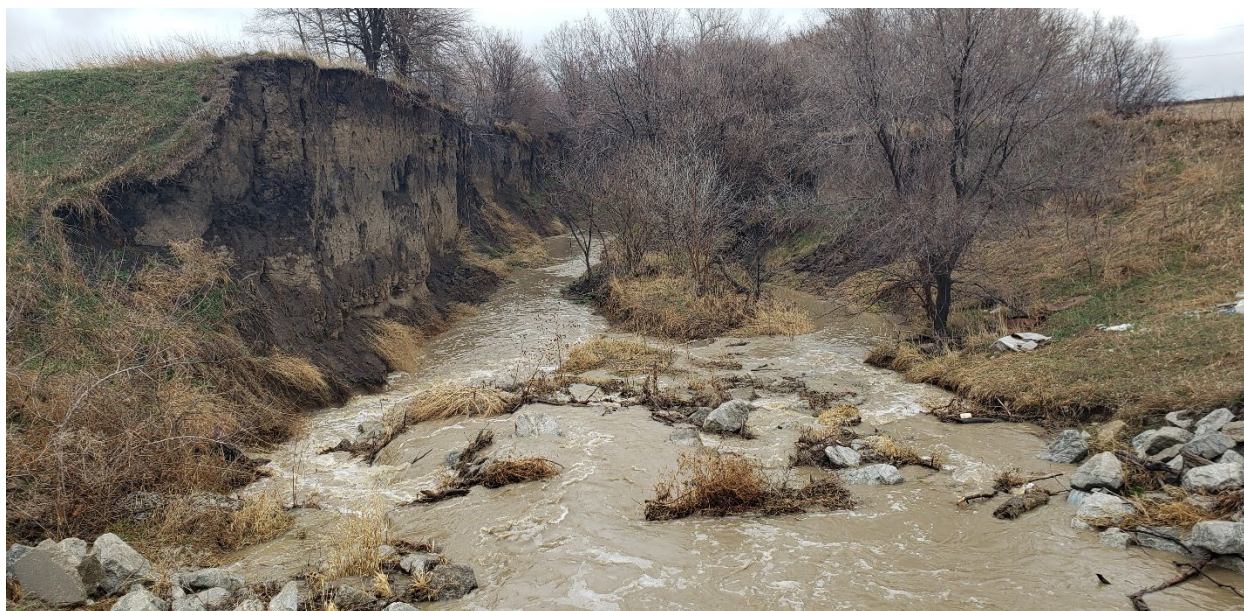
**Figure 8-12: FG Reach 6, South Papillion Creek – Downstream of Giles Road Culverts Showing Local Channel Degradation at Culvert Outlets and Unstable Banks Downstream**

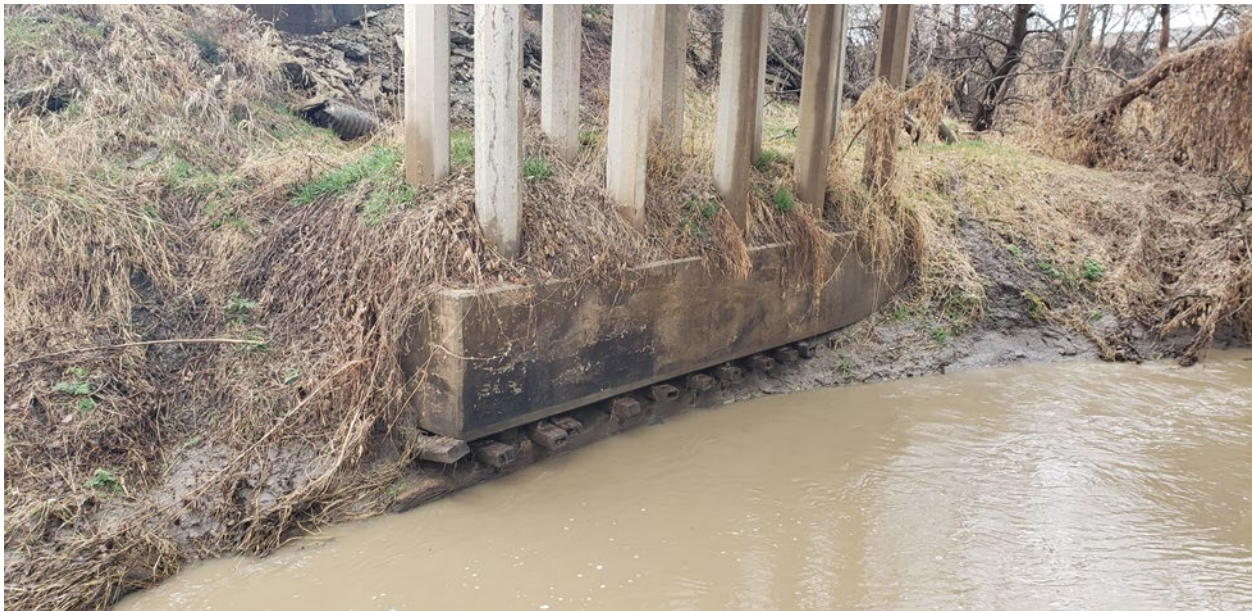
**Figure 8-14: FG Reach 6, South Papillion Creek – Railroad Bridge in Upstream Section of Reach Showing Scour and Potential Undercutting of the Wood Footings**
