NPDES PERMIT (NER210000) FOR SMALL MUNICIPAL STORM SEWER DISCHARGES TO WATERS OF THE STATE LOCATED IN DOUGLAS, SARPY, AND WASHINGTON COUNTIES OF NEBRASKA

NPDES PERMIT NUMBER (NER210000)

2024 ANNUAL REPORT

CITY OF BELLEVUE
1500 WALL STREET
BELLEVUE, NE 68005

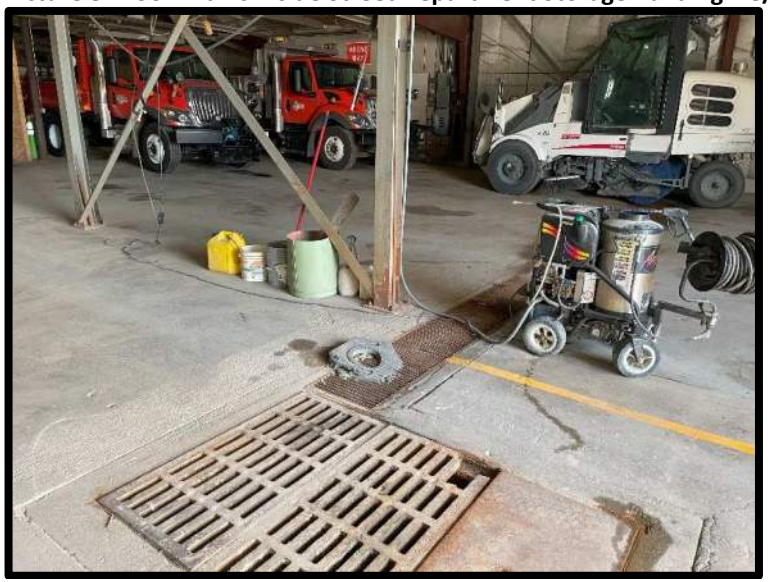
Picture 8: Floor Drains Inside Street Department Storage Building – 8/27/2024

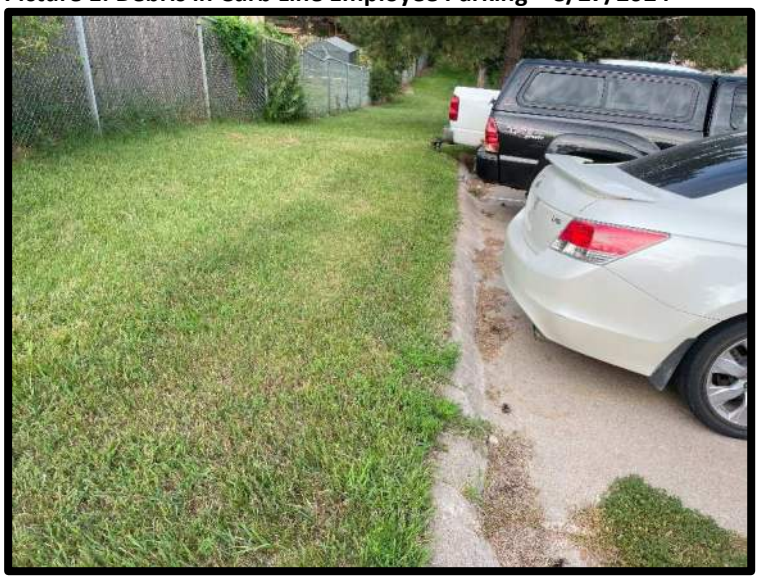
Picture 1: Debris in Curb Line Employee Parking – 8/27/2024

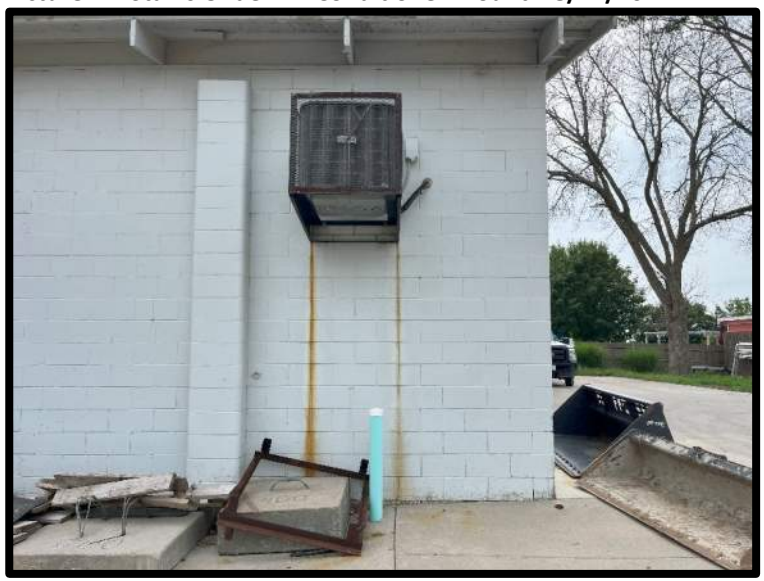
Picture 14: Stains Under Air Conditioner Mount – 8/21/2024

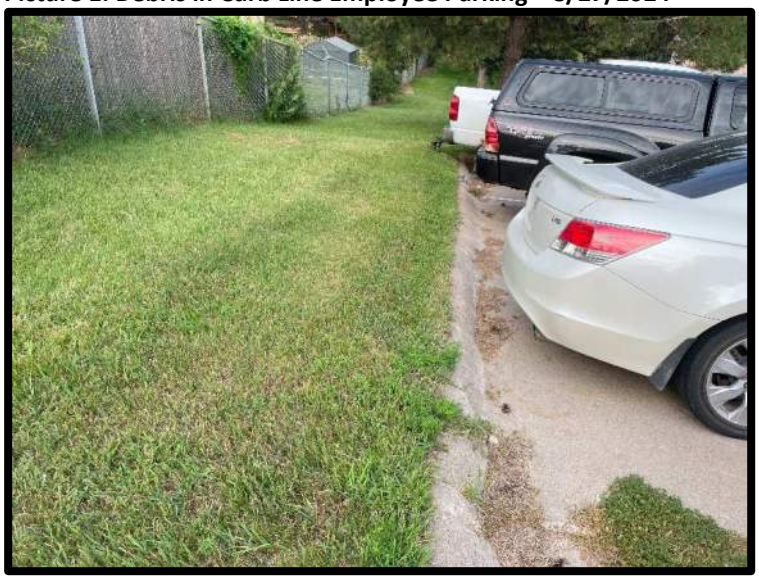
Picture 1: Debris in Curb Line Employee Parking – 8/27/2024

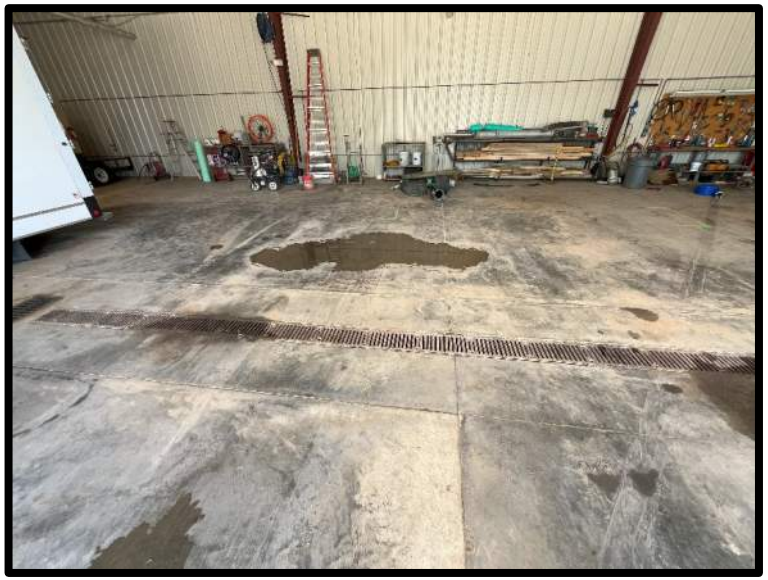
Picture 30: Main Office Interior Trench Drains – 8/15/2024

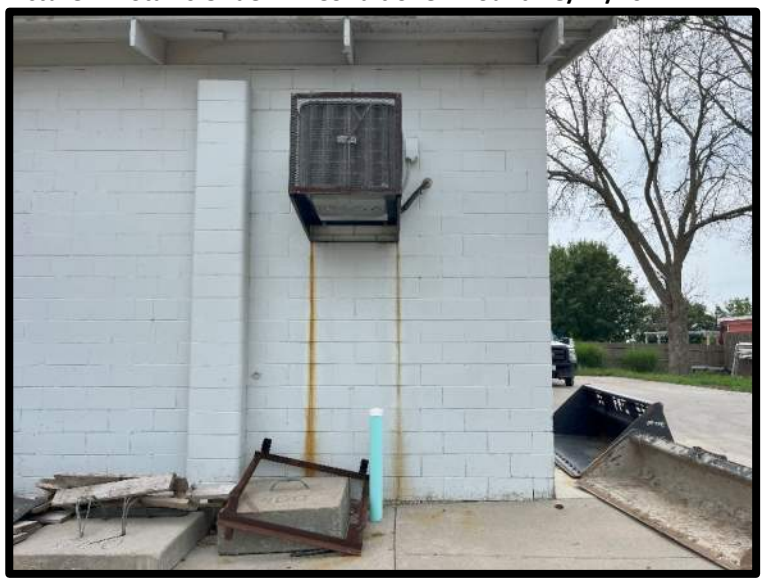
Picture 14: Stains Under Air Conditioner Mount – 8/21/2024
