# **Papillion Creek Watershed**

## **Streambed Degradation Study**

### **Section 22: Planning Assistance to States**

#### **Final Report**

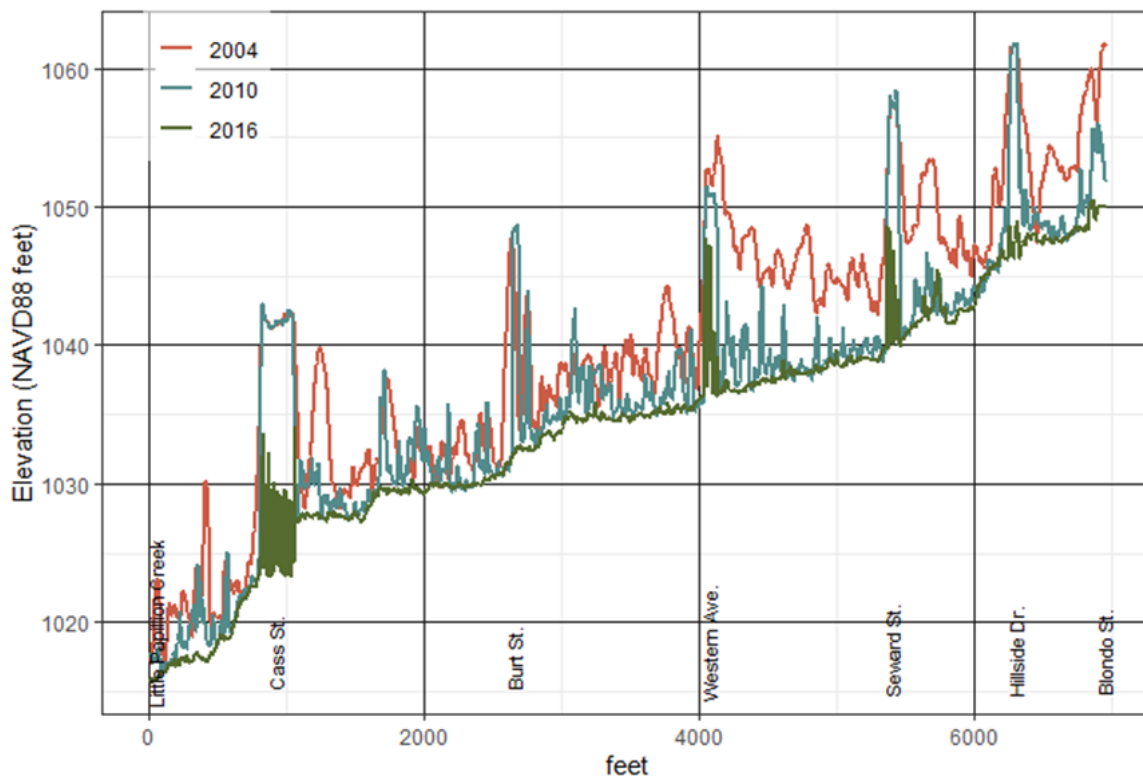
**Figure 4-9: FG Level 1, Reach 1 – LiDAR Water Surface Profiles**

The lower section of the reach has relatively close matching profile (Figure 4-9) and cross-sections (Figures 4-10 and 4-11) showing little or no changes between the 2004 to 2016 data. The profile within this reach is relatively consistent except for the channel section upstream of Western Avenue.

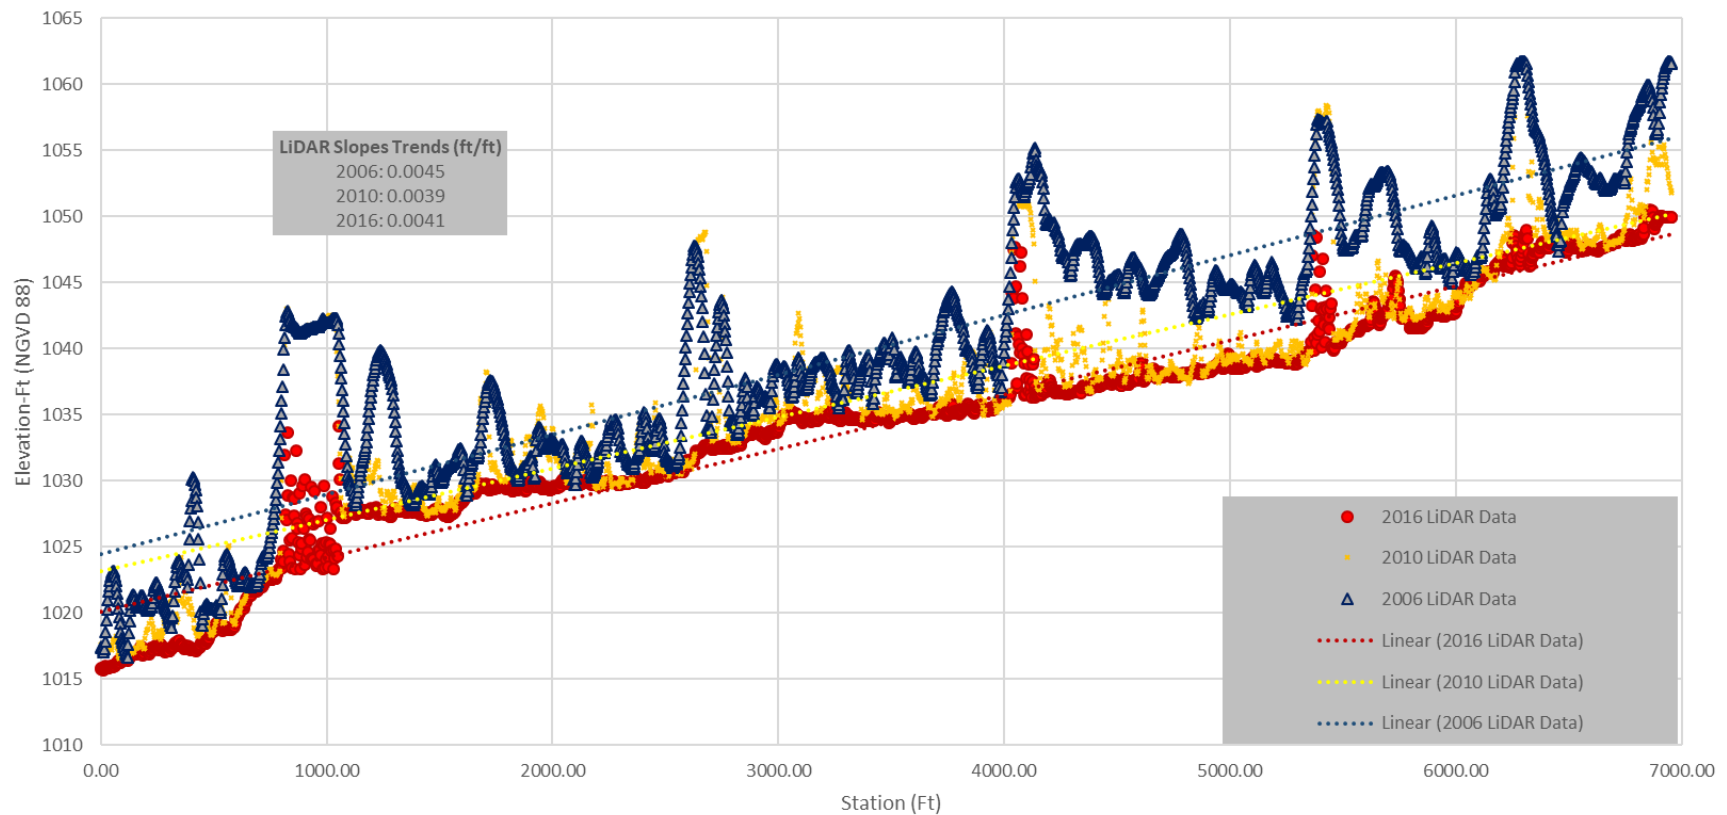
**Figure 4-14: Reach 1 – LiDAR Slope Trends**

- The LiDAR water surface slopes are plotted in Figure 4-14. The slope trends show a decrease in channel slope from 0.0045 to 0.0041 ft/ft. The slopes are largely being controlled by the road culverts and concrete rubble in the channel bottom.

- Based on the FG Level 1 analysis, the lower section of Reach 1 appears to have a stable bed with local channel erosion downstream of the Western Avenue culvert. Upstream of the culvert there appears to be channel degradation and some lateral bank erosion. The section above Western Avenue should be further investigated to field-validate the information from this report.

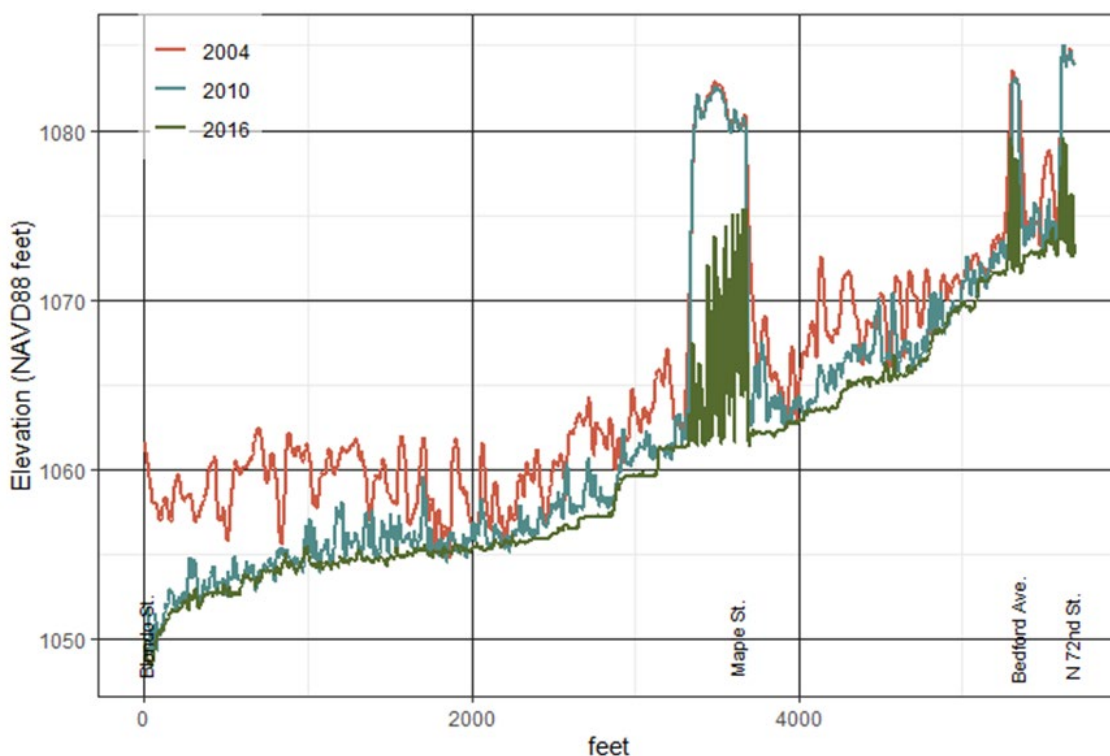
**Figure 4-16: FG Level 1, Reach 2 – LiDAR Water Surface Profiles**

The water surface profiles show a trend of channel degradation in the downstream section of the reach (cross-sections 1-26) from Blondo Street to approximately station 1800. The bed lowering was likely caused by the culvert changes downstream in the upper section of Reach 1. The middle section of Reach 2 (cross-sections 27-57) approximately station 1800 to the Maple Street culvert is not as incised. This sub-reach has much lower bank heights, eight to 10 feet, with some access to active floodplains. Figure 4-17 illustrates potential channel degradation as the channel appears to deepen and widen at this cross-section location. Figure 4-18 shows channel migration with no associated degradation.

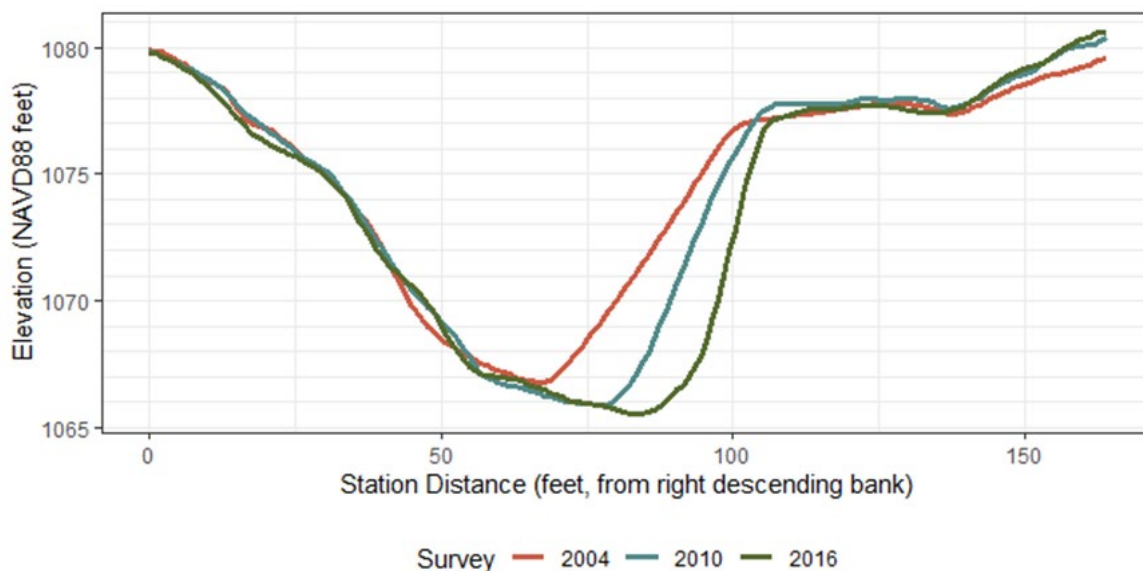
**Figure 4-19: Reach 2 – Cross-section 86 Illustrating Lateral Right Bank Erosion**

The channel bed upstream of the Maple Street culvert is relatively stable with some bank erosion (right) in the range of 10 to 15 feet (Figure 4-19). The bank erosion appears local as many of the cross-sections appear to match well, showing some minor bed and bank erosion (Figure 4-20).

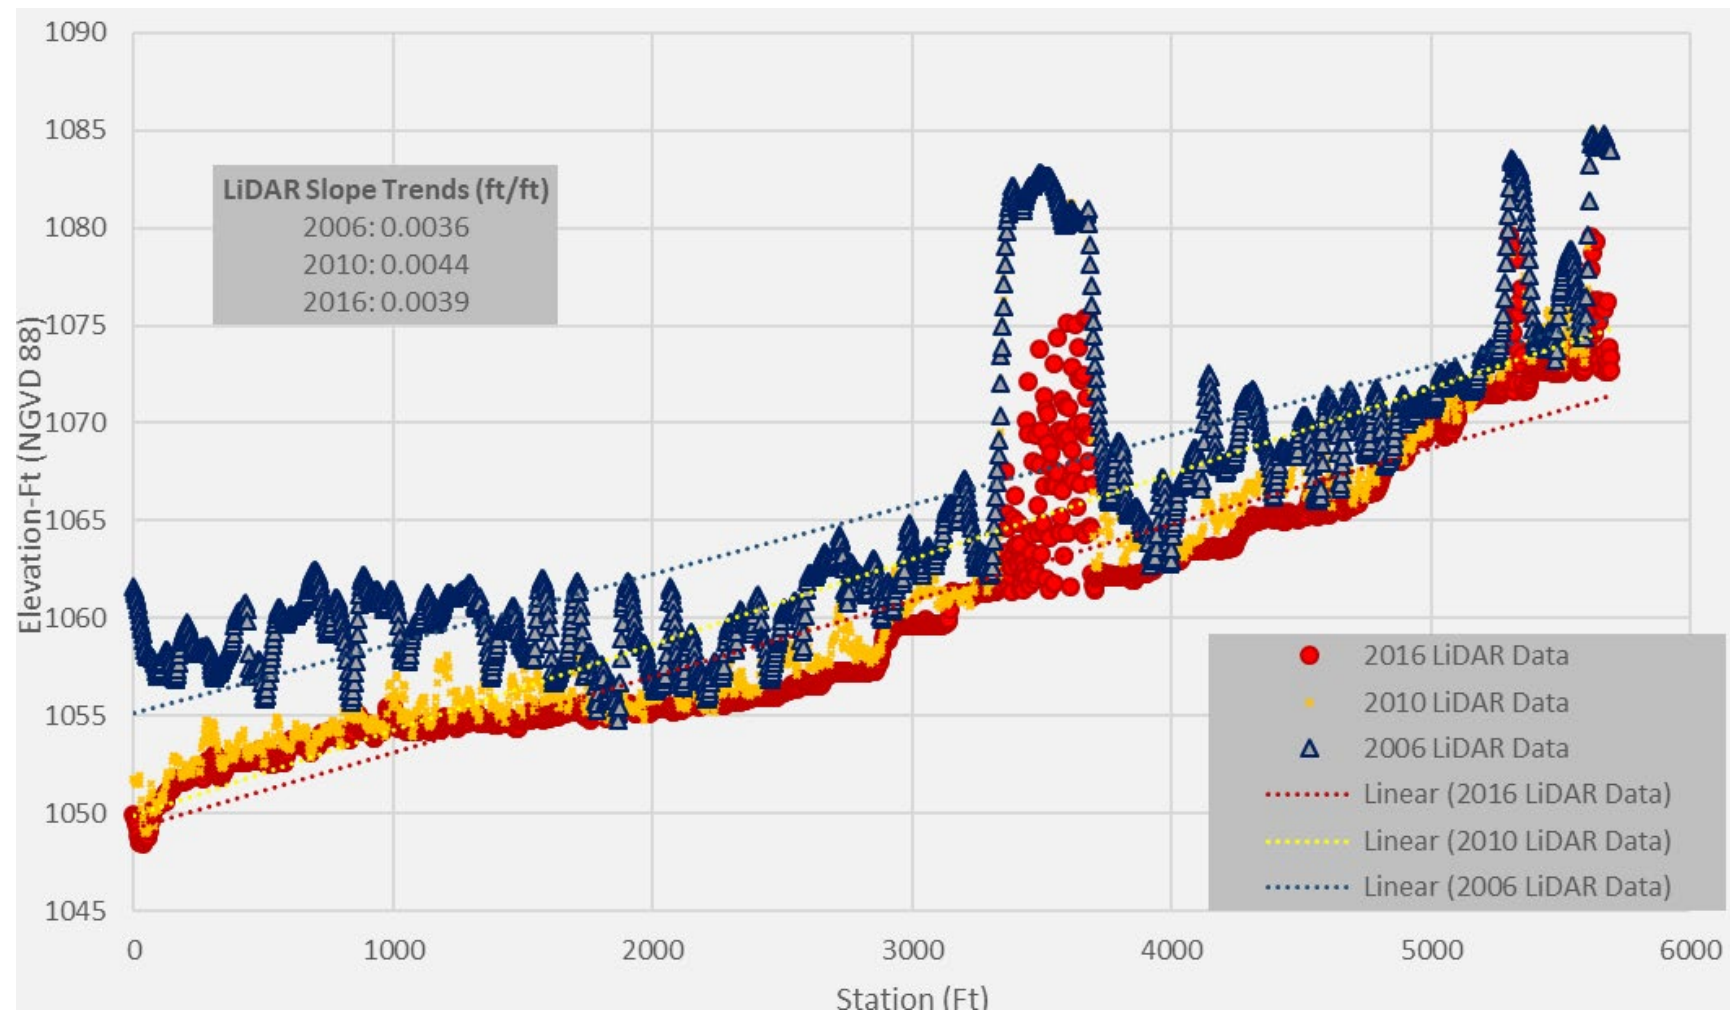
**Figure 4-21: Reach 2 – LiDAR Slope Trends**

- The LiDAR water surface slopes are plotted in Figure 4-21. Different LiDAR slope trends range from 0.0036 to 0.0044 ft/ft. The water surface slopes steepened from 2004 to 2010 and is now trending back closer to the 2004 slope.

- Based on the FG Level 1 analysis, the lower section of Reach 2 has channel degradation occurring. The middle section has good access to a floodplain but has some channel migration occurring as well. The rest of the reach upstream of the Maple Street culvert is relatively stable with some bank migration occurring. The downstream section should be further investigated all the way to the Maple Street culverts to verify current channel conditions.

- If there is active channel bed degradation occurring from channel changes that occurred in the downstream Reach 1, then there is likely further migration of the instability into the middle section of this reach.

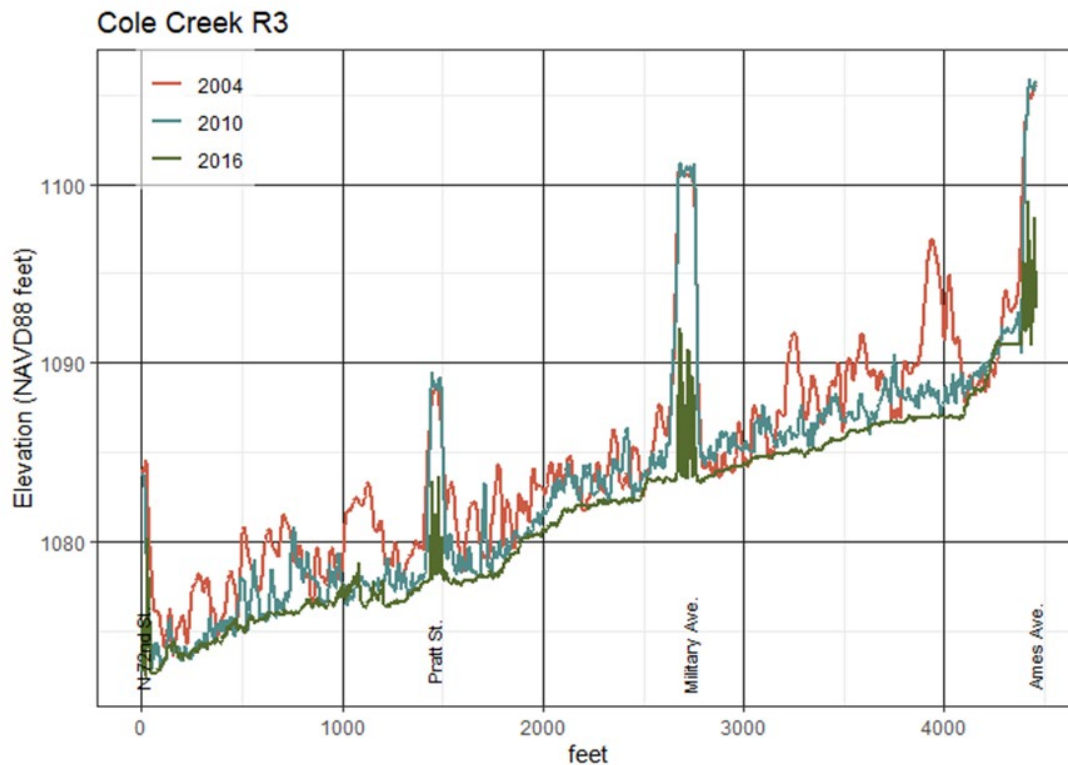
**Figure 4-23: FG Level 1, Reach 3 – LiDAR Water Surface Profiles**

The water surface profiles show a slight trend of channel degradation from 2004 to 2016; however, the lowest plotted points from the 2004 LiDAR do fall relatively close to the same elevations as the 2010 and 2016 counterparts, so there are likely some local channel changes occurring, but not a general trend for the reach over the 10 years between data sets. Figure 4-24 illustrates the stable channel conditions throughout this reach based on the LiDAR cross-sections.

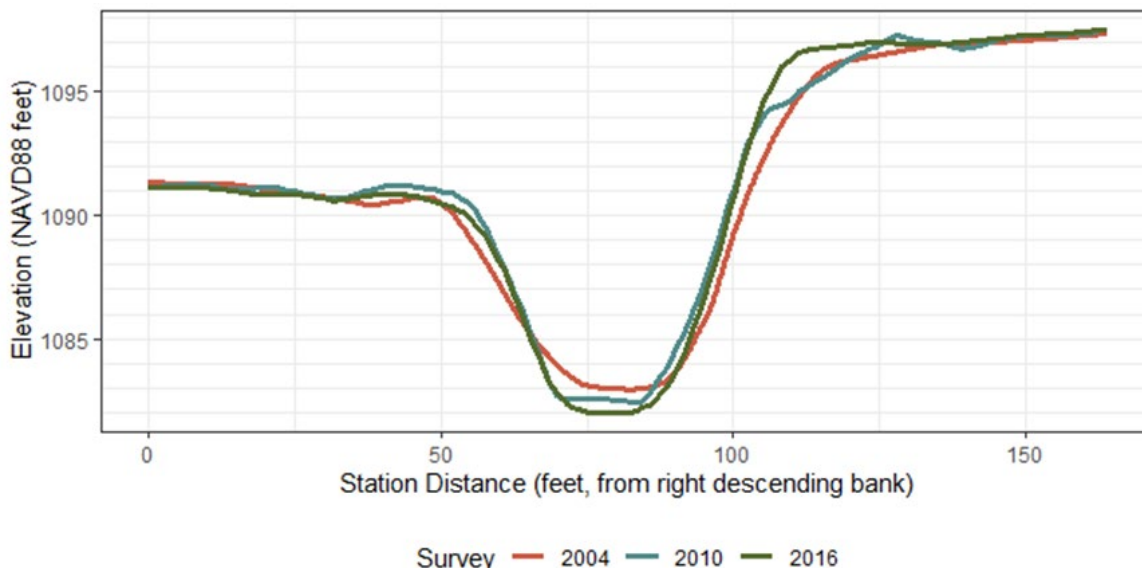
**Figure 4-24: Reach 3 – Cross-section 81 Depicting a Relatively Stable Bank**

- Part of the reach has access to a floodplain and is likely a CEM Stage V; however, some areas still have not developed any floodplain berms (Figure 4-24) that may indicate a late CEM Stage IV.

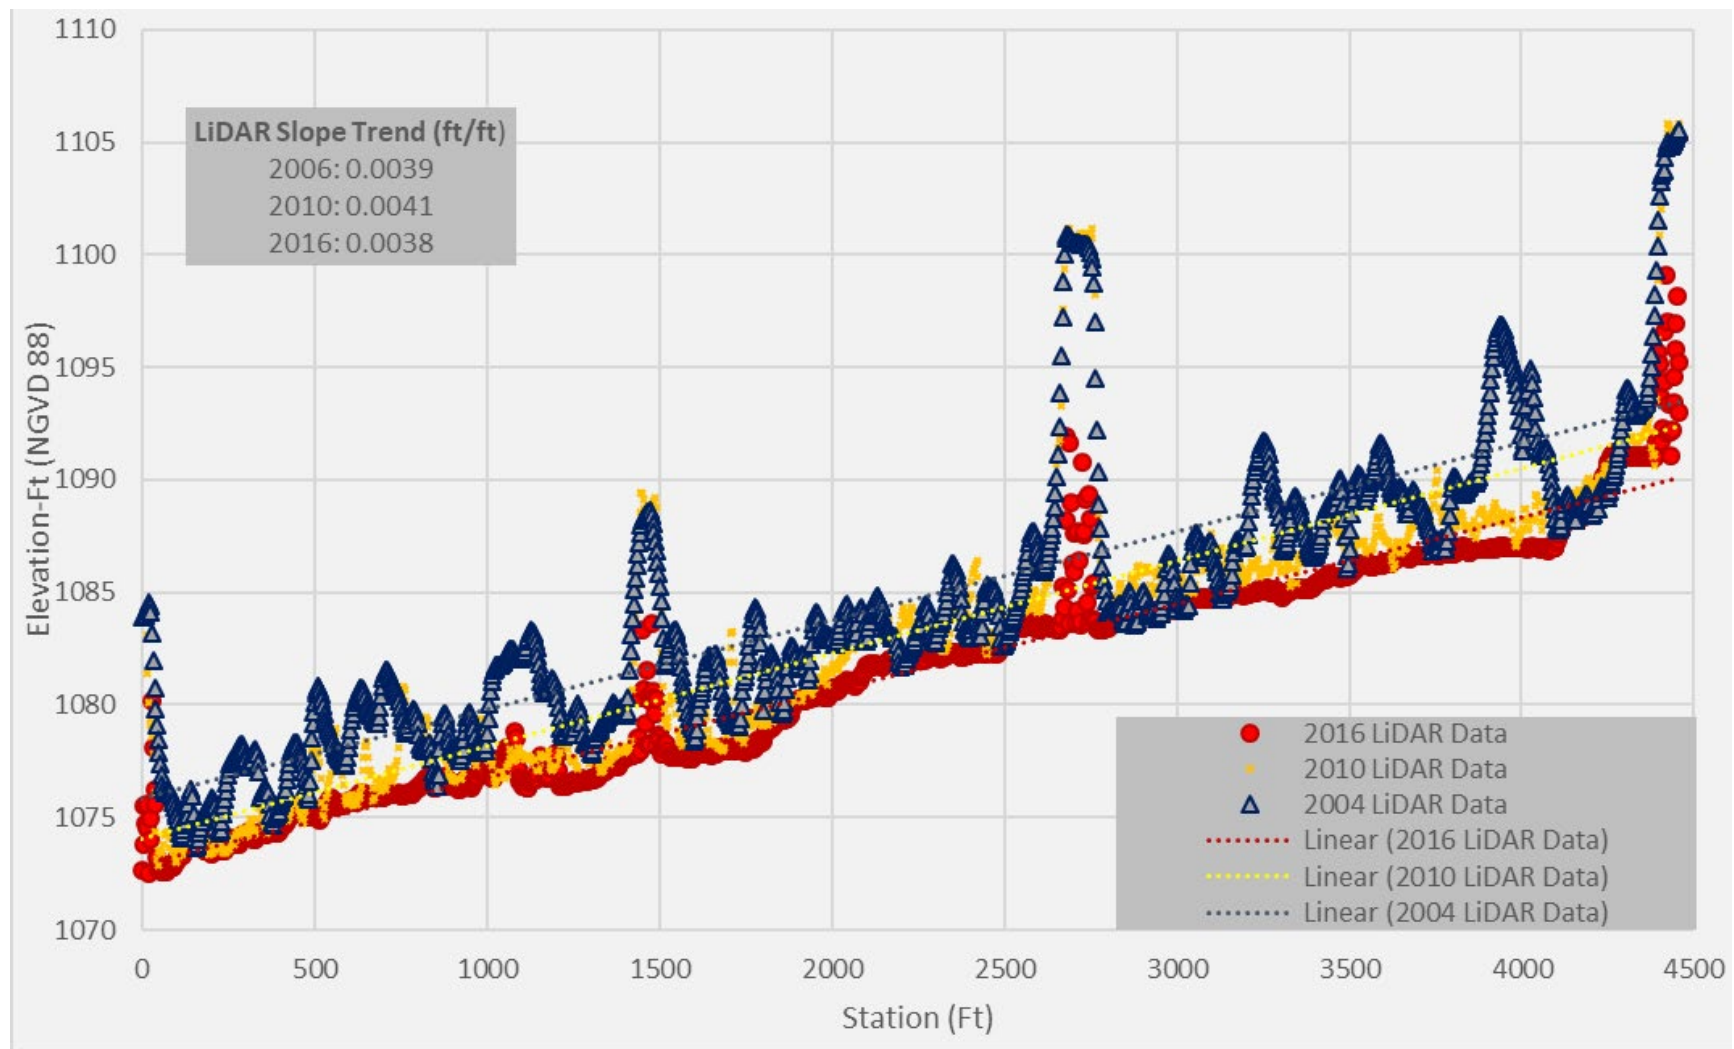
Figure 4-25: Reach 3 – LiDAR Slope Trends

- The LiDAR water surface slopes are plotted in Figure 4-25. This may be the best example of a stable slope within all reaches. The slopes range from 0.0038 to 0.0041 ft/ft. and have remained constant in the past 10 years.

- Based on the FG Level 1 analysis, this reach appears to be stable from a bed and bank erosion perspective. There were no locations within the reach that appeared to be changing relative to the analysis period between LiDAR data sets.

- It would be good to field-validate this conclusion with a site visit to the three main areas within the reach. Field validation will provide information regarding determination of stable channel equilibrium slopes for project design. The sub-reaches within the reach are downstream reach-downstream of Pratt Street, middle reach between Pratt Street and Military Avenue and the upstream reach between Military Avenue and Ames Avenue.

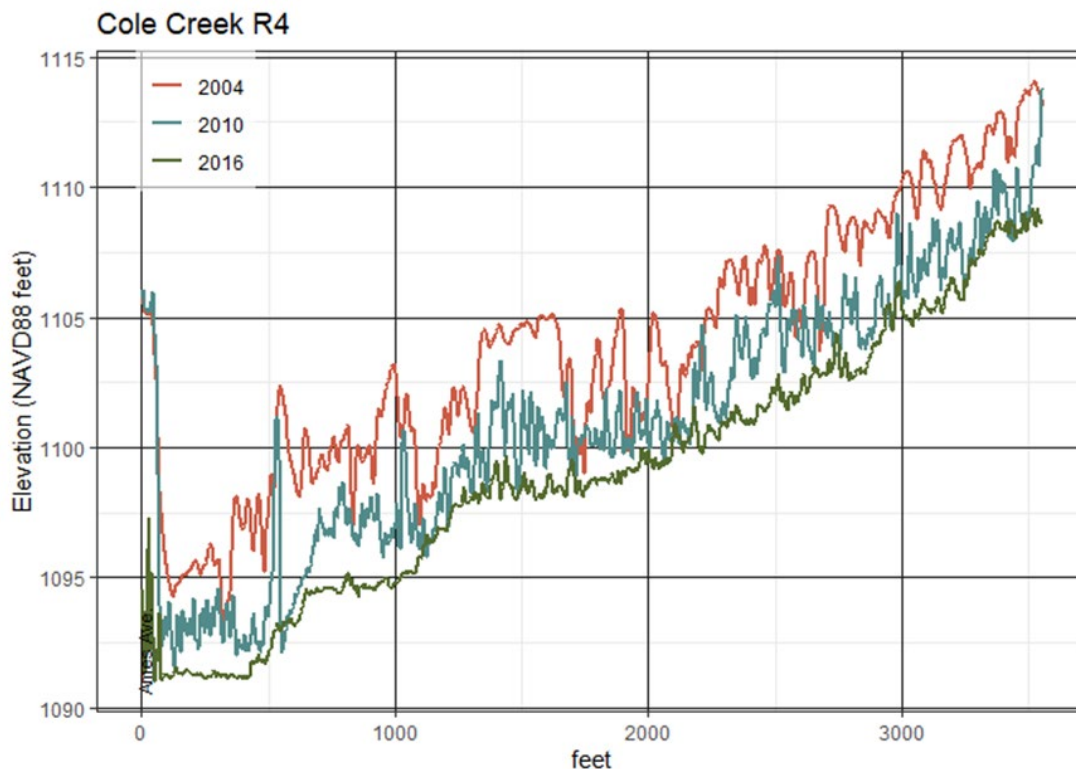
**Figure 4-27: FG Level 1-Reach 4: LiDAR Water Surface Profiles**

The water surface profiles indicate a trend of channel degradation ranging from approximately two to four feet. The incised channel locations are located on the downstream section of the reach as indicated by the bank heights. The channel bed lowering is more significant in the downstream section (Figure 4-28) of the reach than in the upstream section (Figure 4-29). There are larger slope breaks in the downstream section of the reach where there are riprap Grade Control Structures (GCS) (Figure 4-27). There is also local bank protection that has occurred throughout the reach.

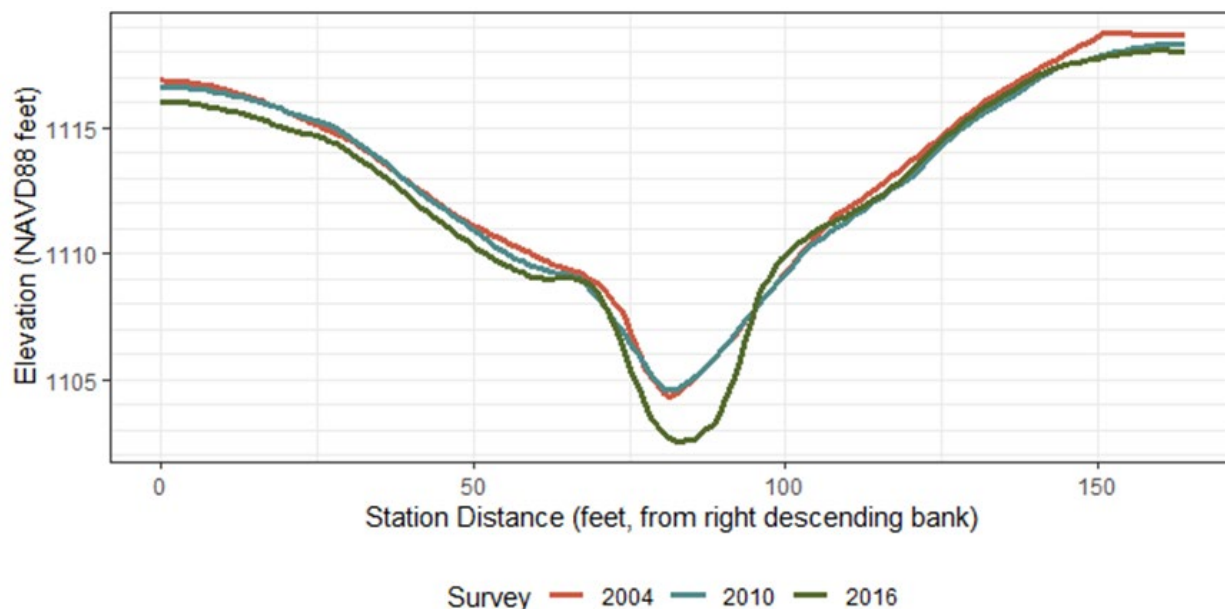
**Figure 4-29: Reach 4 – Cross-section 52 Illustrating Bed Changes Between 2004 and 2016**

- The reach has access to a floodplain (Figure 4-29) in some locations then transitions to areas that are incised (Figure 4-30). Overall, it is hard to determine specific CEM stages for this reach as there appears to be channel bed degradation but little lateral bank erosion or channel widening. The introduction of GCSs and local bank erosion control measures has stabilized the reach. The CEM Stage likely varies from a Stage IV to a VI.

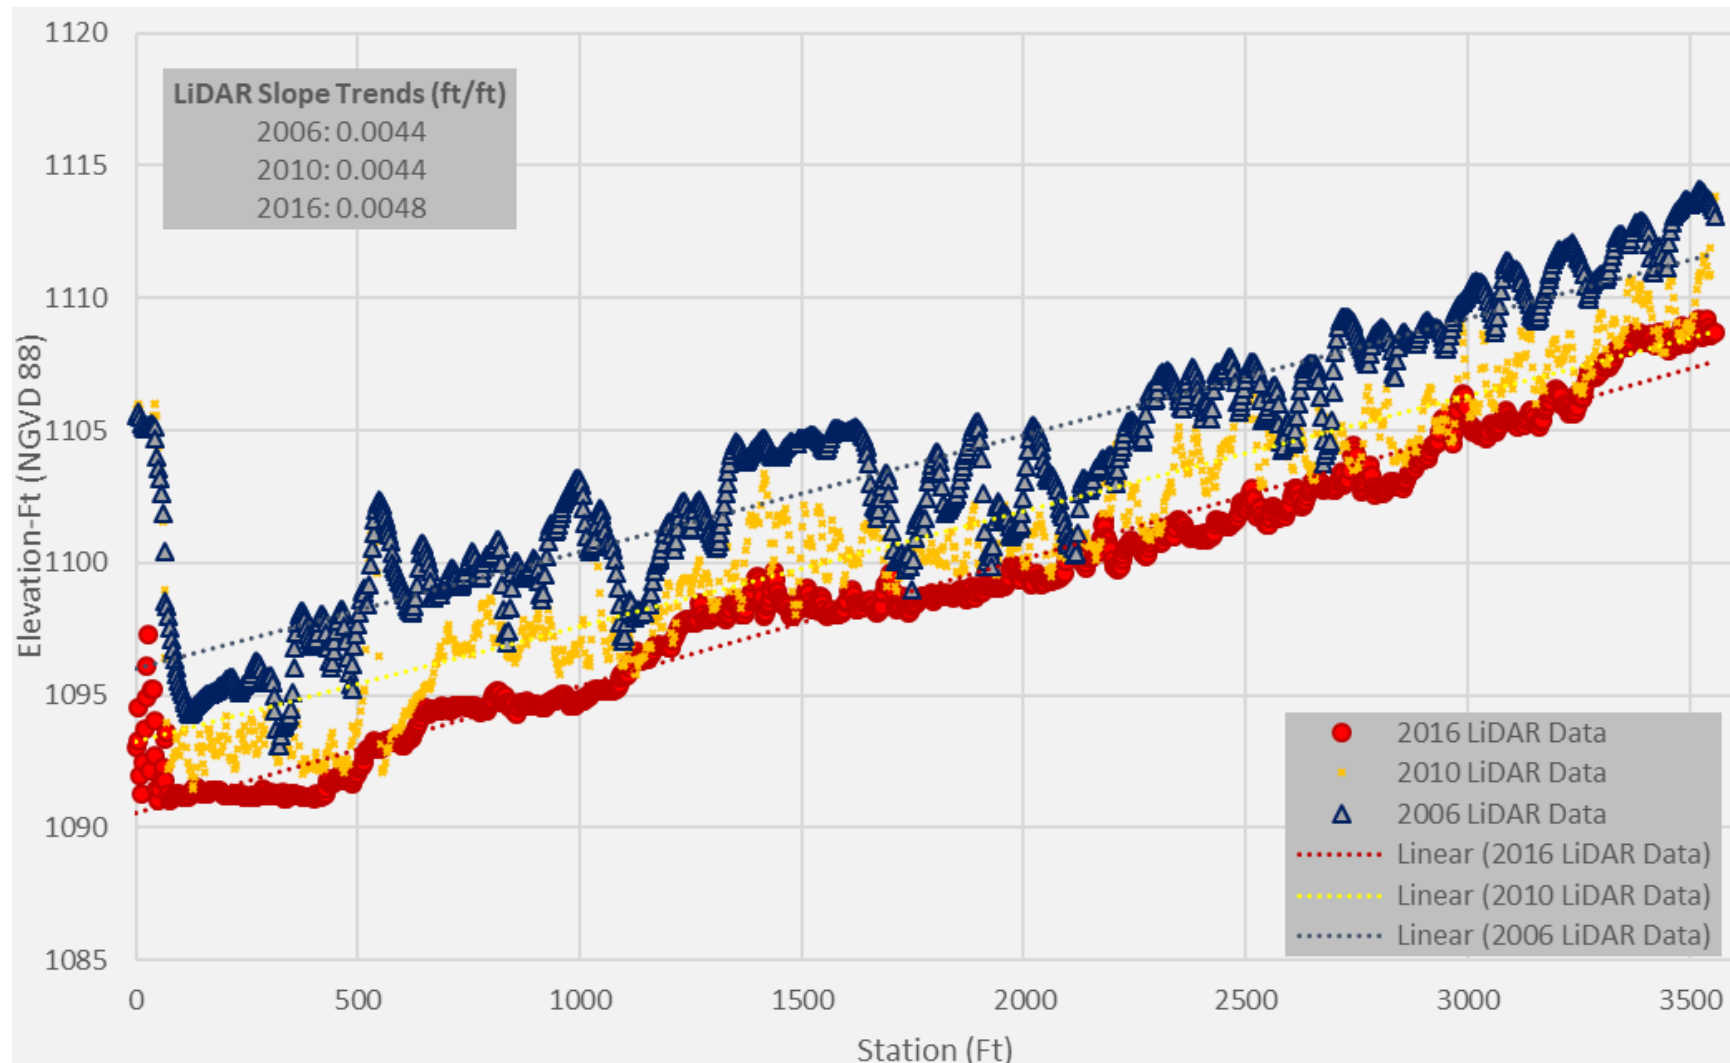
Figure 4-30: Reach 4 – LiDAR Slope Trends

- Figure 4-30 illustrates the LiDAR water surface slopes for Reach 4. This also may be a good example of a stable slope within all reaches. The slopes range from 0.0044 to 0.0048 ft/ft.

- From the FG analysis, this reach shows a trend of channel incision with very little bank erosion. The golf course has been proactive in treating the bed and bank erosion sites with riprap or other restoration measures so that may be the reason the reach is not in worse condition. It would be good to field-validate this conclusion with a site visit, and discuss the changes the site manager has seen over the past 10 to 15 years.

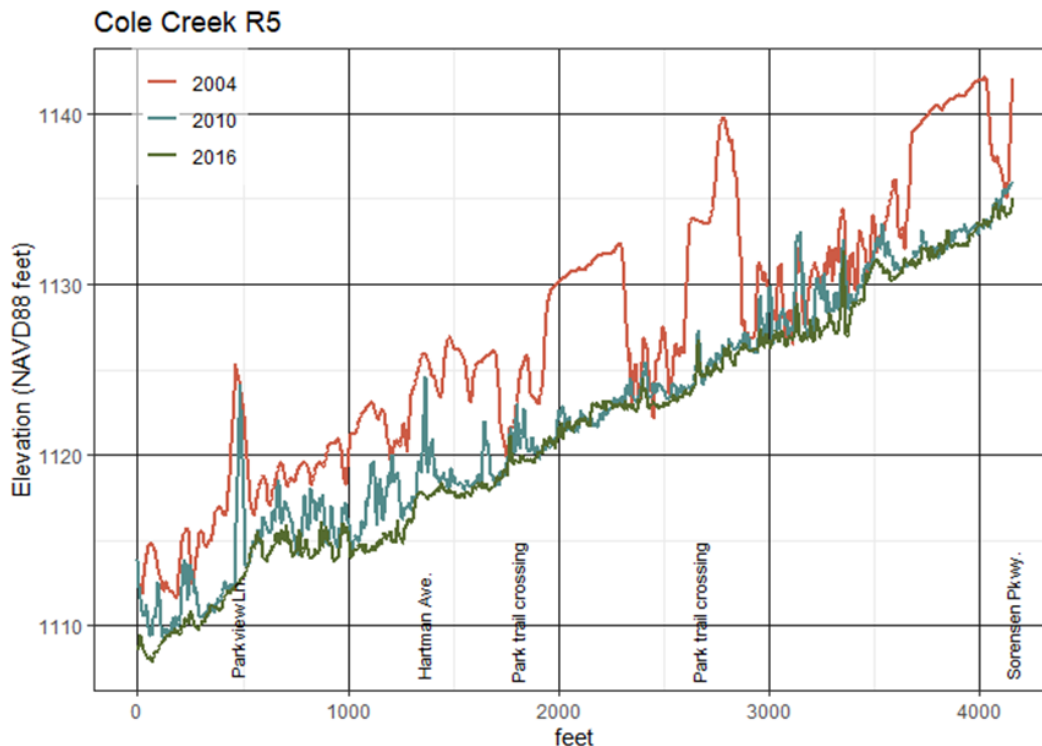
**Figure 4-32: FG Level 1, Reach 5 – LiDAR Water Surface Profiles**

The water surface profiles indicate a trend of channel degradation; however, as mentioned earlier, there has been an extensive amount of channelization during the LiDAR collection periods so the degradation that has been assessed from the water surface profiles is caused by data collected from outside the active channel margins.

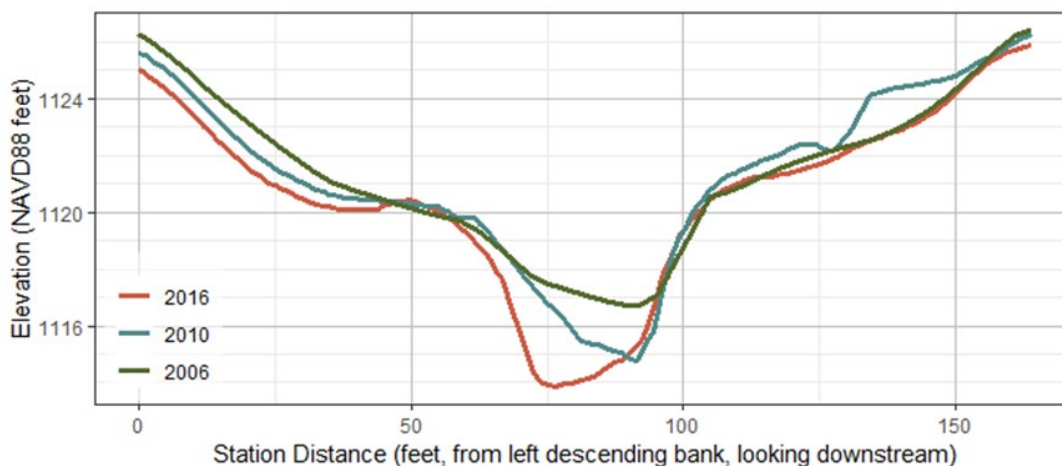
**Figure 4-33: Reach 5 – Cross-section 12 Depicting a Relatively Stable Bank**

Figure 4-33 and 4-34 show cross-sections from the downstream section of the reach that have a relatively close match between the analysis periods. Figure 4-33 appears to show degradation from 2004; however, investigation upstream and downstream do not have a similar trend. This trend is likely from thick vegetation masking the earlier LiDAR data collected. Figures 4-35 and 4-36 illustrate examples of channelization that occurred through the middle and upstream sections of this reach.

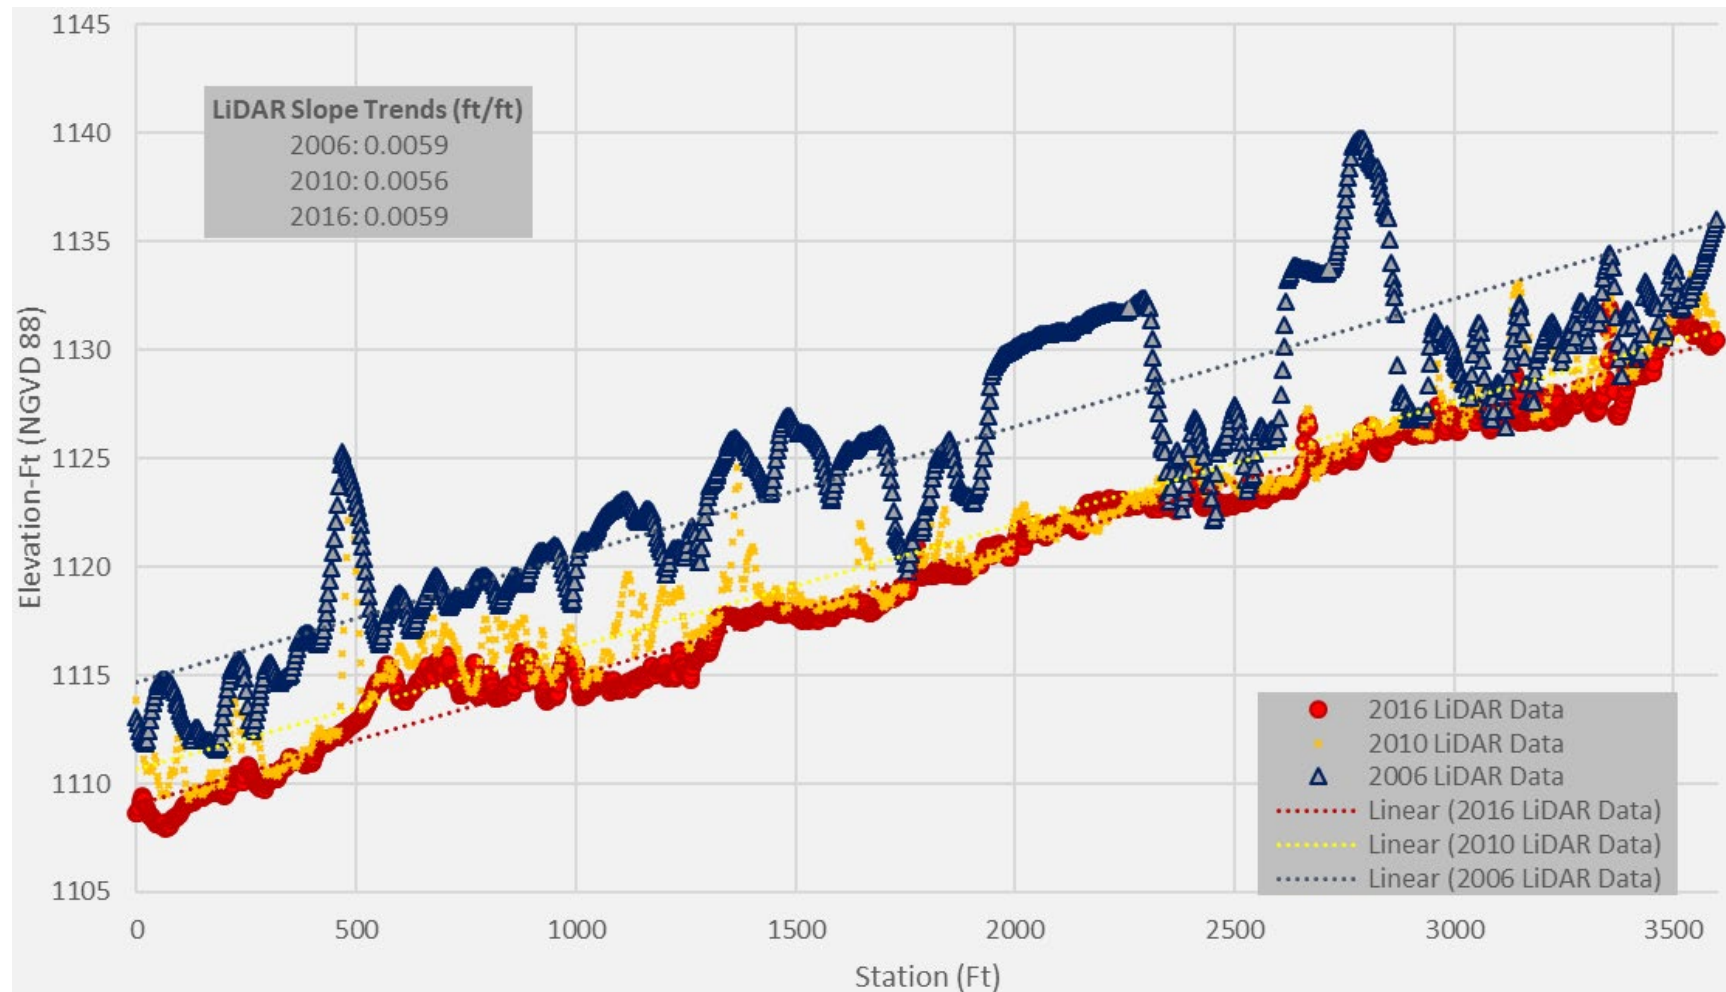
Figure 4-37: Reach 5 – LiDAR Slope Trends

- The reach went through a series of channelization and stabilization efforts from 2009 to 2010. The slope has stayed relatively constant pre-channelization to post-channelization at 0.0059 ft/ft (Figure 4-37).
- The reach would be considered as a CEM Stage VI. The channel realignment and stabilization (both bed and bank) appear to be in a stable condition.
- The bed and bank stabilization appear to have stabilized the reach (based on aerial photo investigation). It would be good to field-validate this conclusion with a site visit to the golf course and discuss the changes the site manager has seen over the past 25 years.

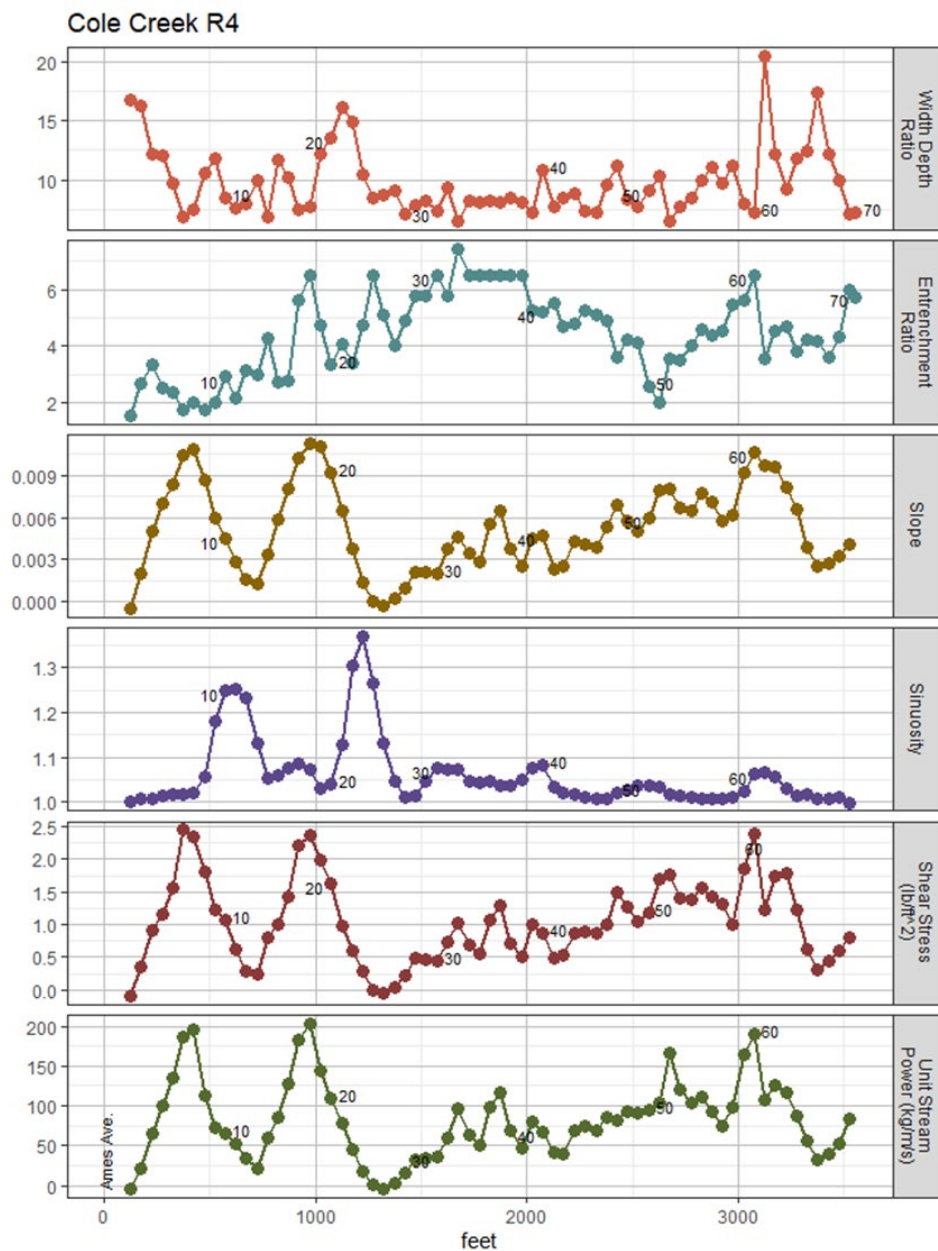
**Figure 4-38: Reach 4 – FG Level 2 Metrics**

Reach 4 was flagged for additional analysis since it showed the most degradational trends within the five reaches studied. The reach is maintained through the Benson Golf Course. The derived metrics for Reach 4 are shown in Figure 4-38.

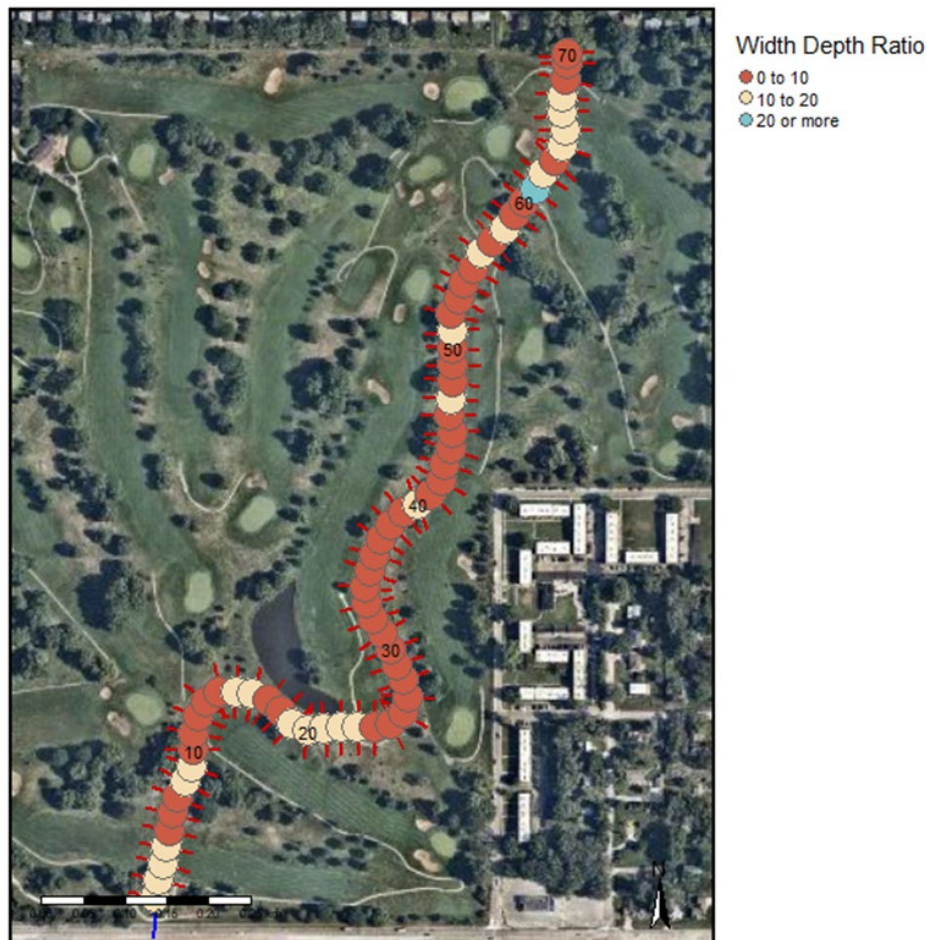
**Figure 4-39: Reach 4 – FG Level 2 Spatial Extent of W/D Ratios**

The W/D ratios are mapped and shown in Figure 4-39 and 4-40. The ratios above 20 represent channel areas that are over-widened and would display (unless there is revetment) sediment bar deposition and erosion of the streambanks.

- Upstream of the two GCSs, there are lower water surface slopes and a slightly trending increase in ER. The ERs are above the moderately-entrenched-stream classification-break of 2.2 (Rosgen, 1996), with the lower section of the reach having ERs less than 1.7. The GCSs and other revetments in the upstream section of the reach appear to have stabilized the channel with high ERs (access to a floodplain at lower flow) and lower W/Ds.

- The larger shear stress and USP occur in sections of the reach that have steeper slopes, below the GCSs or some other channel bed controls.
- The areas that likely have erosion control issues are the low sinuosity, low ERs, low W/Ds, and higher shear stress values. These are cross-section locations 2-10 and 46-53.

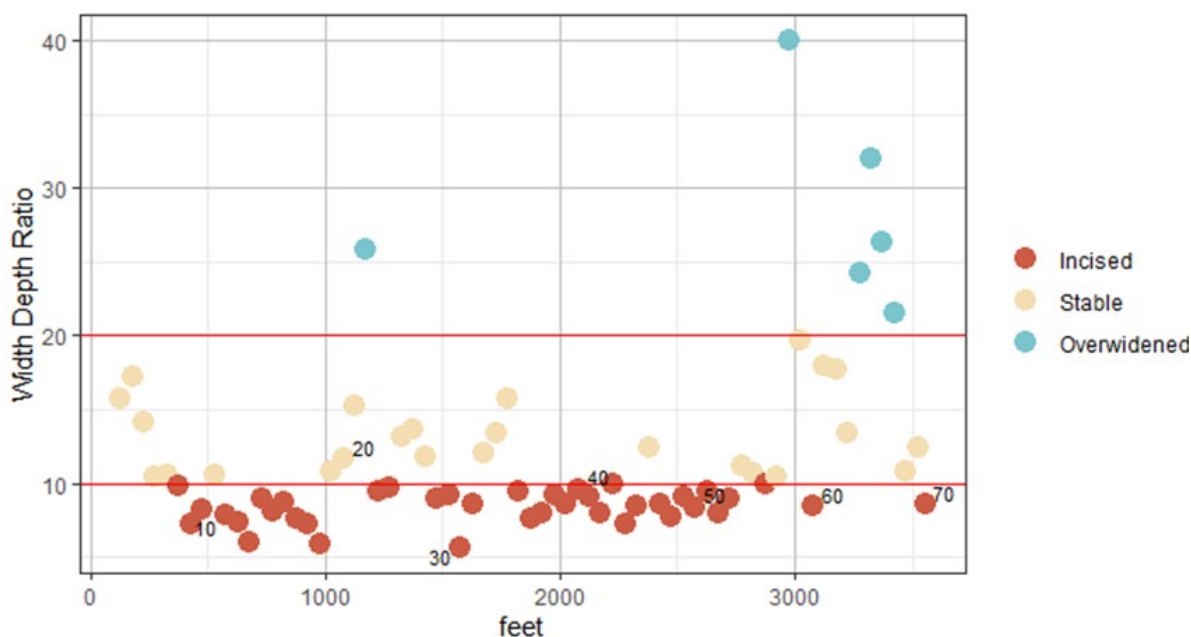
**Figure 4-40: Reach 4 W/D Ratios**

- The W/D and ER show locations where the channel is incised and has limited access to an active floodplain (Figure 4-40). Half of the W/D ratios are below 12 and demonstrate confined channel conditions.

The W/D's below 10 are classified as incised channels and are areas to look for implementing possible bed stabilization measures. These areas may have cohesive bank materials, bedrock, or stabilization revetments present that provide stable banks even though the channel is incised. Incised channels aren't a bad thing in an urban area where channel capacity is needed so that residential and commercial areas do not flood.

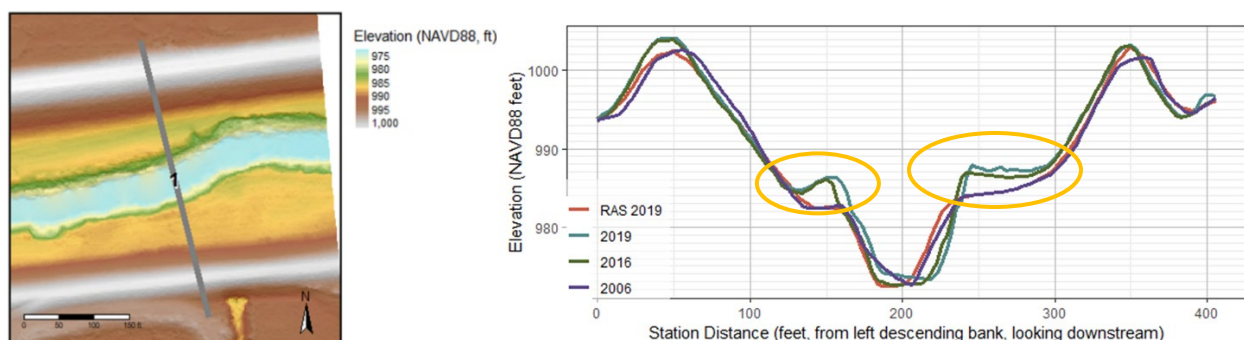
There are many sections of the creek that have some form of revetment, whether it be riprap or other materials present in the channel bed or banks. From site visits, the presence of these materials are providing bed or bank stability. It is not known whether these structures and revetments were designed, or materials were placed in stream to protect utility crossings. In many locations, material has launched and formed GCSs, stabilizing the channel bed in these locations. In some locations in the lower Reaches (1-3), the levee system design cut benches within the channel margins to provide flood flow relief. In other locations, these benches or berms formed from sloughing or eroding banks restabilizing due to the presence of bed and bank revetments and reduced velocities (Figure 4-43). Compared to an incised channel (high banks with no floodplain), the berms provide access to the frequent flood events dissipating flow energy across a wider cross-sectional area. This is a common feature in the urbanized Papillion Creek watersheds that were included in site visits.

**Figure 4-43: Floodplain Berms (orange circles) Developing Upstream of GCSs on West Papillion Creek**

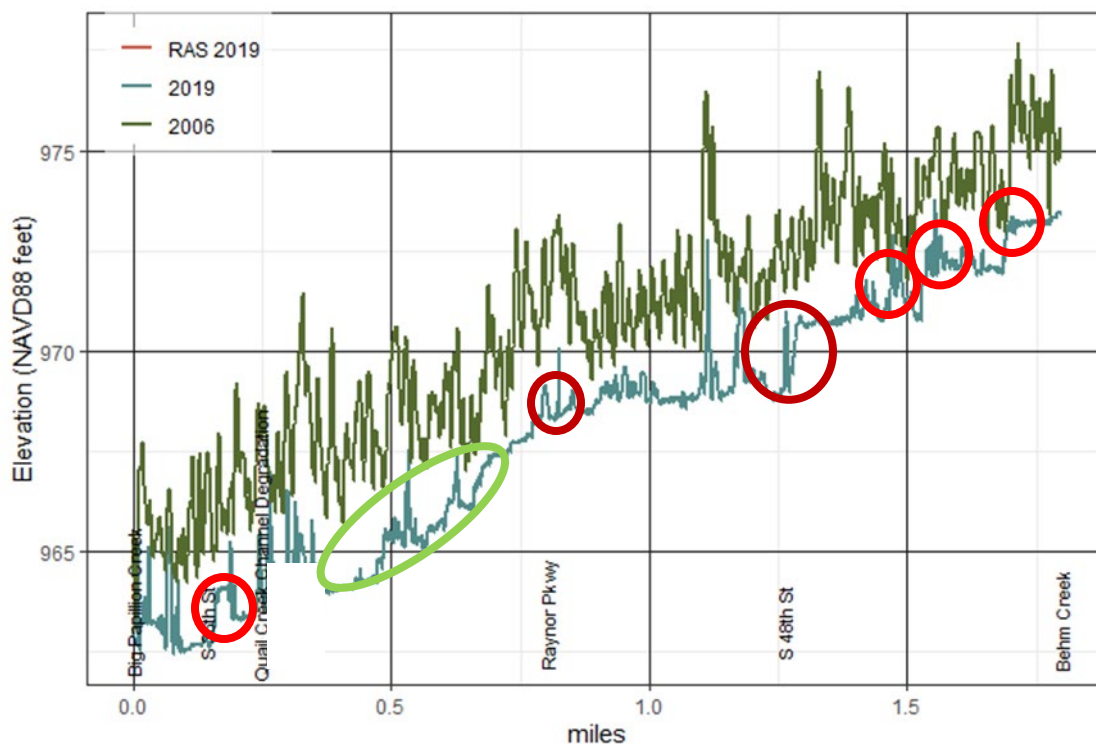
**Figure 4-45: West Papillion Creek FG Reach 1**

- Downstream of Raynor Parkway Bridge, the channel appears to show a trend of degradation. Much of the reach has bank revetments with a meandering pattern starting to form within the incised channel. Early stages of floodplain development are occurring with berms forming where bank slumps have stabilized. Bank failure and continued channel incision will likely continue with increased development in the upstream reaches increasing flows confined within the leveed floodplains.

- This reach is predominantly a sediment pathway with minor sediment sinks with new floodplain berms forming. Still other locations there are areas of bank erosion working through the bank revetments providing minor sediment sources for downstream reaches.
- Establishment of floodplain access areas to dissipate and store floodwater would be a great alternative to establish where applicable to the upstream reaches.

- There are many locations within Reach 1 that would have access to an active floodplain if levees could be setback to provide more room for flood flows. This is still possible (although maybe not attainable) in areas where agriculture is present.
