# **Papillion Creek Watershed**

## **Streambed Degradation Study**

### **Section 22: Planning Assistance to States**

#### **Final Report**

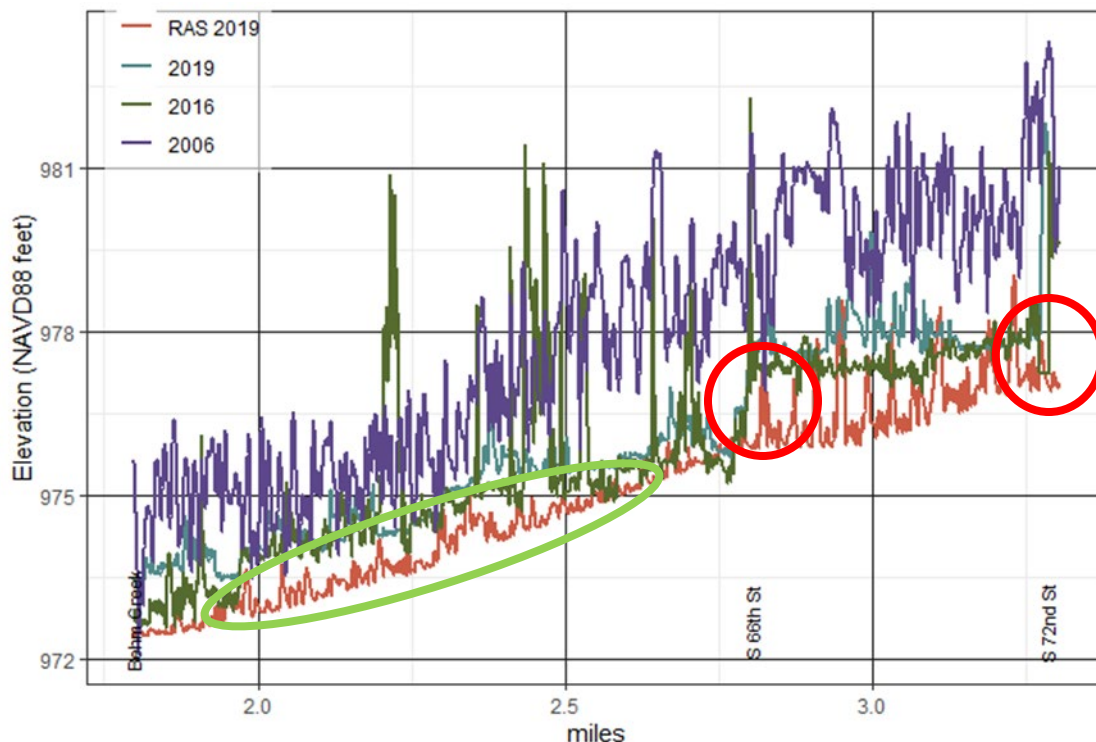
**Figure 4-46: West Papillion Creek FG Reach 2**

- Based on the LiDAR trends and comparison to the RAS 2019 thalweg elevations, there appears to be channel degradation in this reach, especially at the South 66<sup>th</sup> Street Bridge (approximately station 2.75 miles).
- GCSs are spaced out relatively evenly throughout the reach (Figure 4-46). The structures are likely reworked revetment material or were placed to protect utility crossings.
- Reach 2 is likely in an early CEM Stage IV displaying both channel degradation and widening. The degradation is limited due to the extensive rock-line banks and presence of GCSs. The bank revetments act to prevent the channel from meandering and eroding into the levee system.

- Based on the FG cross-sectional analysis, floodplain berms are building within the confined (by levees) floodplain. Like Reach 1, this reach is predominantly a pathway with minor sediment sinks and sources.
- The reach could be enhanced for flood water storage by increasing floodplain connection and access through series of levee setbacks. There are still some areas of agriculture that could be targeted. If sediment delivery to downstream reaches is a priority, then installation of additional bank erosion revetments is recommended.

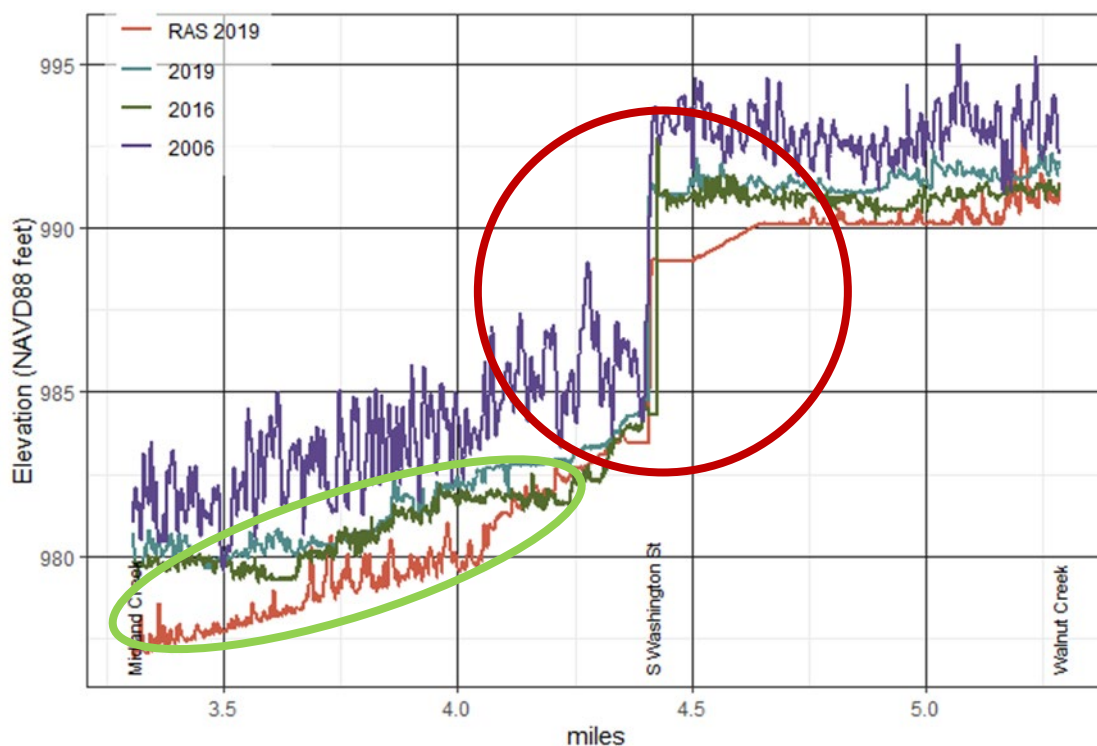
**Figure 4-47: West Papillion Creek FG Reach 3**

Reach 3 has greenspace with more encroachment and no adjacent agricultural land-use. Overall, the reach is degradational with local widening in areas without bank protection, likely a CEM Stage III-IV channel. The South Washington Street Bridge is serving as a GCS with about a six-foot drop, creating a relatively deep incised channel downstream. The list below describes the assessment for the reach.

- Based on the LiDAR channel surface slope and RAS Thalweg Profile, Reach 3 appears to be over-steepened below South Washington Street Dam. The reach is likely in CEM Stage III-IV downstream of the dam and Stage V-VI upstream.
- Reach 3, like previous reaches, has extensive rock-lined banks to keep the channel from meandering. By hardening streambanks and keeping the channel from meandering, it can only adjust in the vertical direction – causing local incision. Bank stabilization measures are forcing the channel to stay within a CEM Stage III channel.

- Continued channel degradation could cause failure of the concrete dam at S. Washington Street and other bank stabilization projects if the over-steepened reach continues to incise. Based on the field investigation, the dam appears to be in working order with no outward signs of erosion issues at the time of this report.
- Based on the FG cross-section analysis, there is bank erosion in many sections of the reach. Additional bank protection revetments and developing a better understanding of the channel bed stability would be recommended. This reach would be considered a sediment source and areas with little or no erosion a sediment pathway.
- There are minimal locations available within the reach to expand access to floodplain areas behind the existing levees.

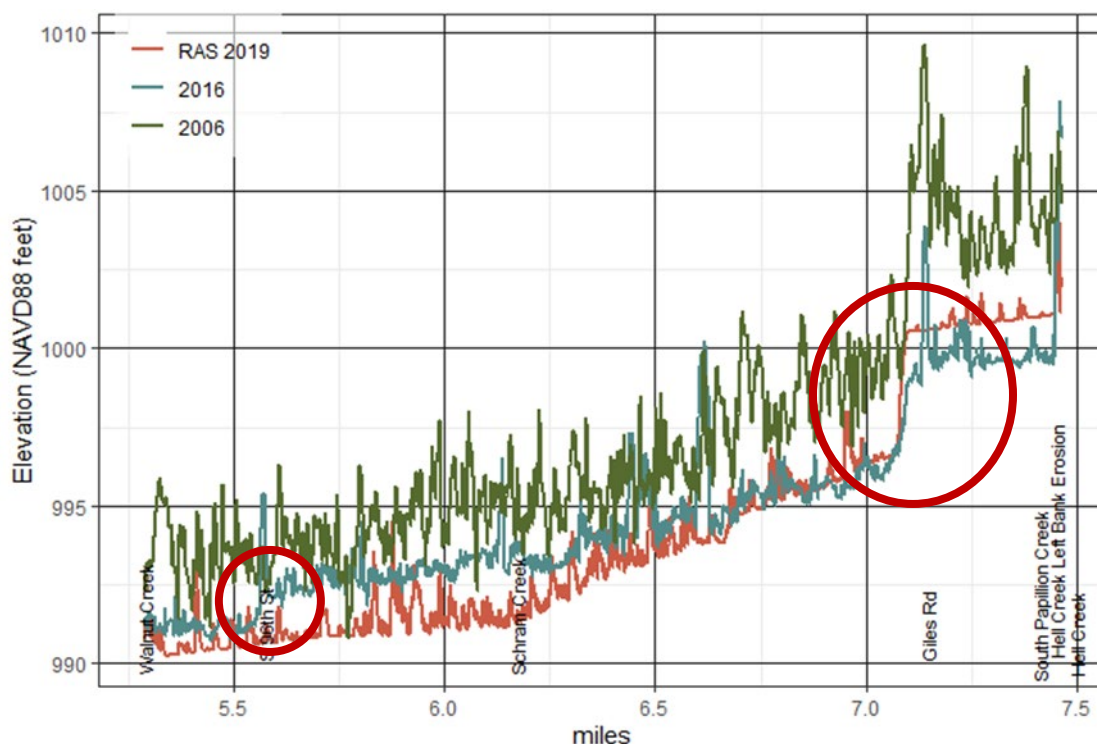
**Figure 4-48: West Papillion Creek FG Reach 4**

- GCSs are present at bridge locations and other locations within the reach, likely from launching revetment materials (Figure 4-48).
- Based on the LiDAR channel slopes, Reach 4 appears to be in a CEM Stage V. The streambed is stable and there is local bank erosion. New floodplain berms have developed in much of the reach showing a trend of stabilization.

- Reach 4, like Reach 3, has extensive rock-line banks to keep the channel from meandering. Although, by keeping the channel from meandering by hardening the streambanks, the channel can only adjust in the vertical direction – causing channel incision. Bank stabilization measures are forcing the channel to stay within a CEM Stage III channel.

- There are locations behind the existing levees on the right terrace/floodplain available to expand access to potential floodplains.

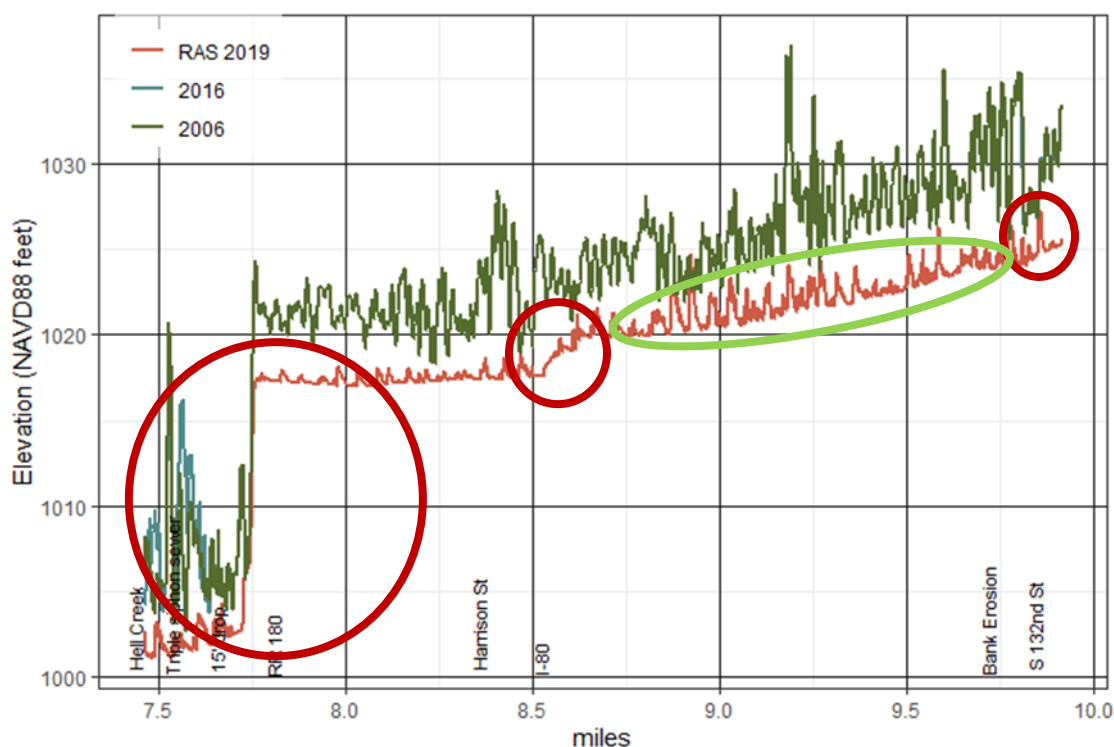
**Figure 4-49: West Papillion Creek FG Reach 5**

- GCSs are present throughout the reach, with the largest at the Railroad 180 Bridge (Figure 4-49).
- There are additional GCSs or other resistant bed materials located within the reach based on the Figure 4-49 profiles and aerial photo interpretation.

- Downstream of Railroad 180 GCS, the channel is likely a CEM Stage IV; upstream the channel is a CEM Stage VI until approximately the I-80 Bridge. Upstream of the I-80 Bridge, the channel slope increases, and streambank erosion is prevalent.

- This reach is a mix of sediment source (upstream and downstream sections) and pathway at Railroad 180 GCS and upstream for three fourths of a mile.
- There are some locations on the right channel margins to expand access to floodplain. The locations are on the right terrace/floodplain upstream of the confluence with South Papillion Creek (lower reach) and upstream downstream of the South 132<sup>nd</sup> Street Bridge.

- **Priority #2:** Assess existing structures and other areas within the reaches that are providing channel and bank stability. This is especially important for the structures in Reach 2 (South Washington Street Dam) and Reach 5 (Railroad 180 GCS). If these structures are compromised, rapid channel degradation (widening and deepening) will occur.

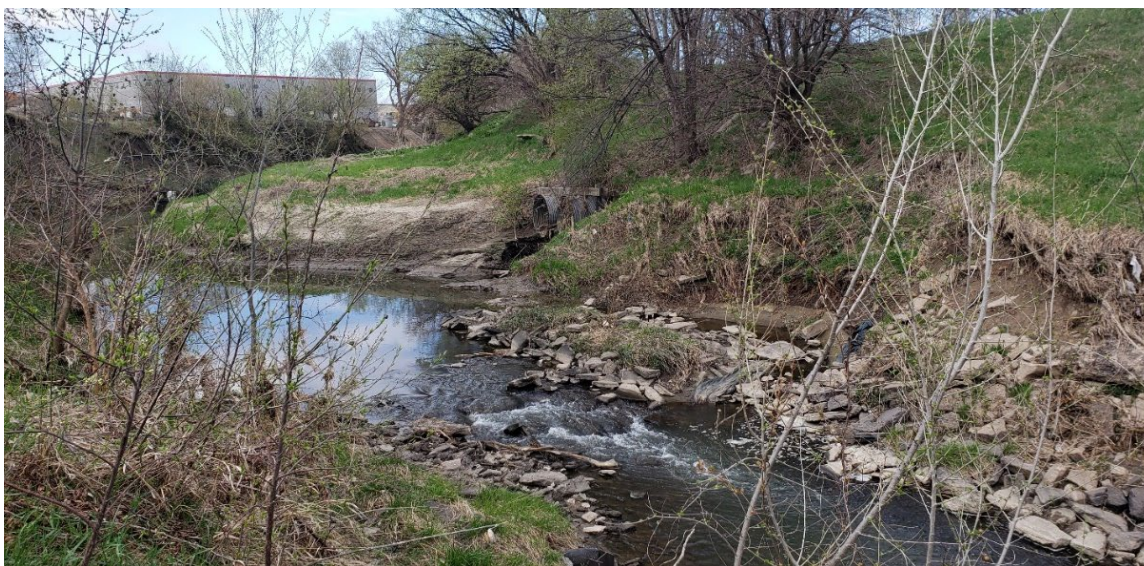
**Figure 4-51: Papillion Creek GCS Upstream of the Giles Road Bridge (Reach 1)**

The GCS and others in upstream reaches have helped stabilize the stream system by providing bed control to a trending degradational channel system.

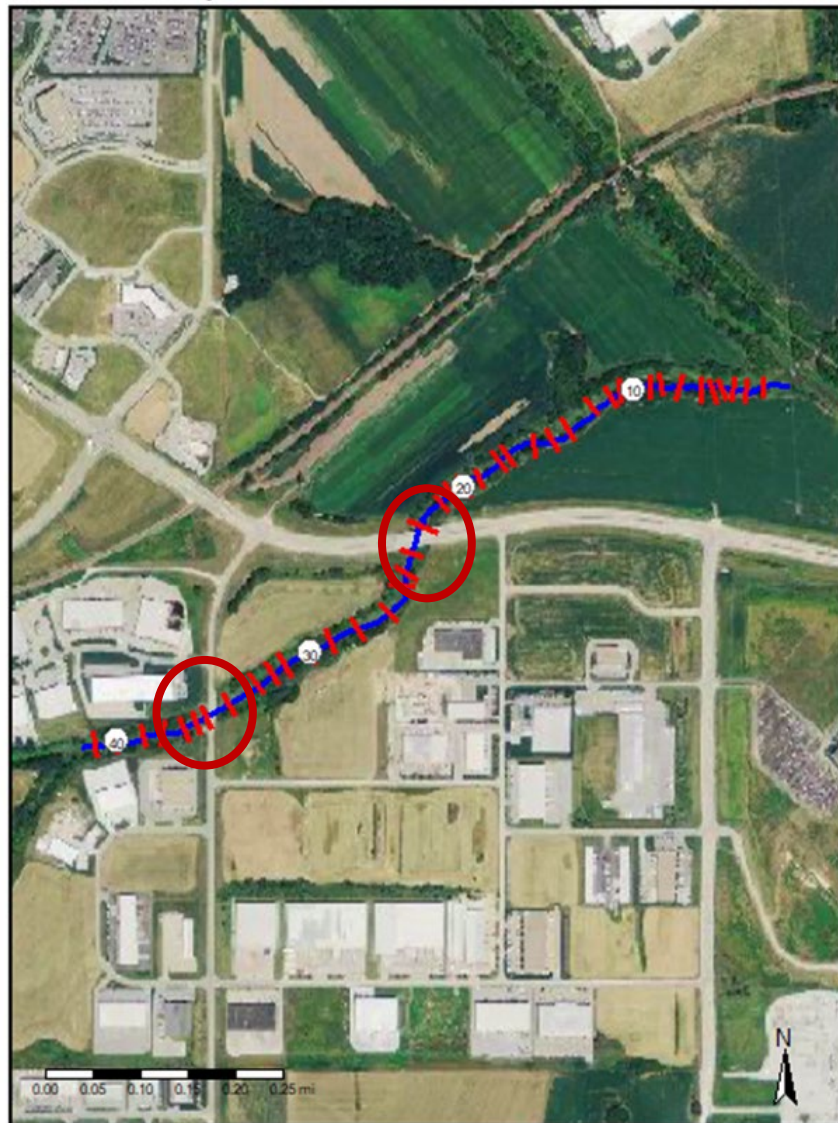
**Figure 4-54: South Papillion Creek Reach 1: Cross-section Location Map**

The Reach 1 site map is illustrated in Figure 4-54 and the water surface profiles from 2004 and 2016 are plotted in Figure 4-55. Overall, the channel is incised with 25-to-30-foot bank heights (terrace). There is some minor meandering occurring within the incised channel margins with the largest meander upstream of the Giles Road Bridge.

Slope and cross-section analysis comparisons of the downstream section of the reach reveals channel degradation and widening (Figures 4-56, 4-57, and 4-58) between 2004 and 2016. There are GCSs at Giles Road Bridge and the South 120<sup>th</sup> Street Bridge (Figure 4-54 and 4-55, red circles). Based on aerial photo investigation, the GCSs were constructed between 2009 and 2010. They are providing stability to the upstream section of the reach and the slope has

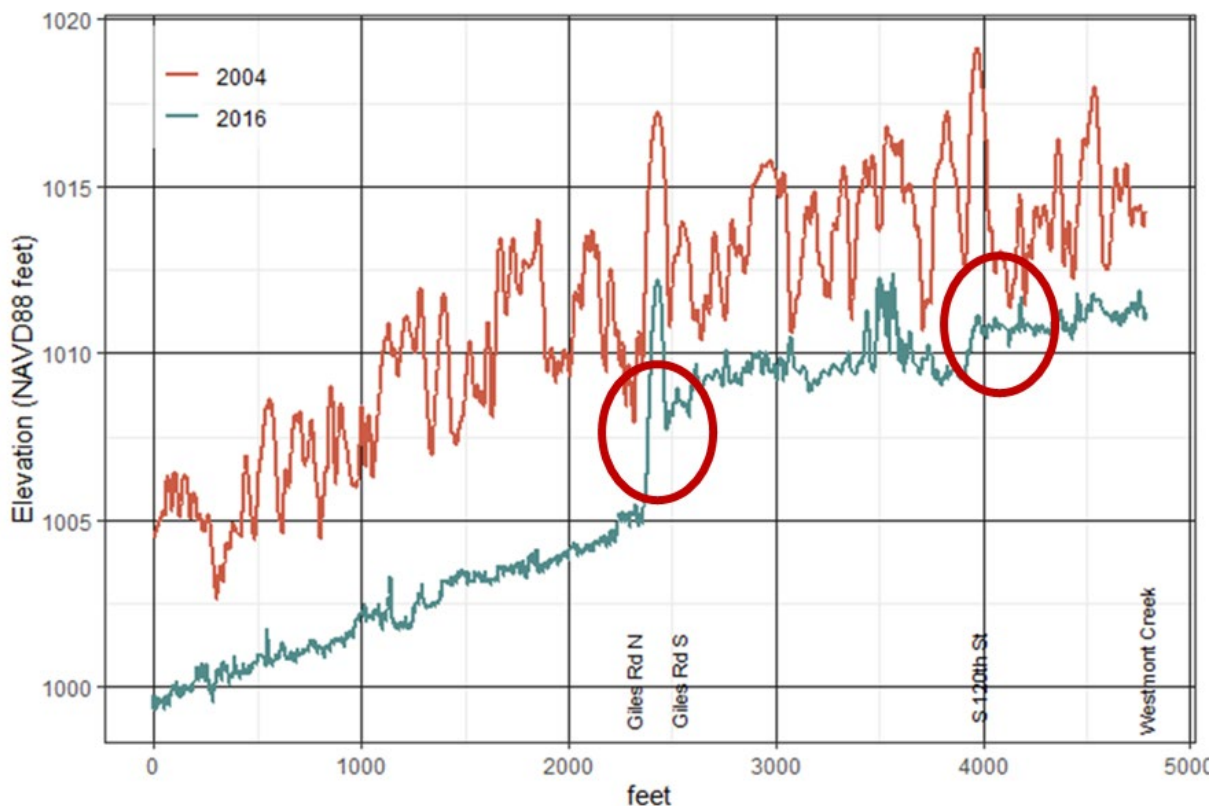
**Figure 4-55: FG Level 1, Reach 1 – LiDAR Water Surface Profiles**

flattened. The water surface profile within this lower reach is consistent at 0.0022 ft/ft. The slope above the GCS is 0.001 ft/ft. Based on the LiDAR trends in the downstream section the reach, the channel bed has dropped approximately three to 3.5 feet (Figure 4-56) and eroded laterally in some locations 20 to 25 feet (Figure 4-57).

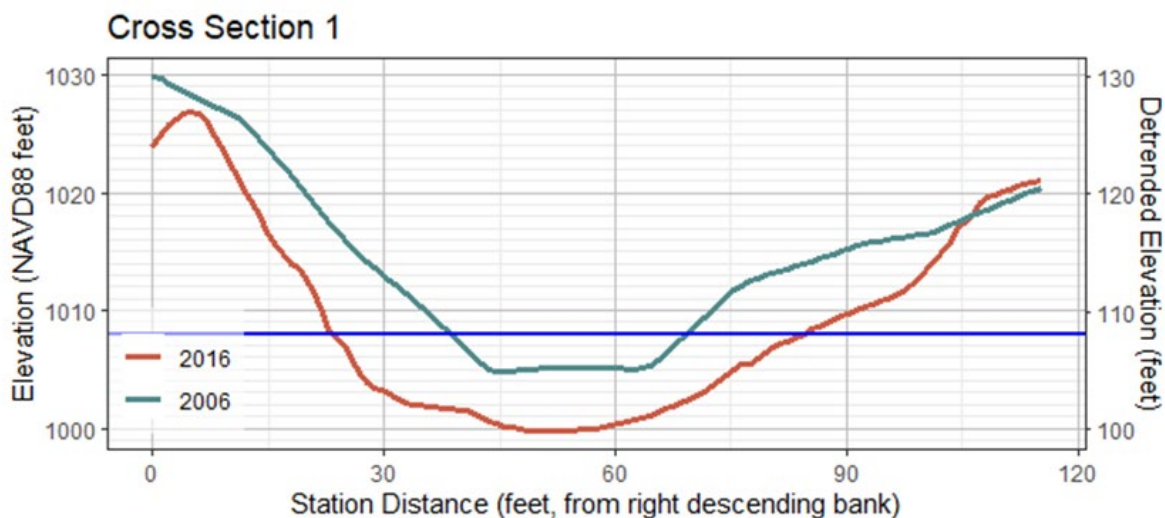
**Figure 4-56: Cross-section illustrating channel degradation and widening**

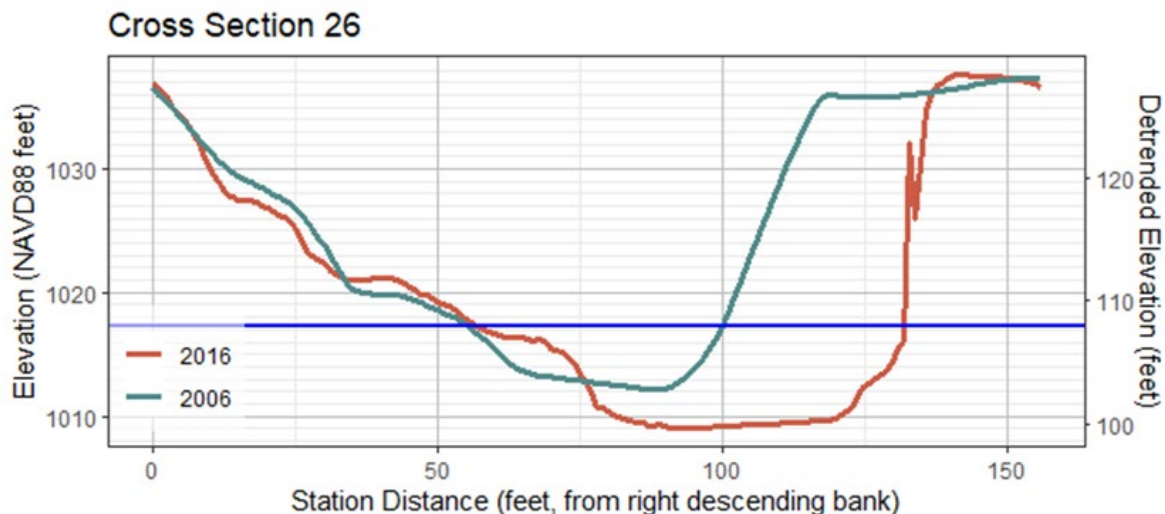
**Figure 4-57: Cross-section Illustrating Channel Degradation and Lateral Bank Erosion**

The channel has built-floodplain-berms within the incised channel margins shown in Figures 4-57 (left bank), 4-58 (both banks), and 4-59 (left bank). This is typically a sign of the channel adjusting to a new quasi-equilibrium (CEM IV and V) and is indicative of areas upstream of a GCS as the channel adjusts to the new stable channel bed invert and the reaches trend toward stabilizing. There will likely be local channel erosion as the channel continues to adjust. Based on the LiDAR trends in the upstream section of the reach, the channel bed has dropped one to 1.5 feet (Figure 4-58) and eroded laterally in some locations 20 to 25 feet (Figures 4-60 and 4-61).

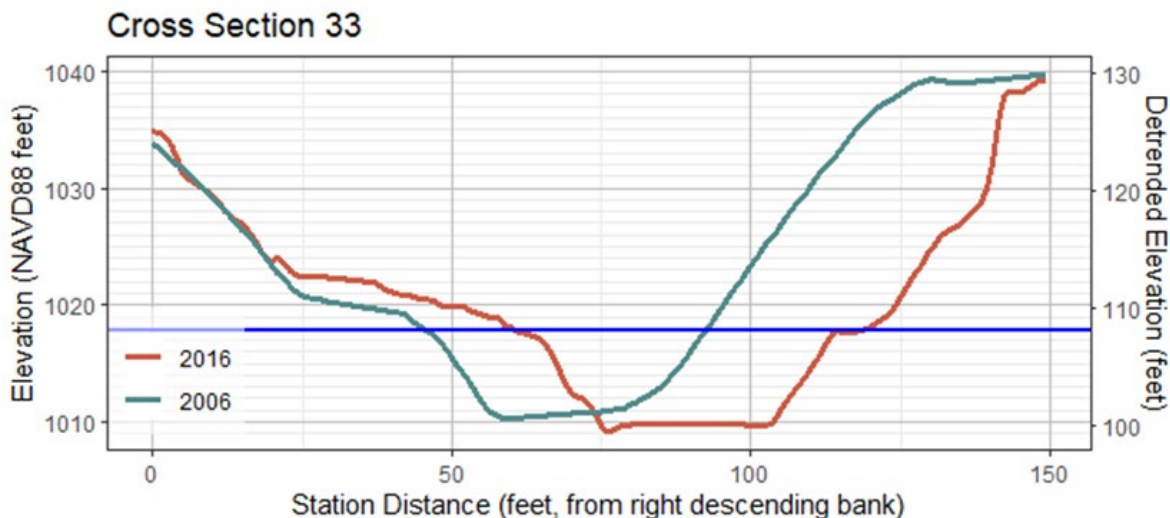
**Figure 4-58: Cross-section 84 Illustrating Lateral Bank Erosion**

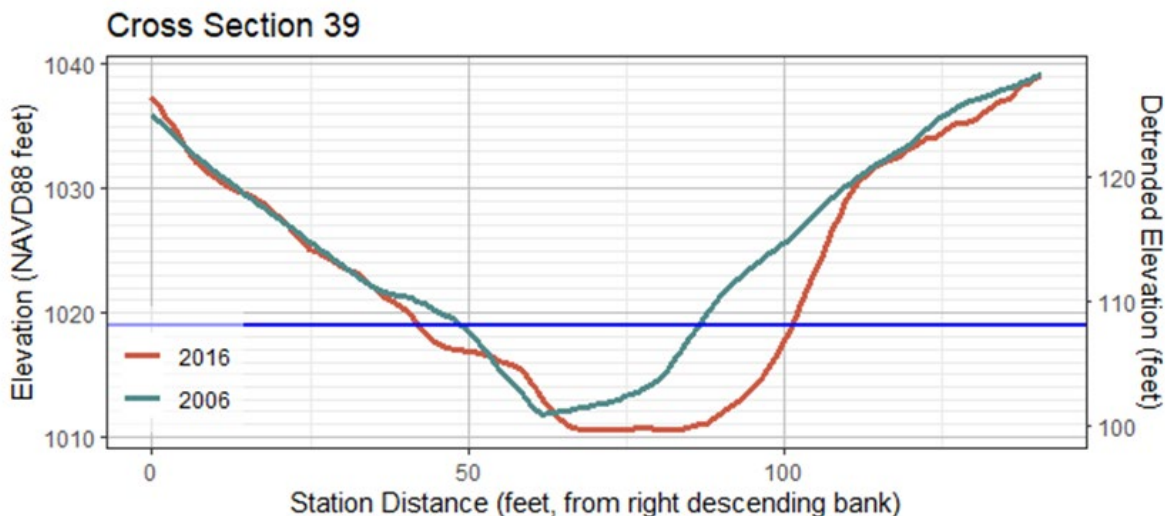
**Figure 4-59: Cross-section Illustrating Bank Lateral Erosion**

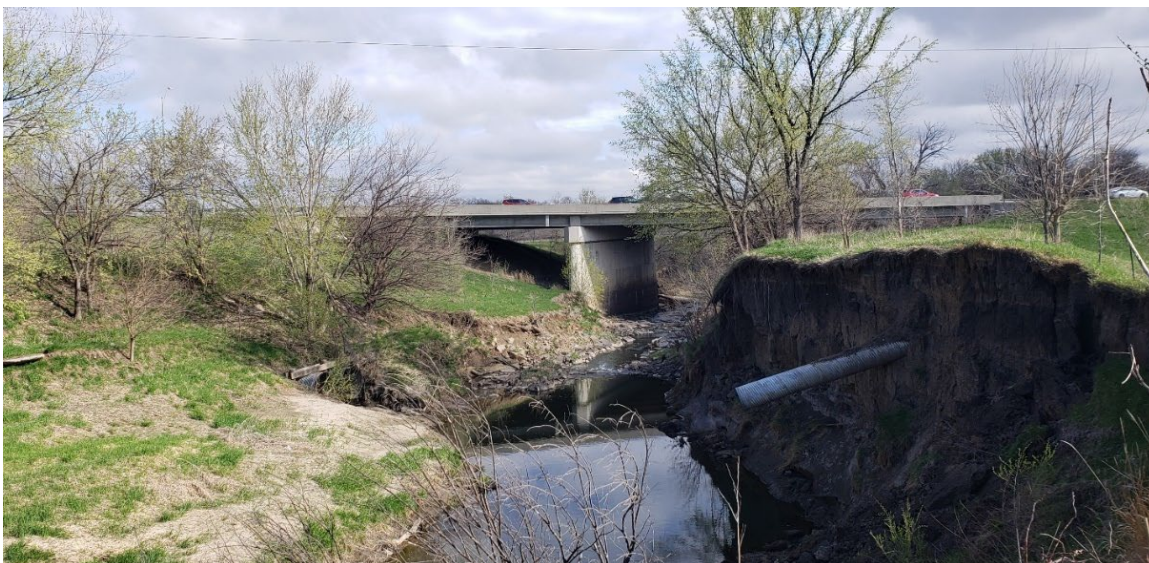
- Reach 1 appears to be stabilizing from a trend of degradation. Based on the WOTUS trip report completed in 2019, there is local bank erosion in locations (Figure 4-60) where the channel is still adjusting, or planform issues are causing accelerated erosion. The downstream section is likely in a late CEM Stage IV transitioning into a CEM Stage V upstream.

**Figure 4-60: South Papillion Creek Upstream of Giles Road Bridge Showing Right Bank Erosion of Culvert Outlet**

- The GCS should be monitored for changes in elevation and scour around the structure. Part of the South Papillion Creek restoration and stabilization plan will likely be enhancing the GCS throughout the watershed.

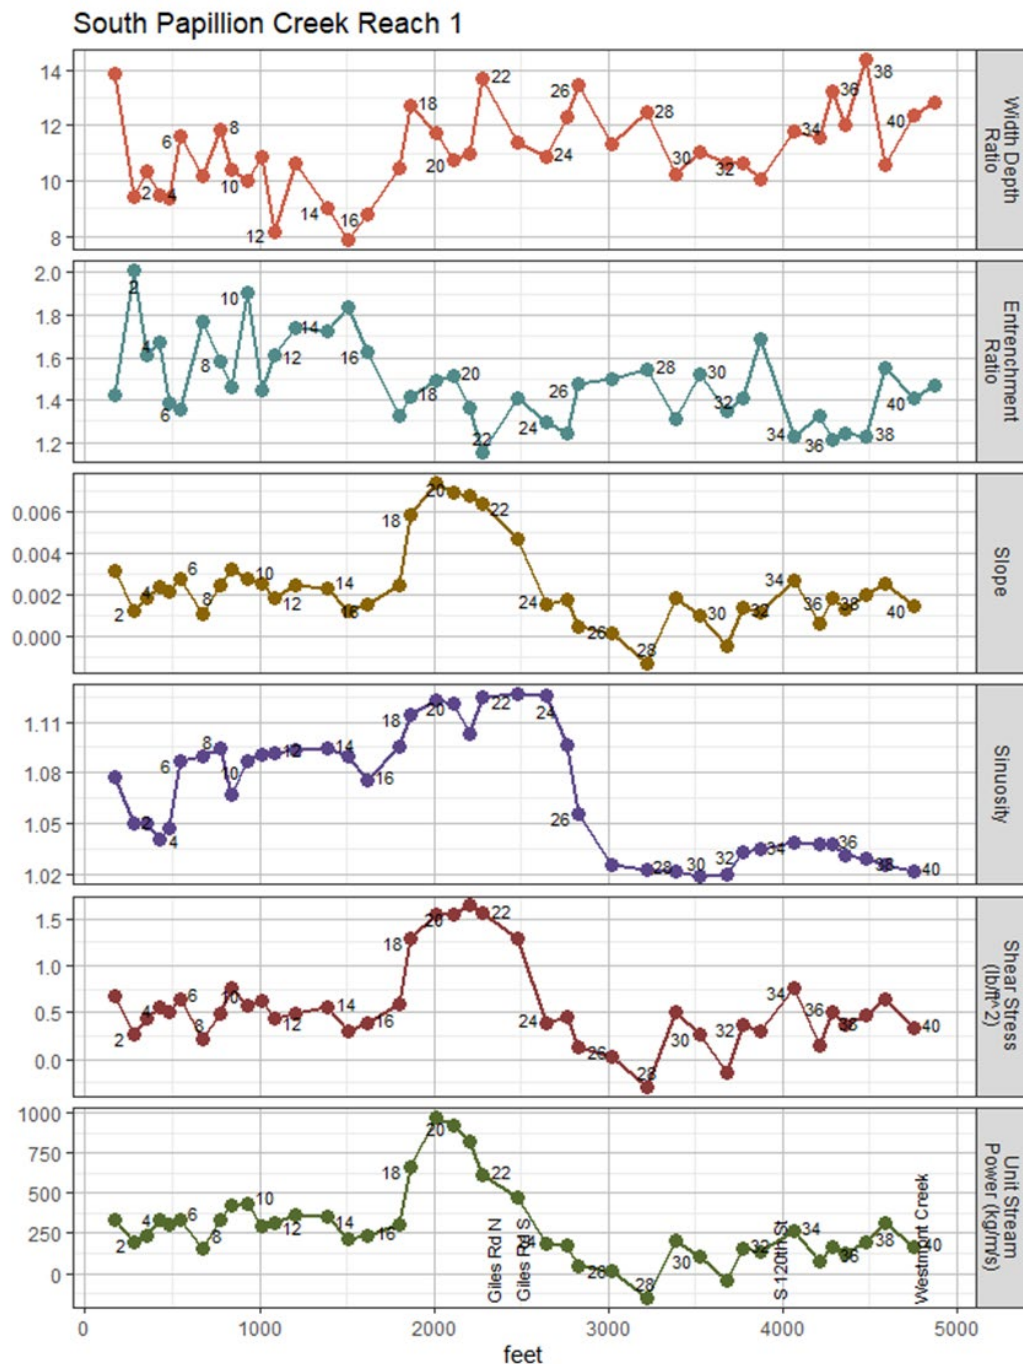
Figure 4-61: FG Level II – Geomorphic Metrics

- The W/D ( $<10$ ) and ER ( $<1.4$ ) show locations where the channel is incised and has limited access to an active floodplain (Figures 4-61, 4-62, 4-63). Most of the W/D ratios are below 12 and demonstrate confined channel conditions.

- The trend of low W/D, high ER, and higher sinuosity downstream of the GCS may indicate that the channel is narrow with sloughing banks and a widening floodplain developing. The higher W/D, low ER, and sinuosity upstream of the GCS appears to be stabilizing the bed and adjusting width, especially in the meander bend through the Giles Road Bridge section.

- Larger shear stress and USP occur in the lower section of the reach below the GCS. Upstream there is low slope and a slightly decreasing ER with less access to floodplain; bankfull berms are actively building.

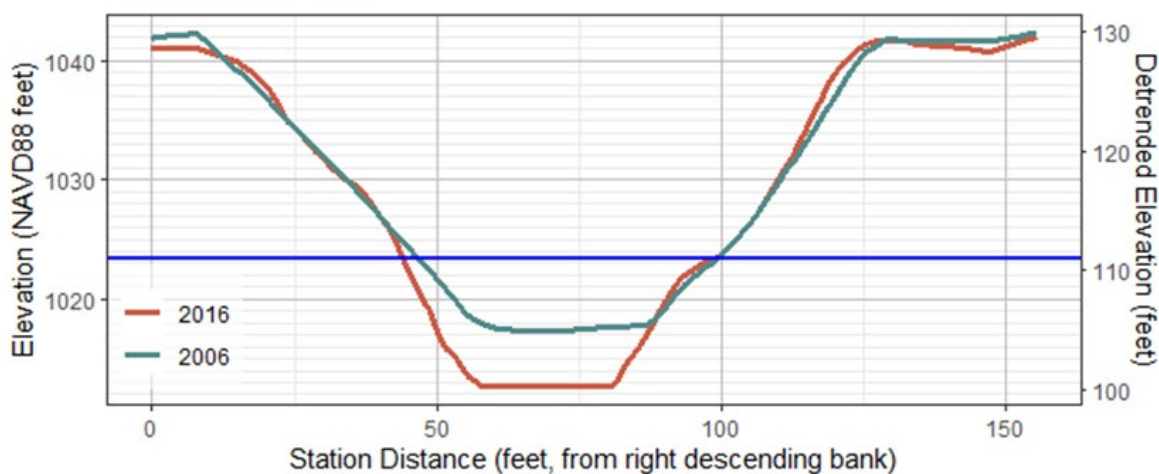
**Cross Section 10**

Slope and cross-section analysis comparisons of the downstream section of the reach reveals channel degradation but relatively no widening (Figures 4-66 to 4-69) between 2004 and 2016. There are GCSs at the South 126<sup>th</sup> Street Bridge, a two-level GCS approximately 750 feet downstream of the South 132<sup>nd</sup> Street, and one more located between the South 132<sup>nd</sup> Street Bridge and I-80 Bridge (Figures 4-64 and 4-65, red circles). Based on aerial photo investigation, the GCSs appear to have been constructed in the same range as the Reach 1 GCS in 2009 or 2010. The GCSs are providing stability to the entire reach and the slope has flattened. The water surface profile within this downstream section of the reach is consistent at 0.0014 ft/ft. The slope in the middle of the reach is 0.00025 ft/ft and the upper section upstream of station 4,000, 0.0016 ft/ft. Based on the LiDAR trends in the downstream and middle sections the reach, the channel bed has dropped approximately three to 3.5 feet (Figure 4-66 and 4-67) and experienced little to no laterally erosion (Figures 4-66 to 4-69).

**Figure 4-66: Reach 2a – Cross-section Depicting Channel Degradation**

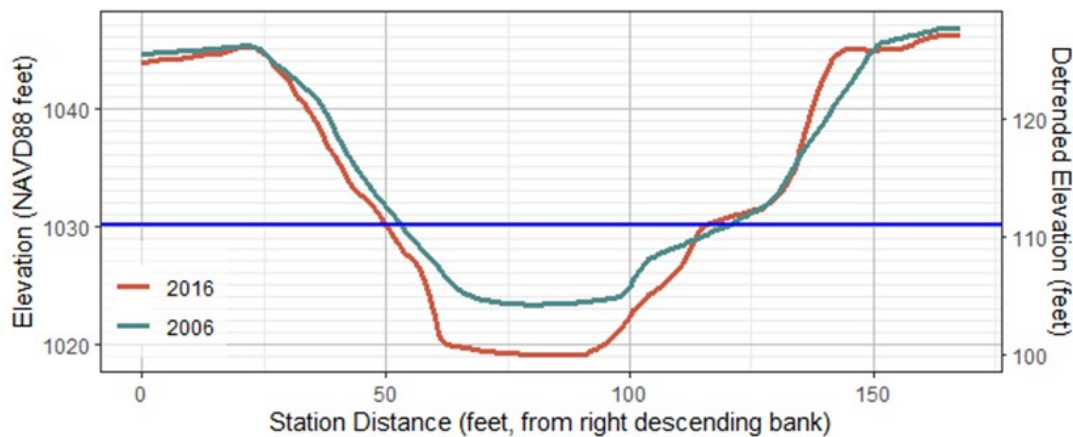
**Cross Section 29**

**Figure 4-67: Reach 2a – Cross-section Illustrating Channel Degradation**

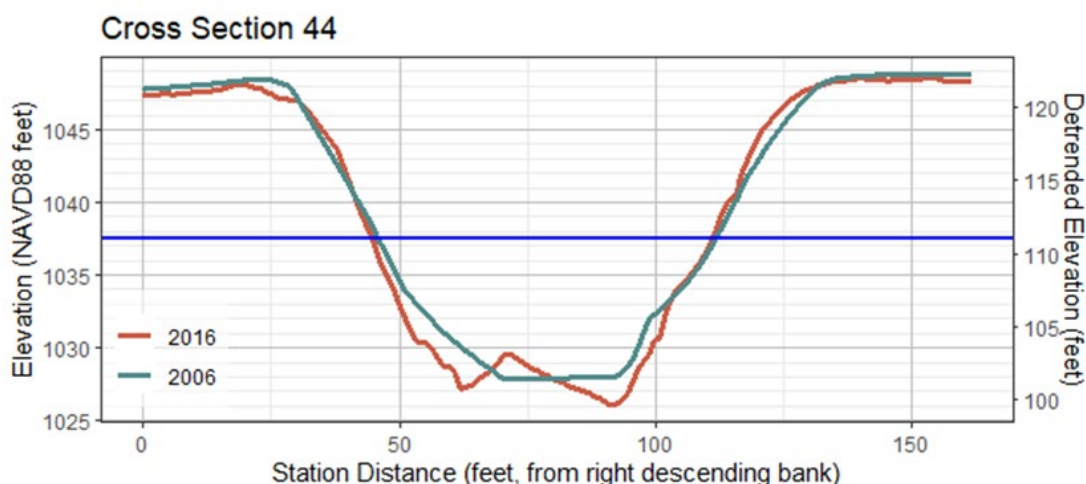
The water surface profiles show a trend of channel degradation in the downstream and middle sections of the reach (cross-sections 1-40) from approximate station 0+00 to 40+00. All sections of the reach appear to have stabilized based on the cross-sectional comparisons. The presence of floodplain berms in Figures 4-68 and 4-69 appears to demonstrate a trend toward reach stability with little bed or bank movement.

**Figure 4-68: Reach 2a – Cross-section 86 Illustrating Stable Channel Bed and Banks**

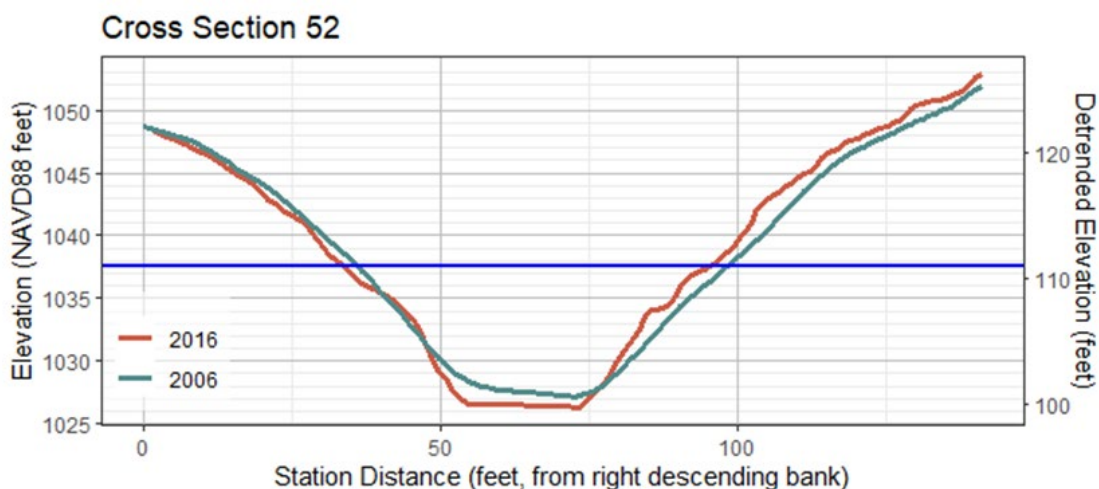
**Figure 4-69: Reach 2a – Cross-section Depicting a Relatively Stable Bank**

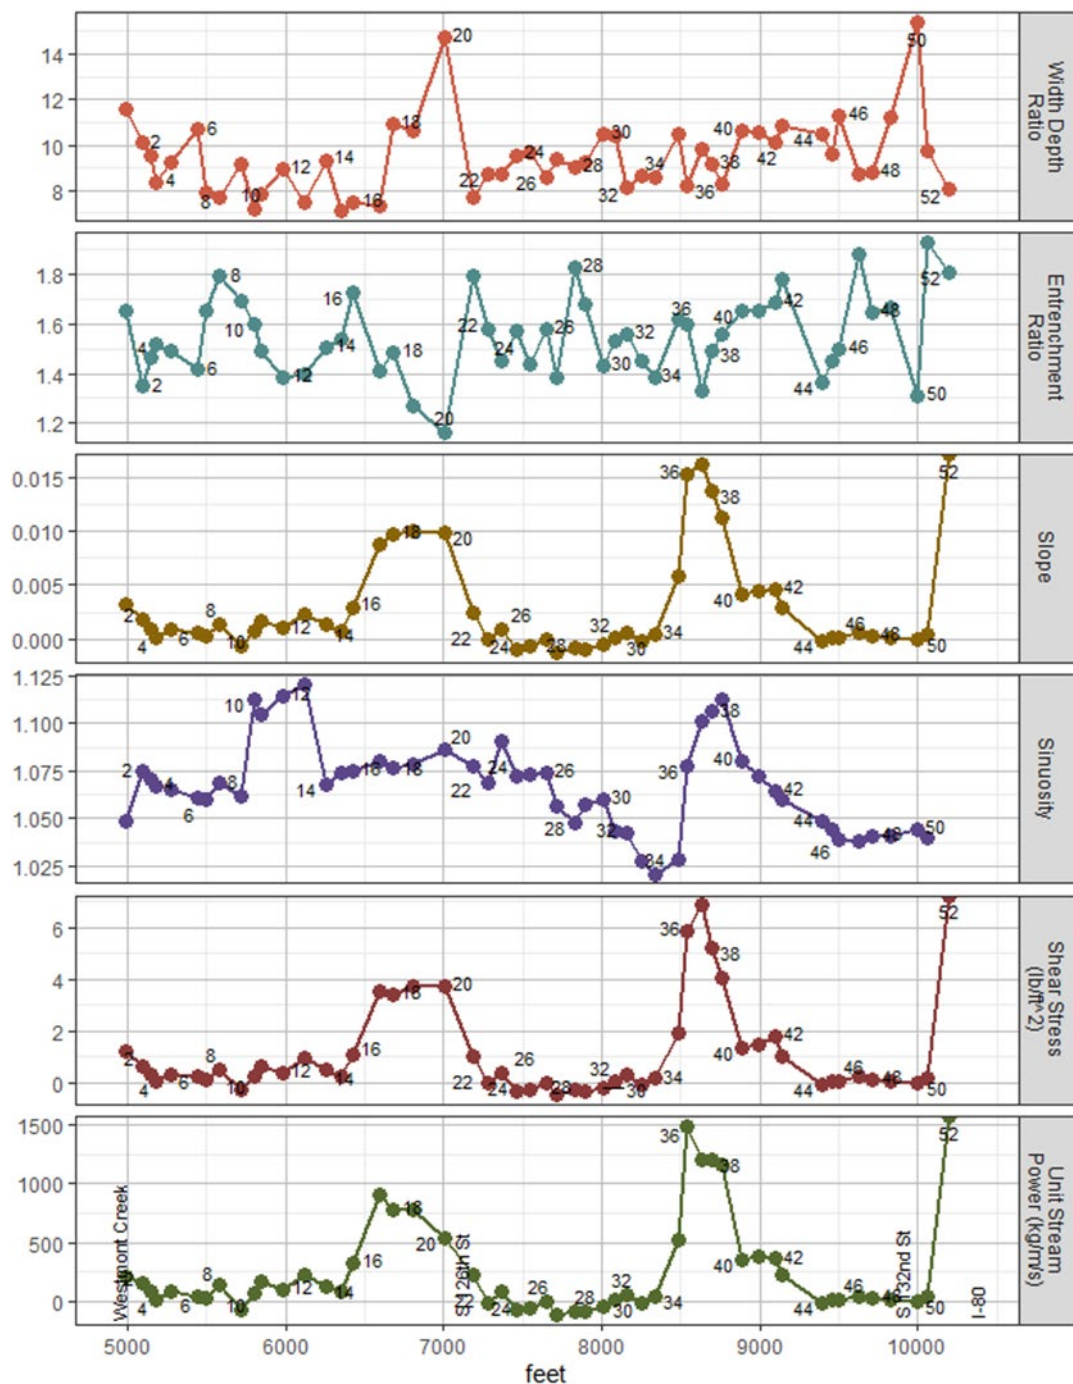
Figure 4-70: FG Level II – Geomorphic Metrics

- The W/D and ER show locations where the channel is incised and has limited access to an active floodplain. Most of the W/D ratios are below 12 and demonstrate confined channel conditions.

- Sinuosity is between 1.0 and 1.1, as the channel is relatively straight.
- Shear stress and USP are fairly consistent except where elevated values are associated with GCS locations.

- The reach appears to be relatively stable. The GCSs are providing bed stability and the lower streambanks are stabilizing. This conclusion should be field-validated.

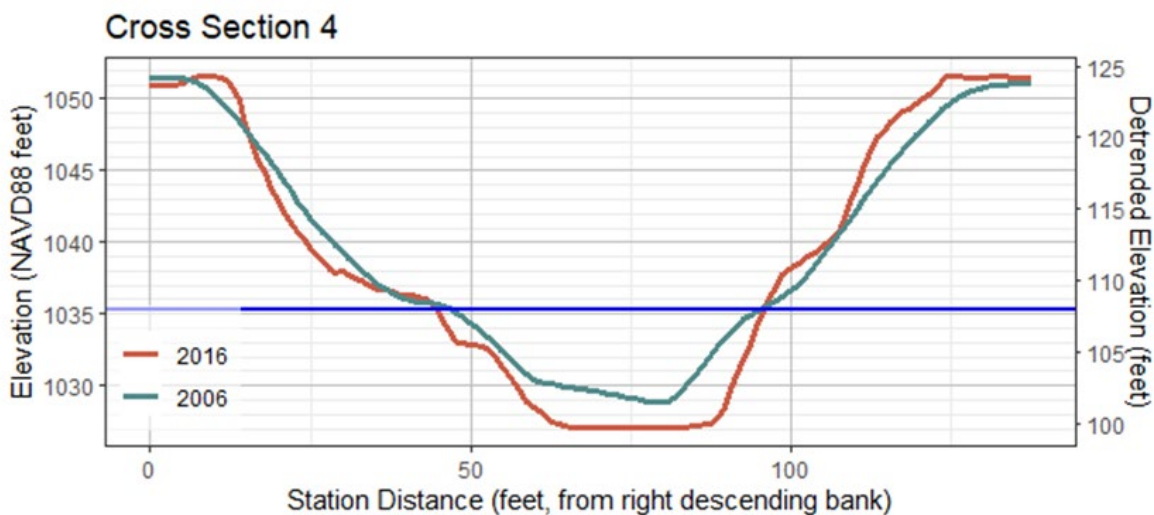
There are floodplain berms in the reach that were used to identify the bankfull channel conditions. The berms are shown in Figure 4-75 (left bank), 4-76 (left and right bank), and 4-77 (left bank).

**Figure 4-75: Reach 2b – Cross-section Depicting Relatively Stable Banks**

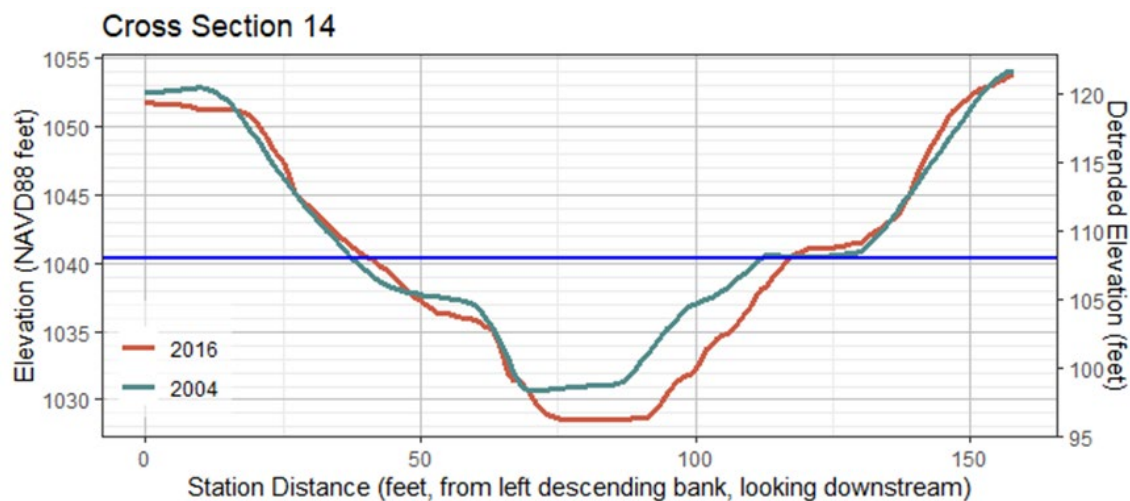
Based on the water surface profile and aerial photo investigation, there is only one GCS in the reach, approximately 800 feet upstream of the I-80 West Bridge (Figures 4-73 and 4-74, red circles). The water surface profile at the GCS fits the 2004 and 2016 very closely. In addition to the GCS, there is likely erosion resistant materials in the channel bottom and banks upstream throughout the reach. The water surface profile within the reach is consistent at 0.0017 ft/ft. This slope should be analyzed further to determine if this slope could be used as a template for determining stable channel slopes for other reaches. Based on the LiDAR water surface slope there are no discernable bed degradational trends (Figures 4-75 and 4-78); however, there is some local scour and erosion as depicted in Figure 4-76.

**Figure 4-76: Reach 2b – Cross-section Depicting Slight Bed and Bank Erosion**

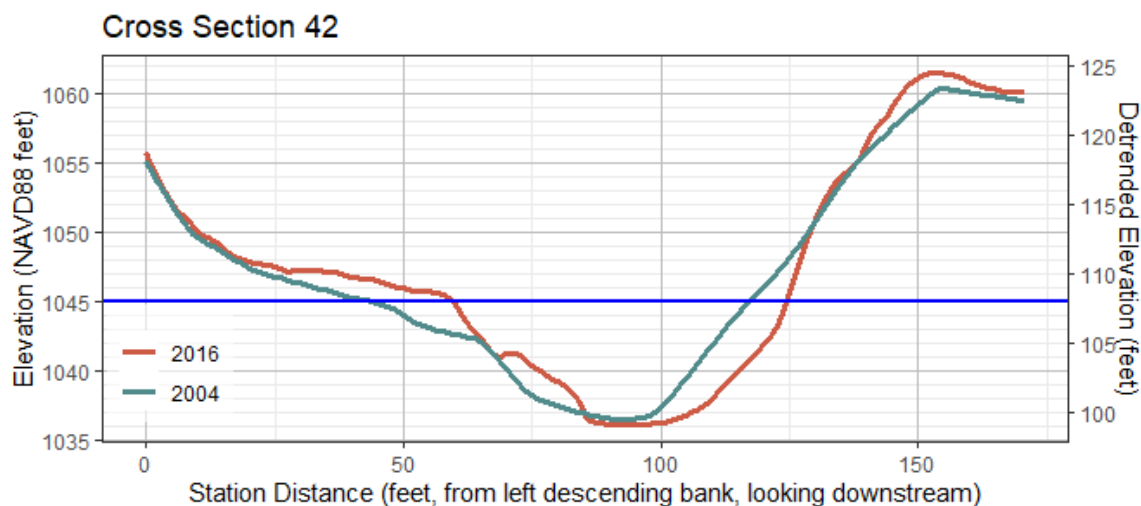
**Figure 4-77: Reach 2b – Cross-section Depicting a Relatively Stable Bank**

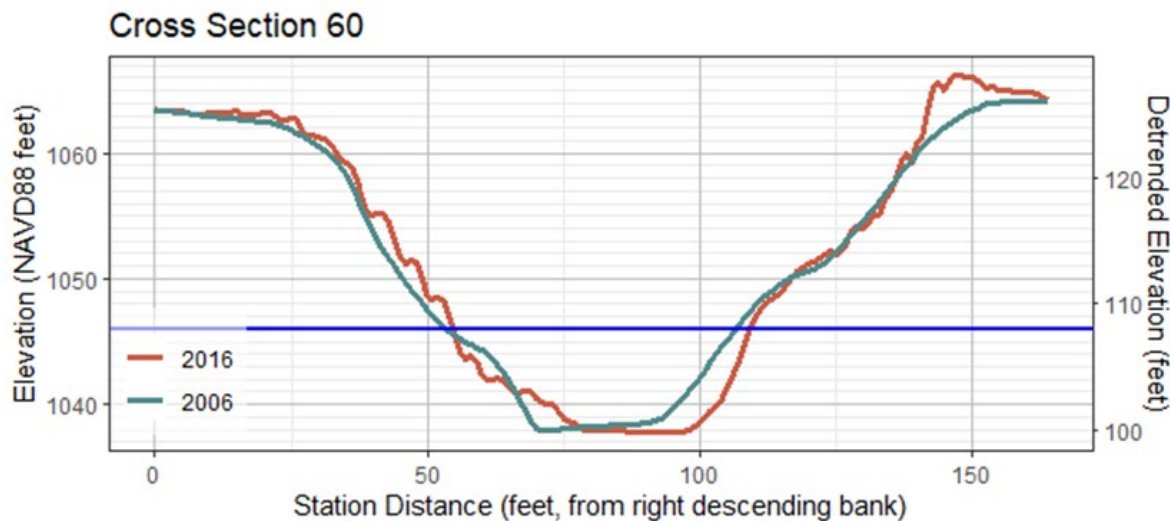
**Figure 4-78: Reach 2b – Cross-section Depicting a Relatively Stable Bank**

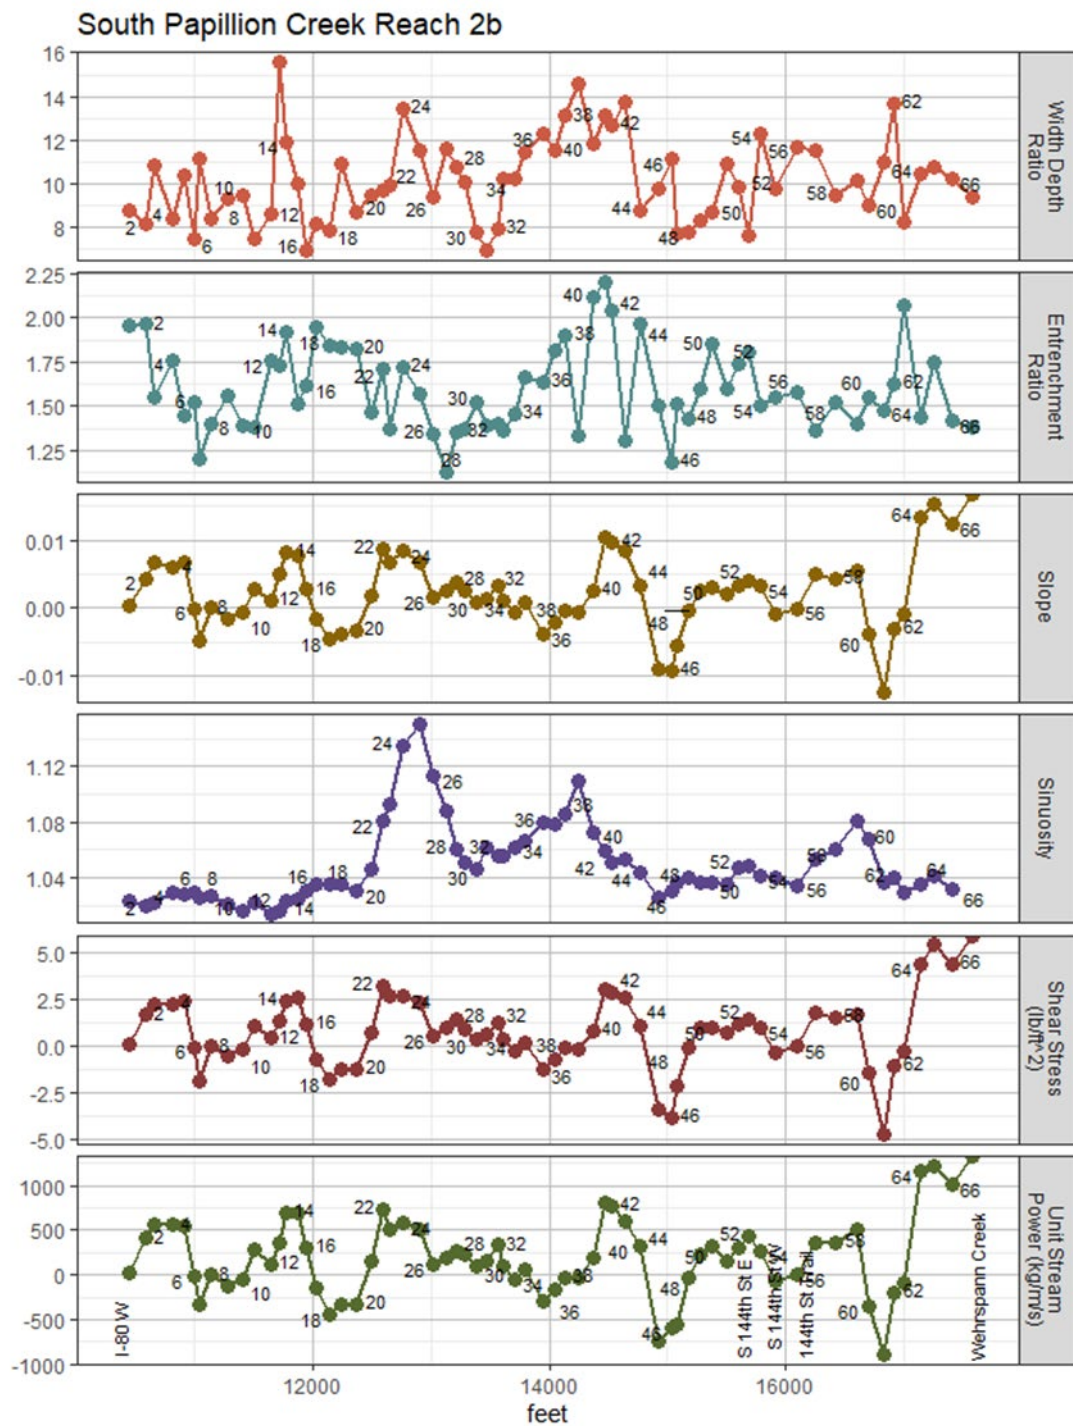
Figure 4-79: FG Level II – Geomorphic Metrics

- The W/D and ER show locations where the channel is incised and has limited access to an active floodplain (Figures 4-79, 4-80, 4-81). Most of the W/D ratios are below 12 and demonstrate confined channel conditions.

- All the reach ERs are below the moderately entrenched stream-classification break of 2.2 (Rosgen, 1996). Moderate to entrenched sections are likely continuing to develop an active floodplain so will likely continue to cause bank erosion as the channel continues to adjust. This may be lessened by resistant lower bank materials (cohesive materials), vegetation and existing stabilization materials in the bed or bank.

- Reach sinuosity ranges from 1.0 to 1.15 as the channel is relatively straight.
- The GCS is providing stability to the reach. The channel slope of 0.0017 ft/ft is stable upstream of the structure.

- The reach appears to be relatively stable. The GCS is providing bed degradation protection and the lower banks are stabilizing. This should be field validated.

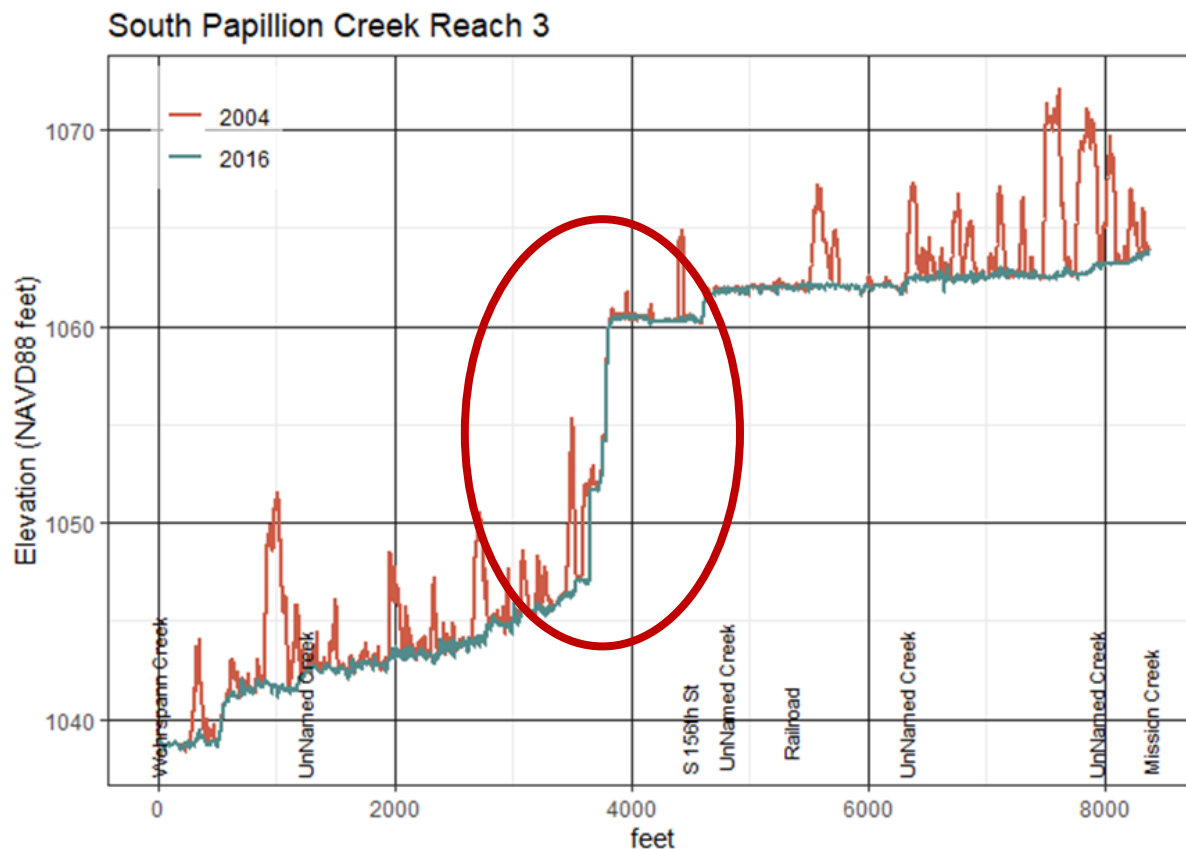
**Figure 4-83: FG Level 1, Reach 3 – LiDAR Water Surface Profiles**

The water surface profile within the reach below the GCS is 0.0023 ft/ft. Upstream of the GCS the channel slope is much flatter at 0.0009 ft/ft. Based on the LiDAR slope there is no discernable bed degradational trends (Figure 4-83).
