# **Papillion Creek Watershed**

## **Streambed Degradation Study**

### **Section 22: Planning Assistance to States**

#### **Final Report**

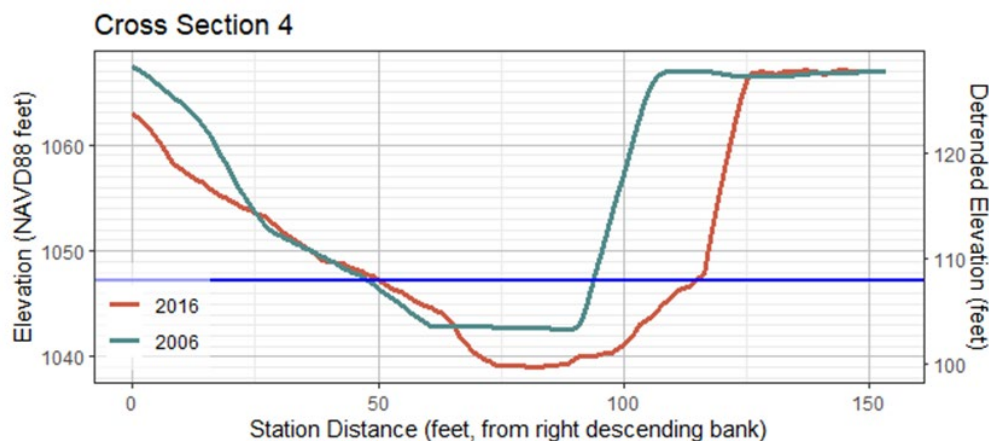
Based on cross-section analysis, there is a significant amount of local channel erosion in the reach (Figures 4-84 to 4-87). The streambank erosion appears to be the worst in the upper section where there is a meandering course at the mouth of Mission Creek.

**Figure 4-84: Reach 3 – Cross-section Illustrating Right Bank Erosion**

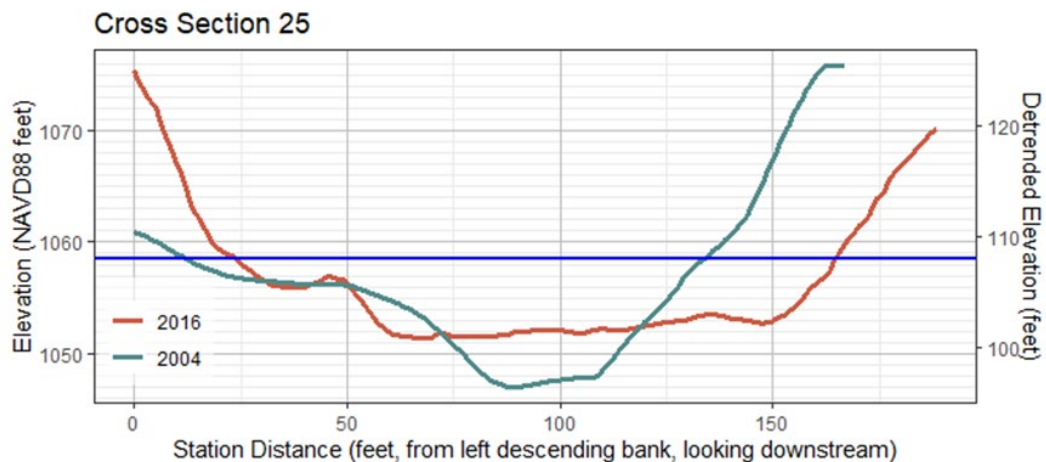
**Figure 4-85: Reach 3 – Cross-section Showing Channel Widening Downstream of GCS**

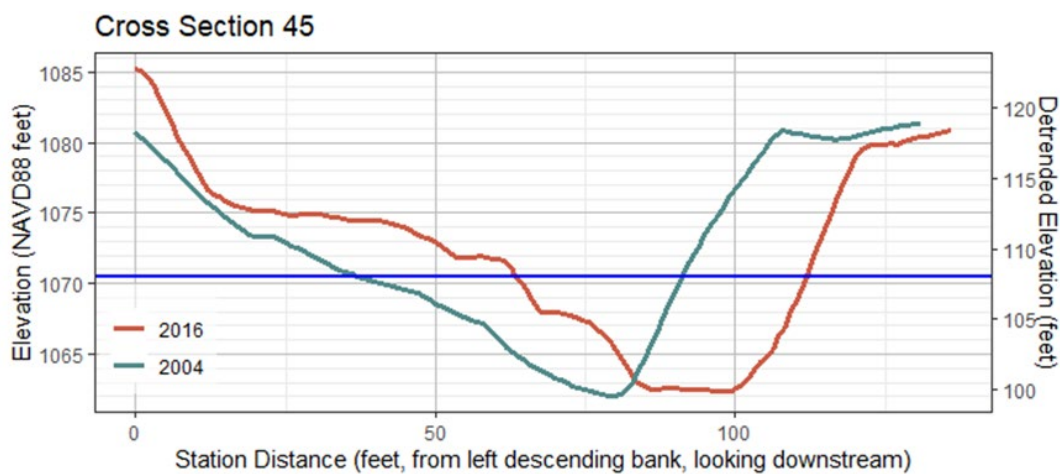
**Figure 4-86: Reach 3 – Cross-section with Right Bank Erosion and Left Bank Deposition**

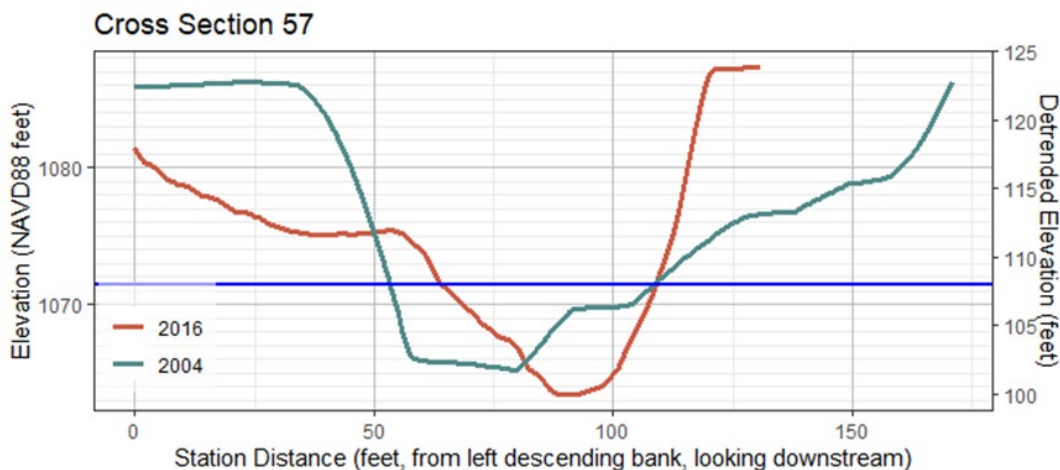
**Figure 4-87: Reach 3 – Cross-section with Right Bank Deposition and Left Bank Erosion**

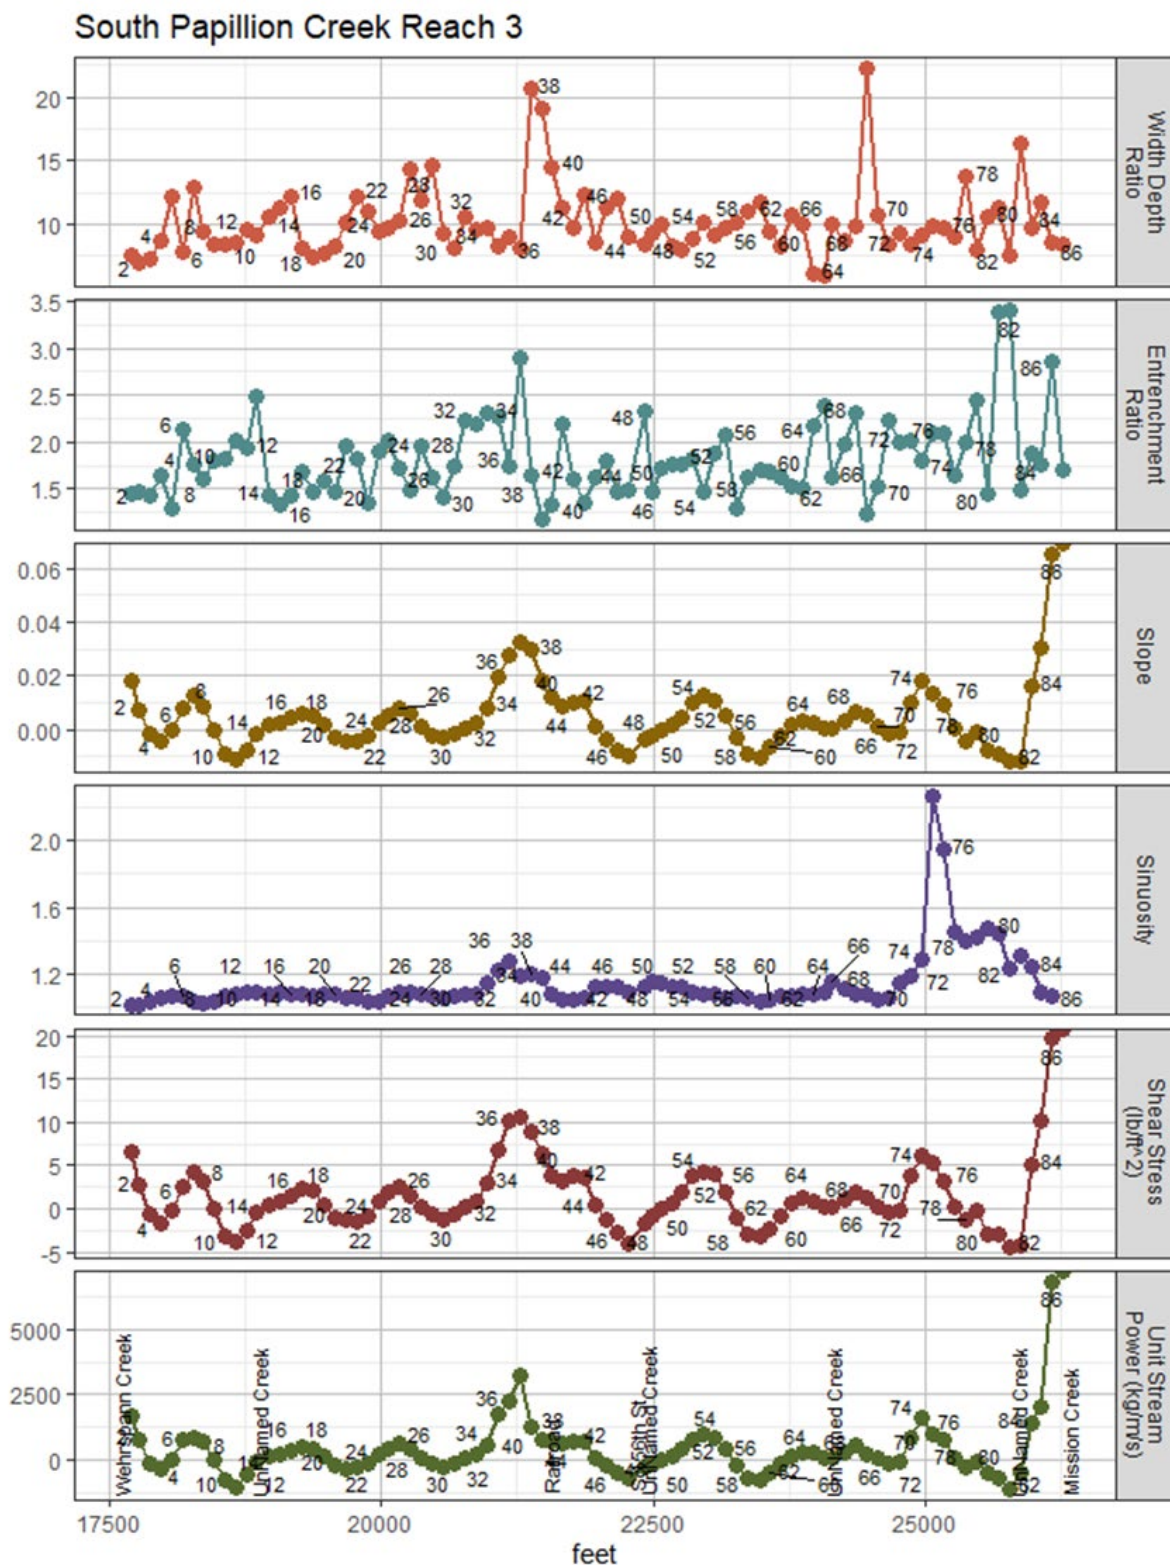
Figure 4-88: FG Level II – Geomorphic Metrics

- The W/D and ER show locations where the channel is incised and has limited access to an active floodplain (Figures 4-88 to 4-90). Most of the W/D ratios are below 15 and trend toward a stabilizing confined channel.

- The reach slope values are showing a consistent pattern of a riffle and pool (Figure 4-88) sequence.
- Sinuosity is below 1.2 for most of the reach showing little variability in meander pattern.

- Additional field-validation is recommended to determine if the reach is relatively stable with such low W/D, ER, and sinuosity values. The bed stability is at least partly from the GCS but may also have resistive cohesive bank materials.

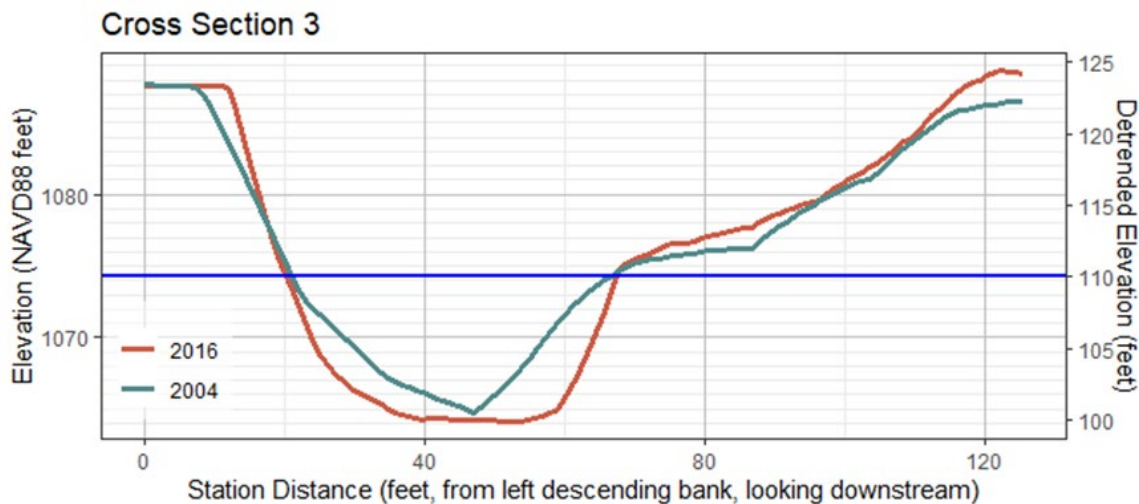
**Figure 4-93: Reach 4 – Cross-section Depicting a Relatively Stable Bank**

- Based on the slope analysis, Reach 4 appears to be in a CEM stage IV and possibly early-stage V. The streambed is stable and there is local bank erosion. New floodplain berms are forming in much of the reach showing a trend of stabilization (Figures 4-93 and 4-95).

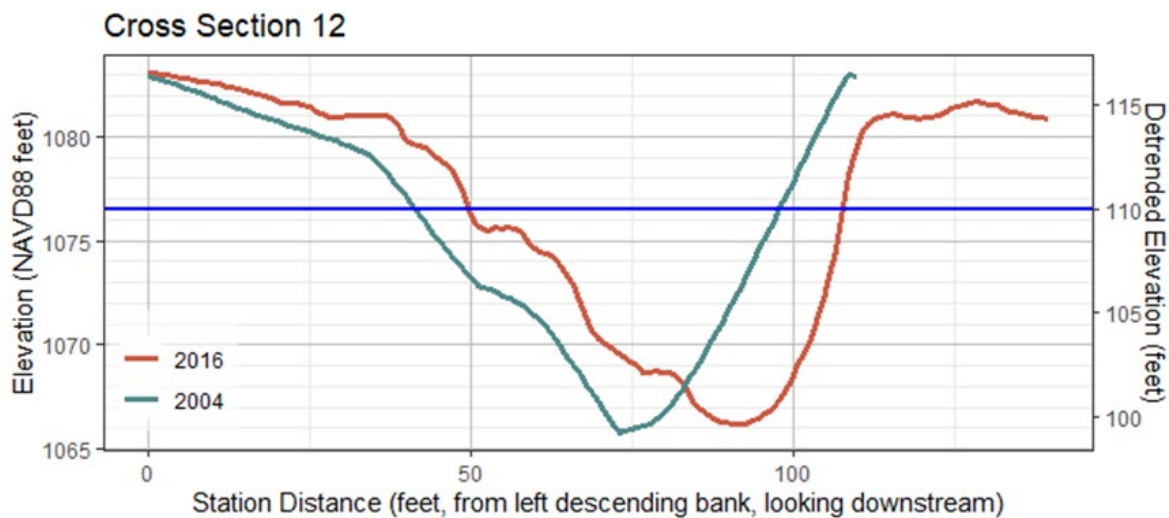
**Figure 4-94: Reach 4 – Cross-section Illustrating Channel Migration**

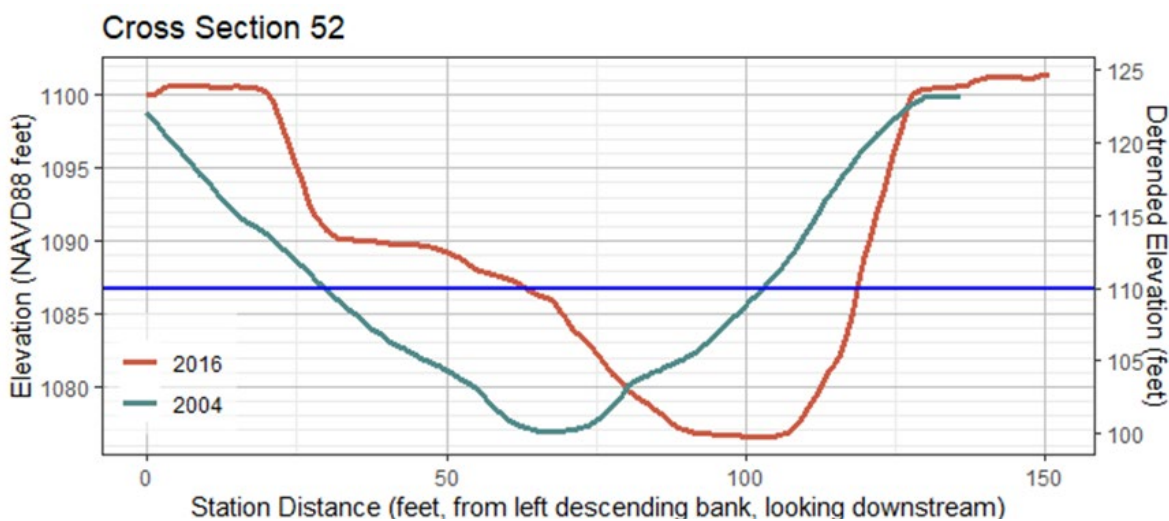
**Figure 4-95: Reach 4 – Cross-section Illustrating Channel Migration**

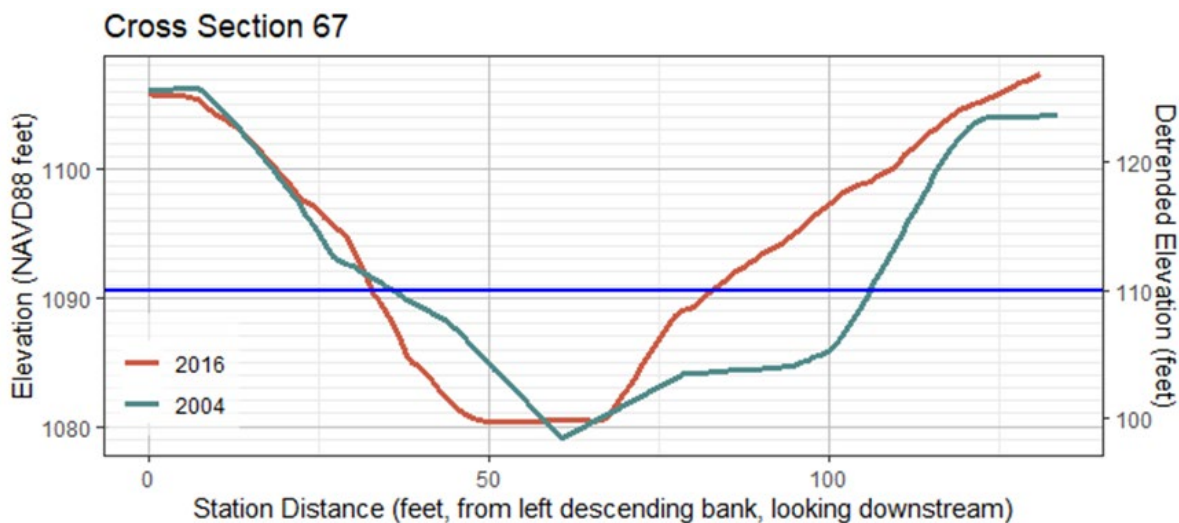
**Figure 4-96: Reach 4 – Cross-section Illustrating Channel Migration**

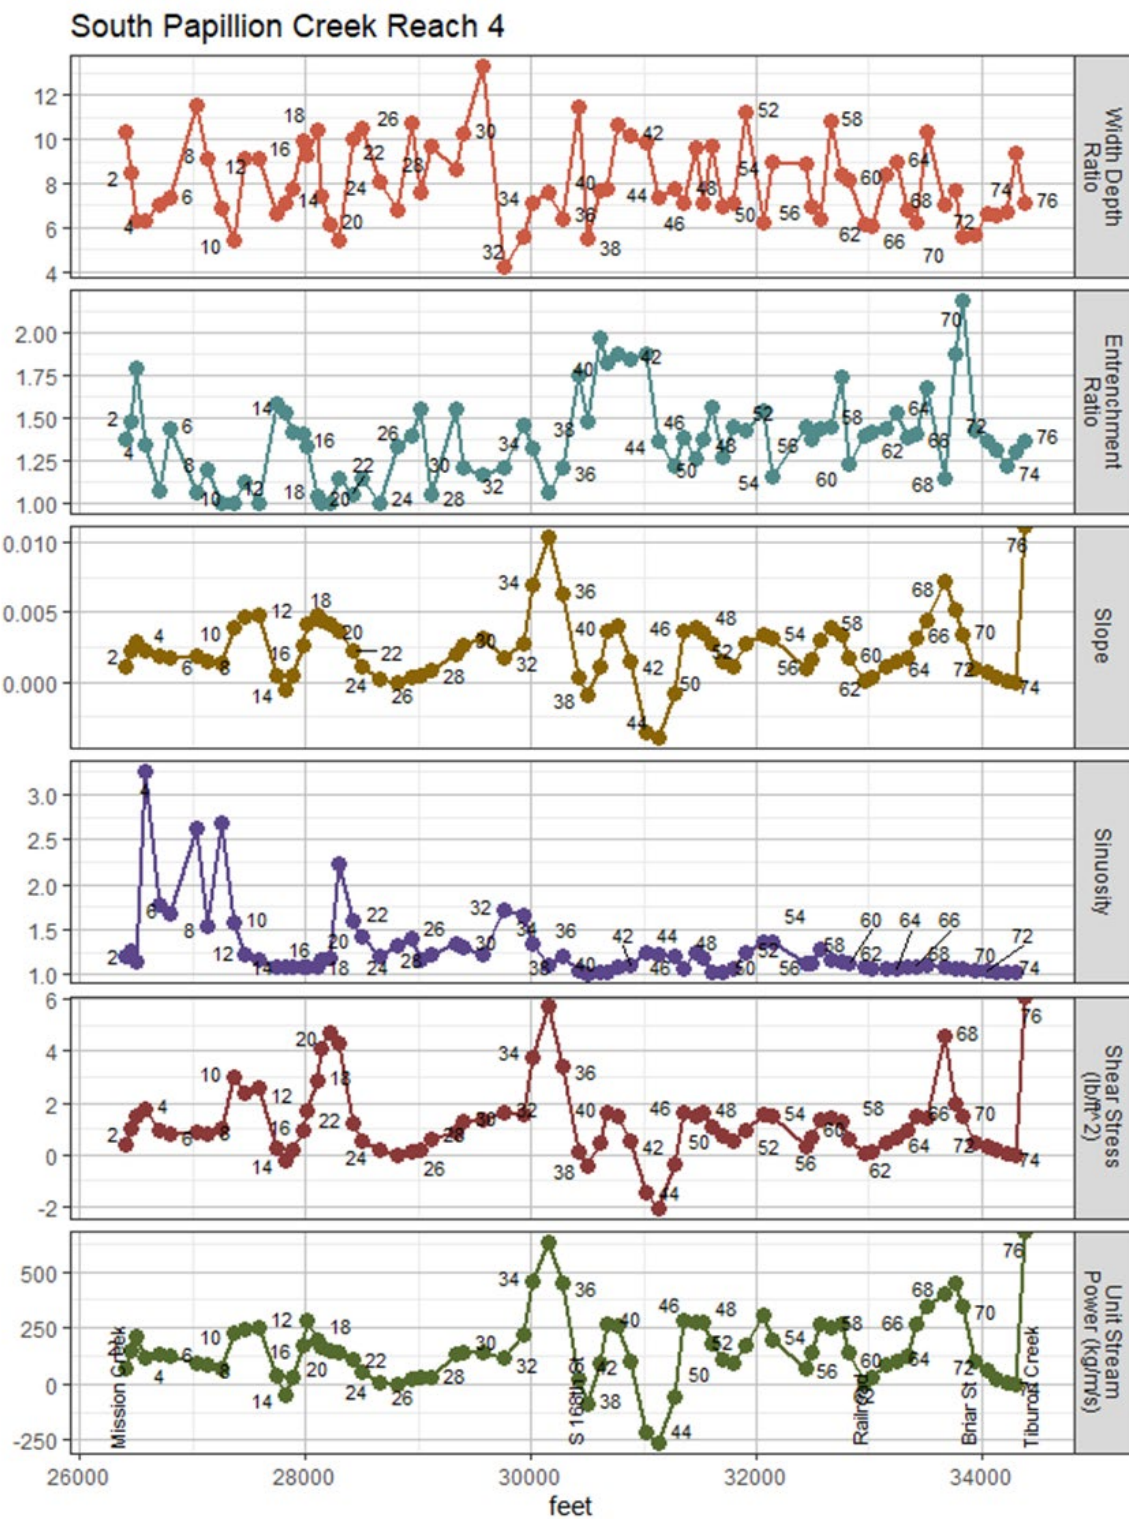
Figure 4-97: FG Level II – Geomorphic Metrics

- The W/D and ER show locations where the channel is incised and has limited access to an active floodplain (Figure 4-97). Most of the W/D ratios are below 12 and the ER trends in the downstream section of the reach are very low ( $<1.25$ ).

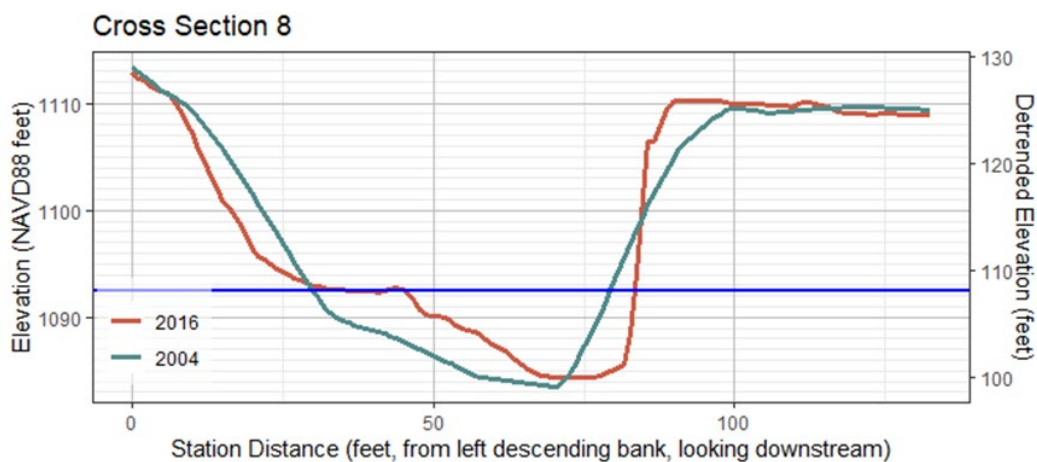
**Figure 4-102: Reach 5 – Cross-section with Right Bank Erosion and Left Bank Deposition**

The water surface profile within the reach below the GCS is 0.0018 ft/ft. Upstream of the GCS the channel slope is much flatter at 0.0009 ft/ft. The channel is likely continuing to adjust to channel bed lowering as there is a significant amount of streambank erosion. The reach is showing signs of stabilizing with the building of active floodplain berms in Figures 4-102 through 4-105.

- Based on the slope analysis, Reach 5 appears to be in an early CEM Stage V. The streambed has recently transitioned to being relatively stable, but there is local bank erosion. New floodplain berms are forming in much of the reach showing a trend of stabilization (Figures 4-102 to 4-105).

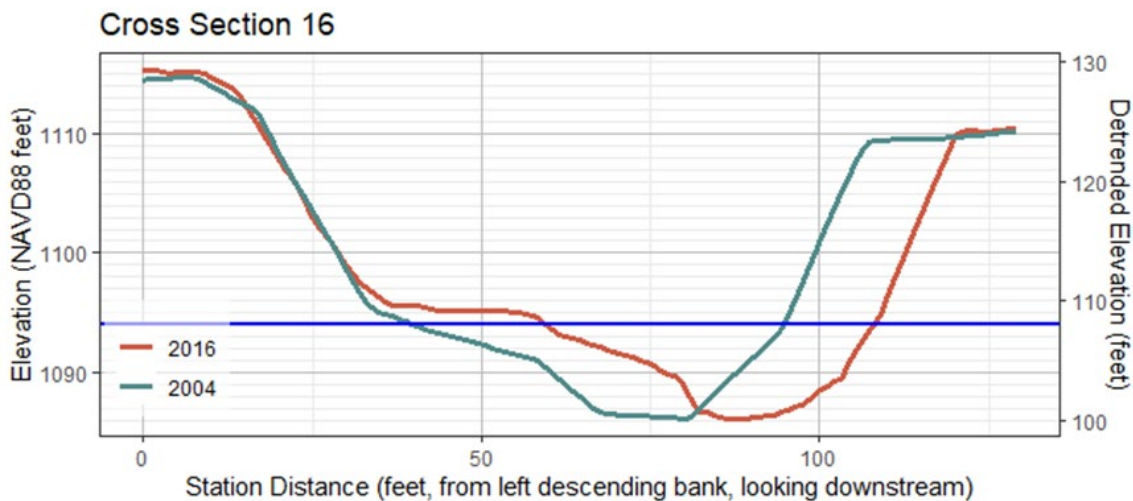
**Figure 4-103: Reach 5 – Cross-section with Right Bank Erosion and Left Bank Disposition**

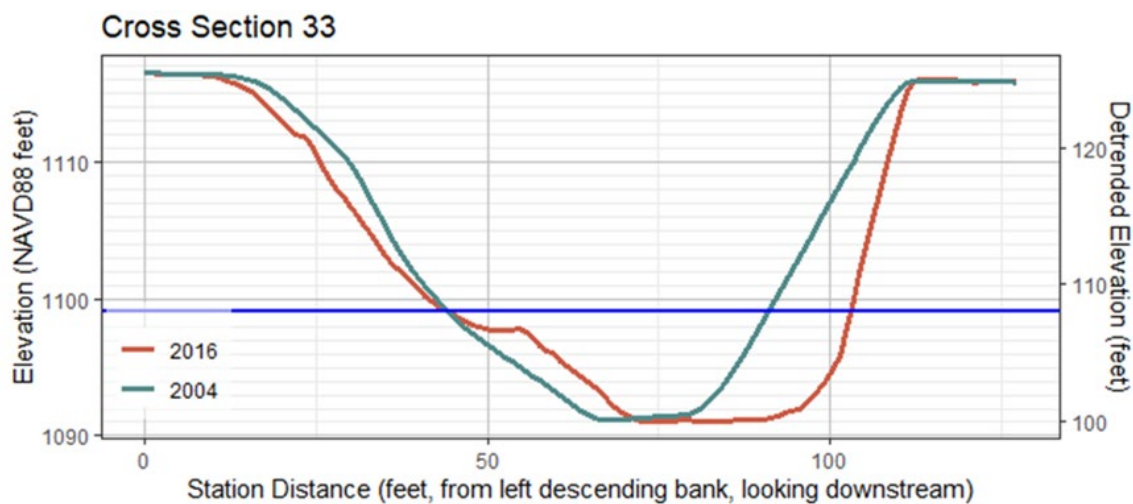
**Figure 4-104: Reach 5 – Cross-section Illustrating Right Bank Erosion**

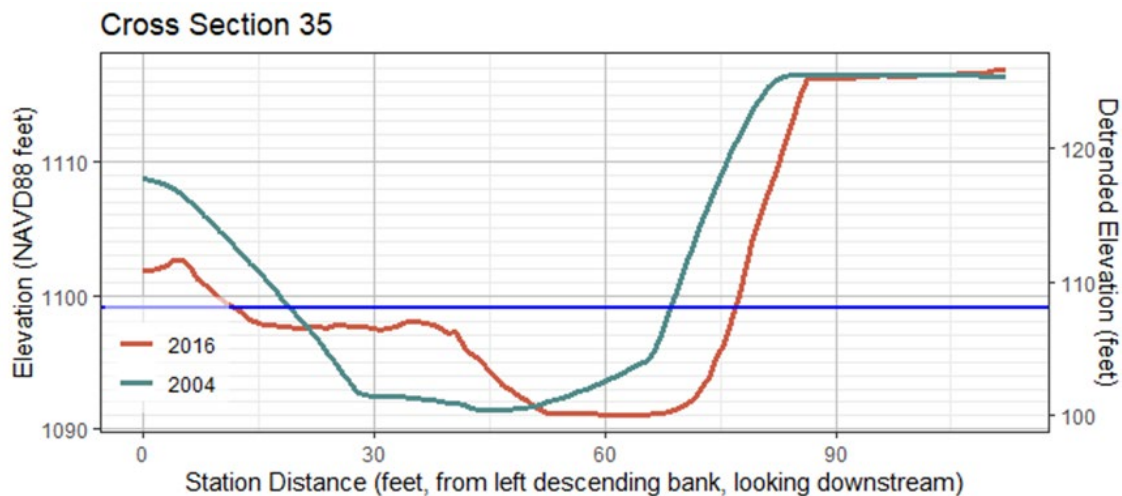
**Figure 4-105: Reach 5 – Cross-section with Right Bank Migrations with Left Bank Berm Forming**

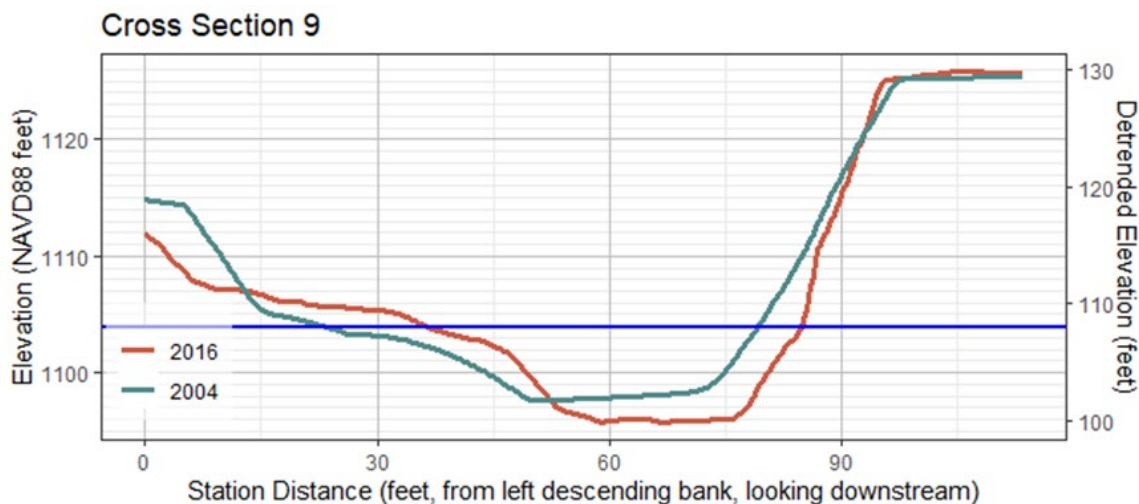
The cross-sectional analysis (Figure 4-111 to 4-118) shows much of the reach is stable with some areas experiencing localized bank erosion. The water surface profile within the reach below the Giles Road Bridge GCS is 0.0039 ft/ft. Upstream of the GCS the channel slope is flatter at 0.0026 ft/ft. The channel upstream of the GCS is adjusting to the bed raising as there is a significant amount of sediment deposited in the previous incised channel. The reach is showing signs of stabilizing with the building of active floodplain berms (Figures 4-111 through 4-114).

**Figure 4-111: Reach 6 – Cross-section Depicting Channel Erosion and Deposition**

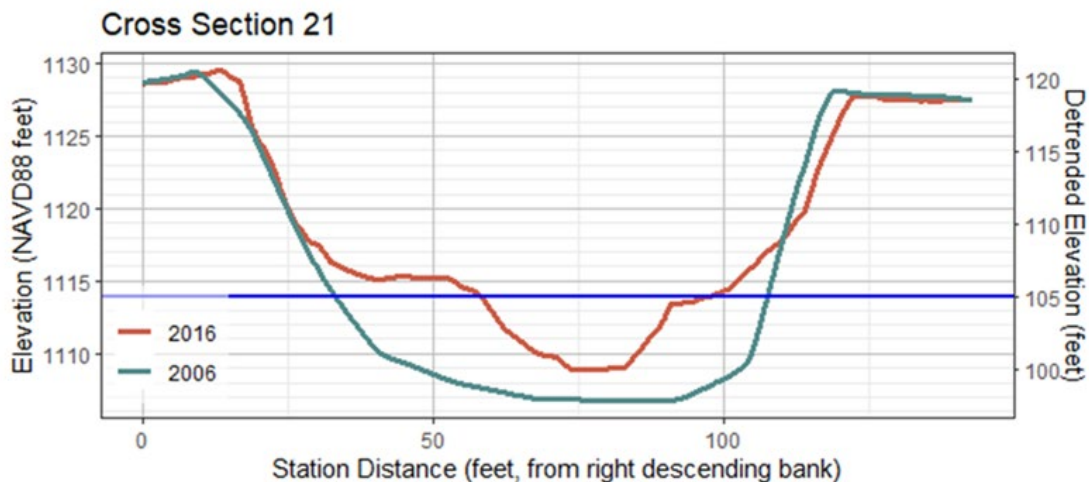
The major structures are located at the Railroad Bridges, Giles Road, and a utility crossing at approximate station 5700. The Giles Road GCS is approximately seven feet high. Upstream of the Giles Road GCS, a series of GCSs appear to have been constructed between 2003 and 2004. This has provided additional bed and bank stability and sediment has infilled the previously incised channel as illustrated in Figures 4-112 and 4-113.

**Figure 4-112: Reach 6 – Cross-section with Channel Fill and Floodplain Development**

- This is the only reach where we have a new channel forming directly within the old, incised channel with floodplain berms forming, showing a trend of stabilization (Figures 4-112 and 4-113).

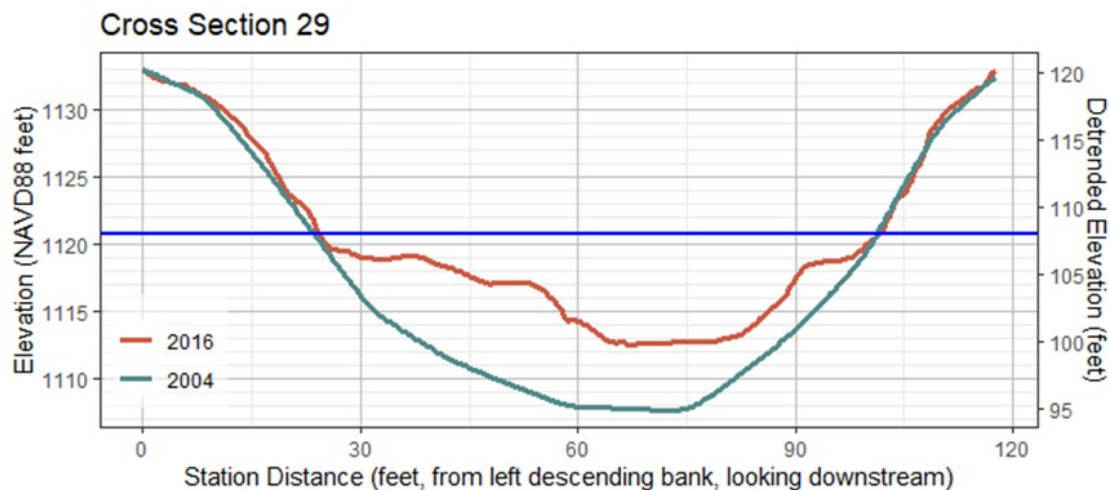
**Figure 4-113: Reach 6 – Cross-section with Channel Fill and Floodplain Development**

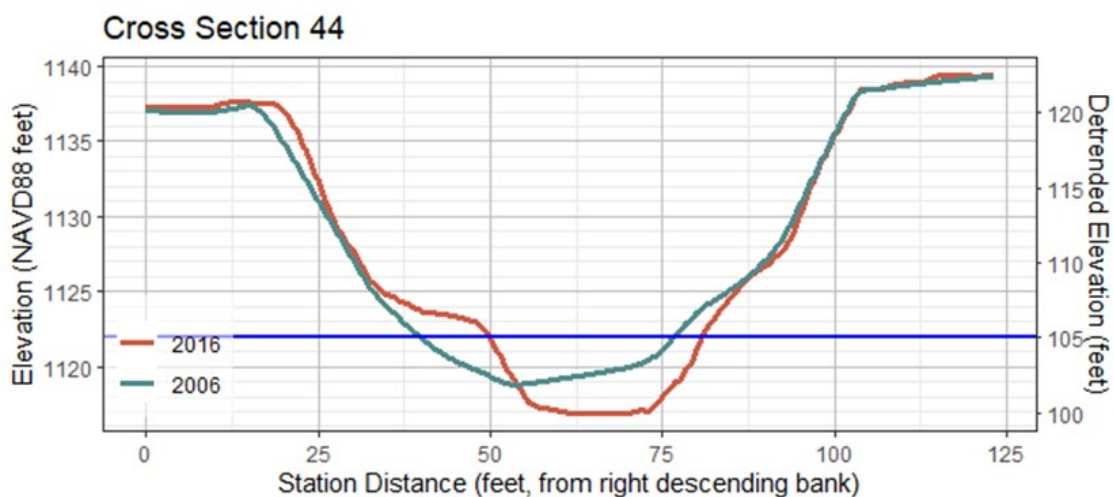
**Figure 4-114: Reach 6 – Cross-section Illustrating Bed Changes Between 2004 and 2016**

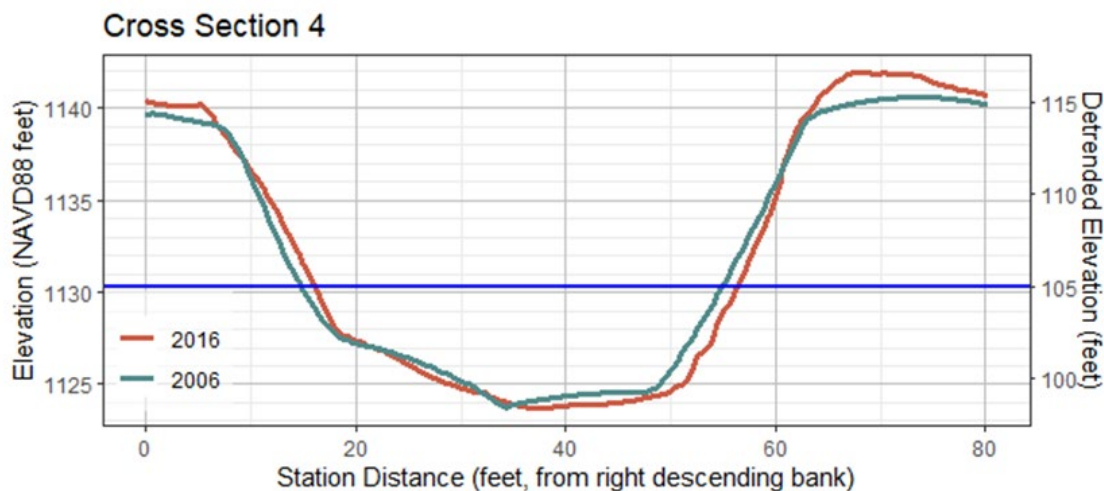
**Figure 4-120: Reach 7 – Cross-section Depicting Relatively Stable Banks**

- The GCSs are providing streambed stability and many of the areas within the reach are in the process of stabilizing and building floodplain berms within the channel margins (Figures 4-120 and 4-121). There is some local bank erosion as the channel continues to adjust. The over-widened W/D areas within the reach are the most susceptible to bank erosion and requires field validation.

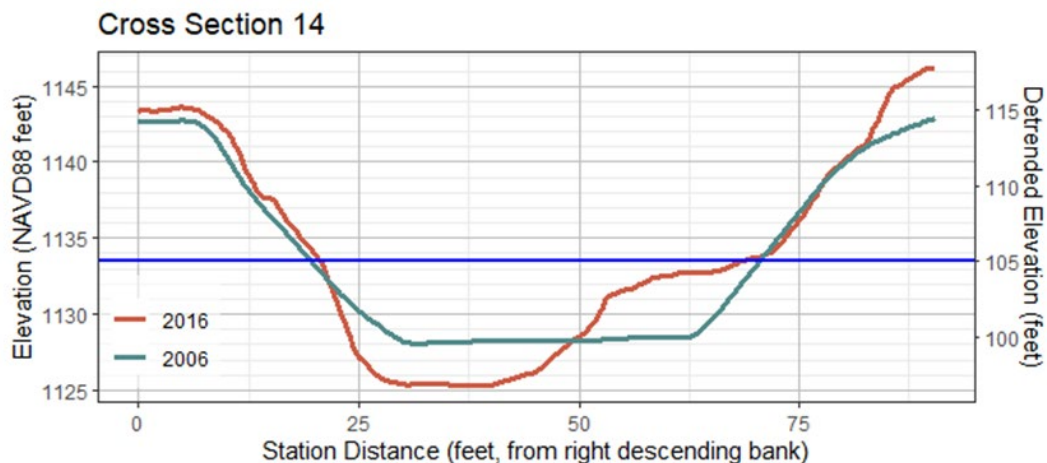
The cross-sectional analysis (Figures 4-120 to 4-123) shows much of the reach is stable with some areas experiencing localized bank erosion (Figure 4-122). The reach is showing signs of stabilizing with the building of active floodplain berms (Figures 4-121 to 4-122).

**Figure 4-121: Reach 7 – Cross-section Showing Right Bank Berm Deposition**

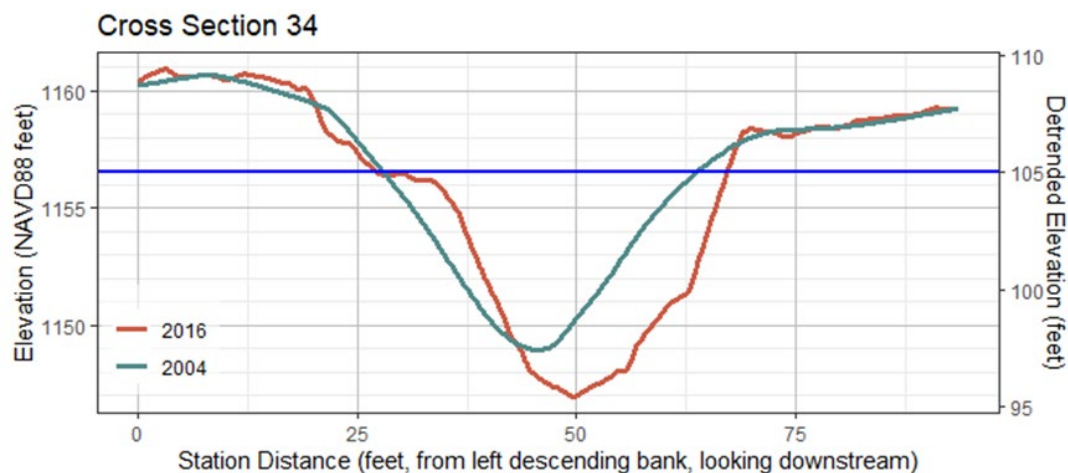
**Figure 4-122: Reach 7 – Cross-section Depicting Right Bank Erosion**

- There is local streambank erosion occurring in the reach (Figure 4-122) Stabilization of bank erosion sites require local treatments. This local treatment option may need to be expanded upon once the middle section of the reach is investigated more. The slope is very steep compared to other reaches and there is no indication of any GCSs in the channel so there may be need for a more holistic approach to stabilization in the reach.

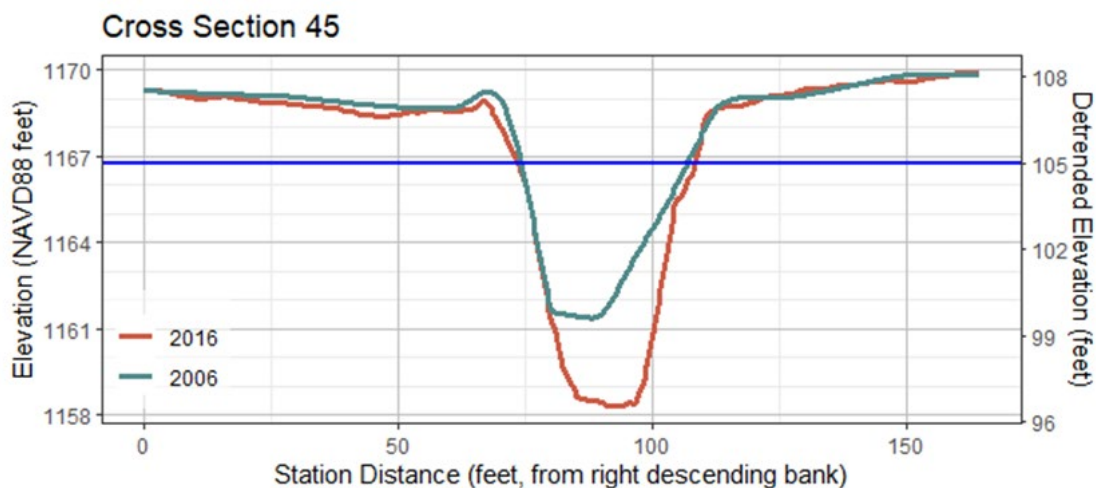
**Figure 4-123: Reach 7 – Cross-section Showing Bed Changes Between 2004 and 2016**

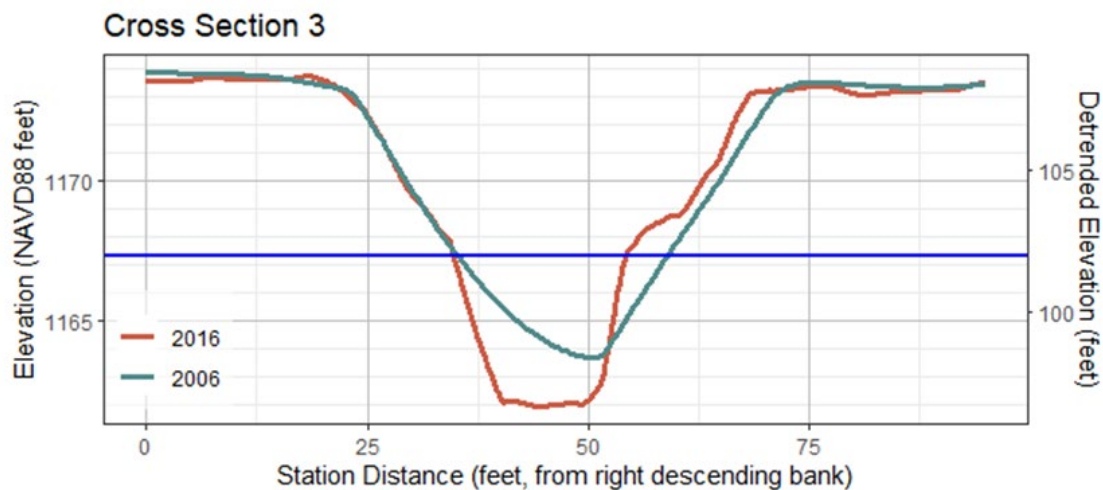
The cross-sectional analysis (Figures 4-129 to 4-132) shows much of the reach appears to have channel degradation with some areas experiencing localized bank erosion (Figures 4-129 and 4-130). The main process appears to be channel incision with very little widening occurring (Figures 4-131 and 4-132). The lack of channel widening could be from encountering more erosion resistant materials in the bed and bank. This should be investigated further in coordination with reviewing the GCSs within the reach.

**Figure 4-129: Reach 8 – Cross-section Depicting Relatively Stable Banks**

- There is significant channel incision occurring in the reach (Figure 4-129 to 4-132). The three known GCSs are providing necessary bed stabilization and have also provided bank erosion control protection within the reach.

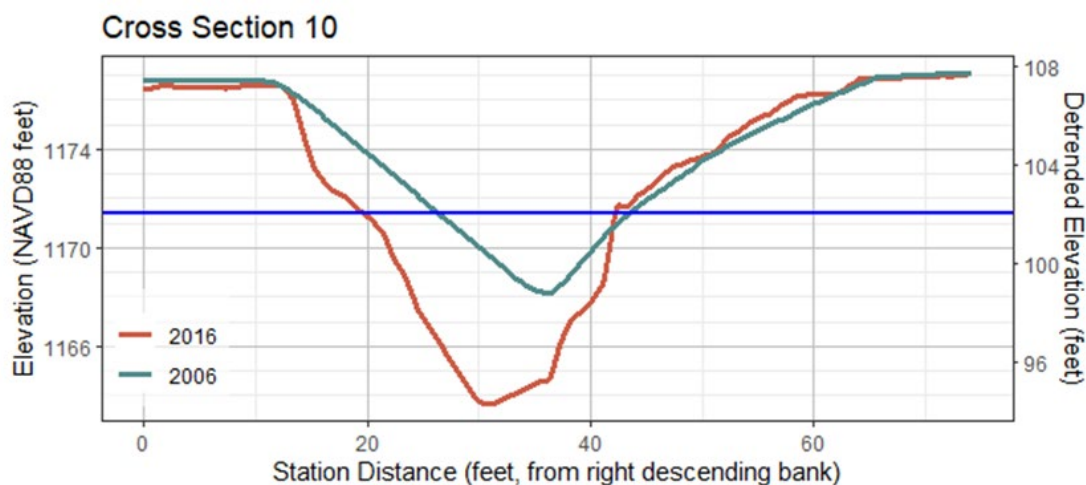
**Figure 4-130: Reach 8 – Cross-section Illustrating Relatively Stable Banks**

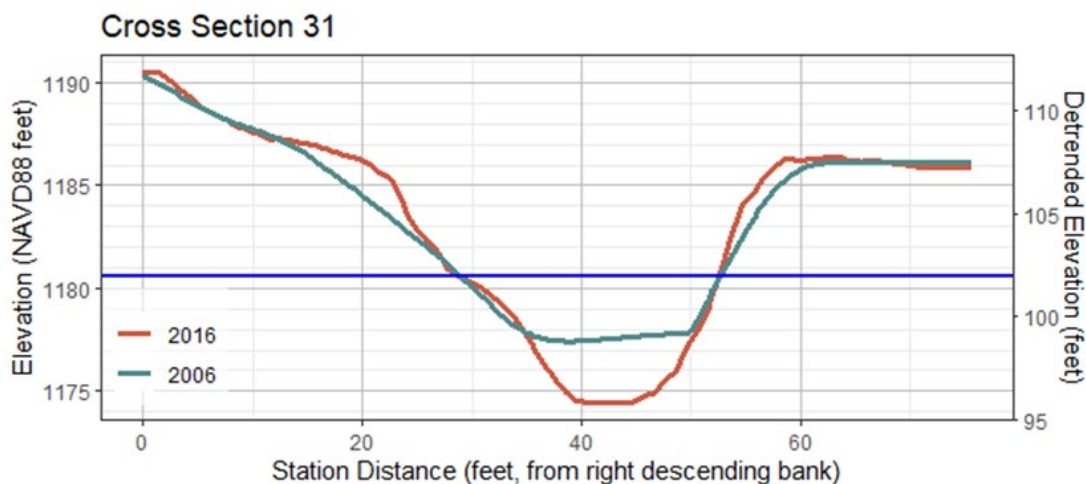
**Figure 4-131: Reach 8 – Cross-section Illustrating Bed Changes Between 2004 and 2016**

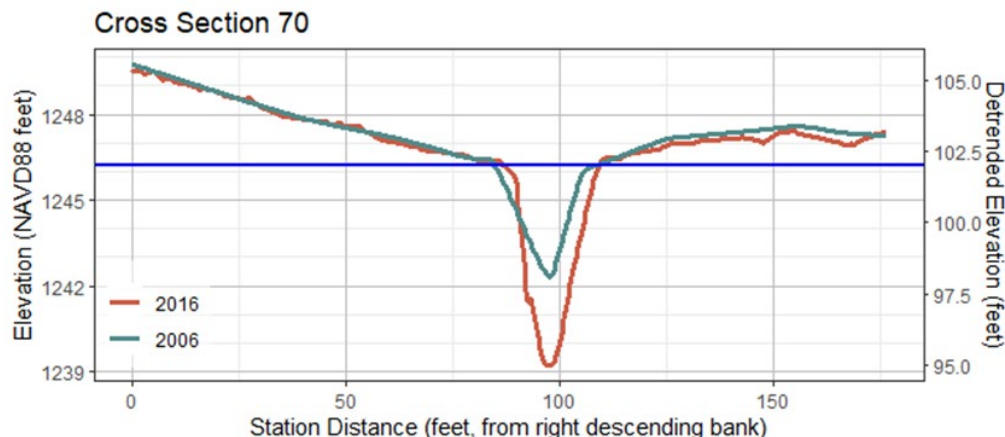
**Figure 4-132: Reach 8 – Cross-section Illustrating Bed Changes Between 2004 and 2016**

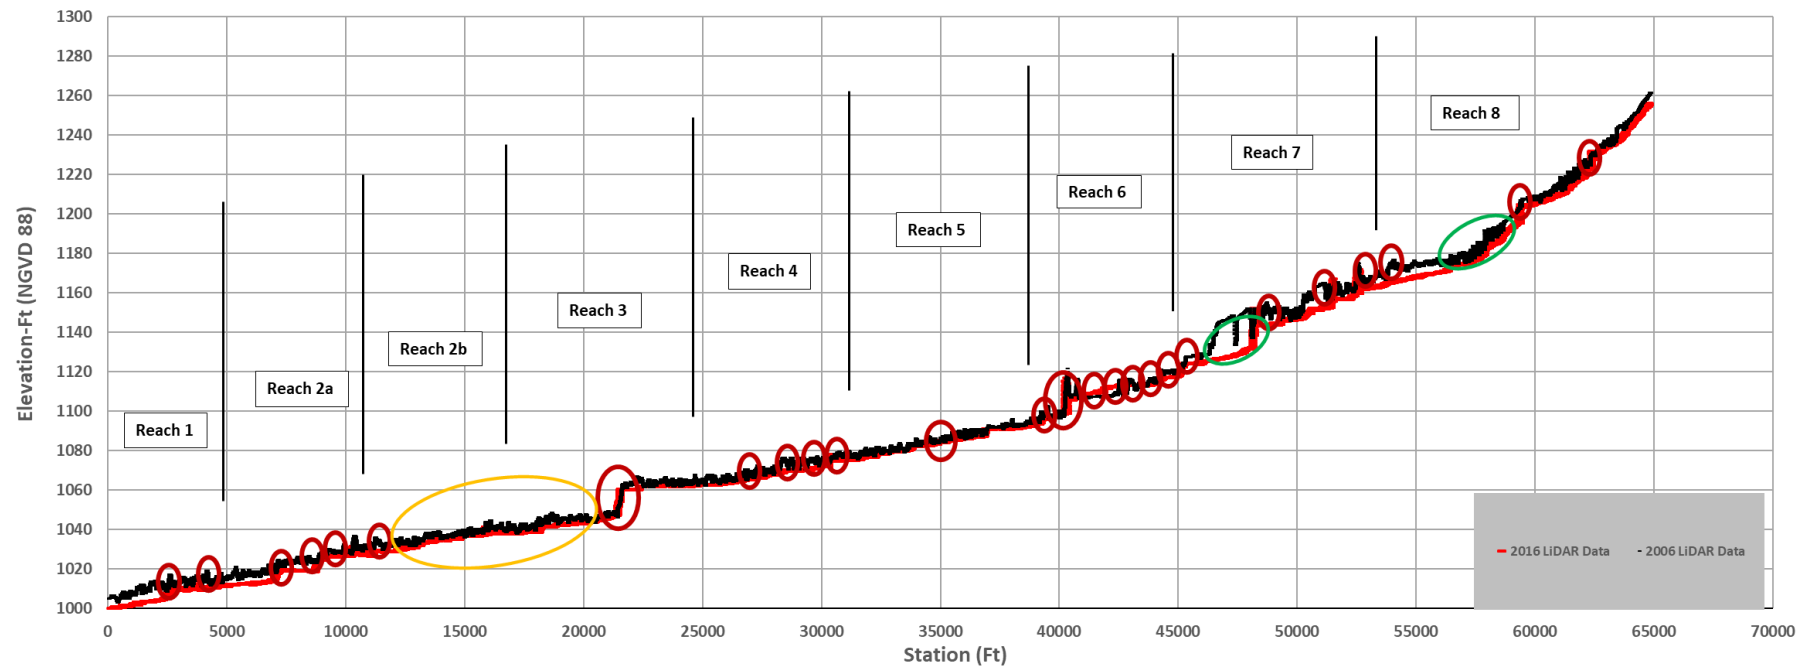
There have been widespread attempts to stabilize many sections of the creek using GCSs as illustrated in Figure 4-136. The figure provides locations where GCSs (red circles) are located within the FG study reaches. The locations were identified by analyzing the 2004 and 2016 LiDAR water surface profiles and review of aerial photographs.

The structures come in various forms; some are loose rock riffles, sheet piles with riprap, road culverts, and farm crossings. Also shown are the locations where there appears to be erosion-resistant materials in the stream (green circles). There were no GCSs identified in these locations and they should be evaluated with site visits. Finally, the orange circle in Reaches 2b and 3 may be defining a stable channel slope for which to consider future bed and bank stabilization design criteria.

**Figure 4-136: South Papillion Creek 2004/2016 LiDAR Water Surface Profiles with GCSs (red circles), Erosion-Resistant Materials (green circles), and Potential Equilibrium Slope (orange circle)**

- Based on the FG Level 1 analysis of water surface slopes and reach cross-sections, the reaches are progressing through various stages of the CEM (Simon and Hupp, 1986), most identified as Stage IV and V. The reaches that are most susceptible to continued channel degradation are the areas in Figure 4-136 that appear to have erosion resistant materials without GCS. These areas should be investigated further to determine what materials are present and if additional GCSs are needed to prevent channel incision from working upstream. The generalized CEM trends were identified using the FG Level 1 CSA and are identified by reach. This assessment is based on 2016 data and requires field validation.

Additional analysis of the spacing of the existing GCSs and assessment of stable channel slopes (Figure 4-136) could assist in further siting of additional GCSs. In all reaches, the stream

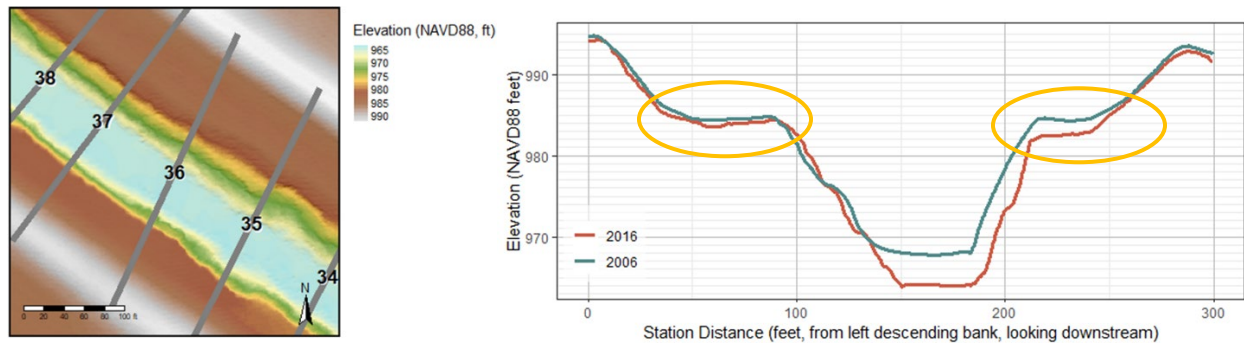
There are many sections of the creek that have some form of revetment, riprap or other materials present in the channel bed or banks. In most cases, these materials are providing bed or bank stability. It is not known whether these structures and revetments were designed, or materials were placed in stream to protect utility crossings. In many locations, material has launched and formed GCSs, stabilizing the channel bed in these locations. Upstream a GCS at South 36<sup>th</sup> Street (Reach 1), floodplain berms developed (Figure 5-2). Compared to an incised channel (high banks with no floodplain), the berms provide access to the frequent flood events

dissipating flow energy across a wide cross-sectional area. This is a common feature in the urbanized Papillion Creek watersheds seen during the limited site visits.

**Figure 5-2: Floodplain Berms (orange circles) Developed Upstream of GCS – Big Papillion Creek**

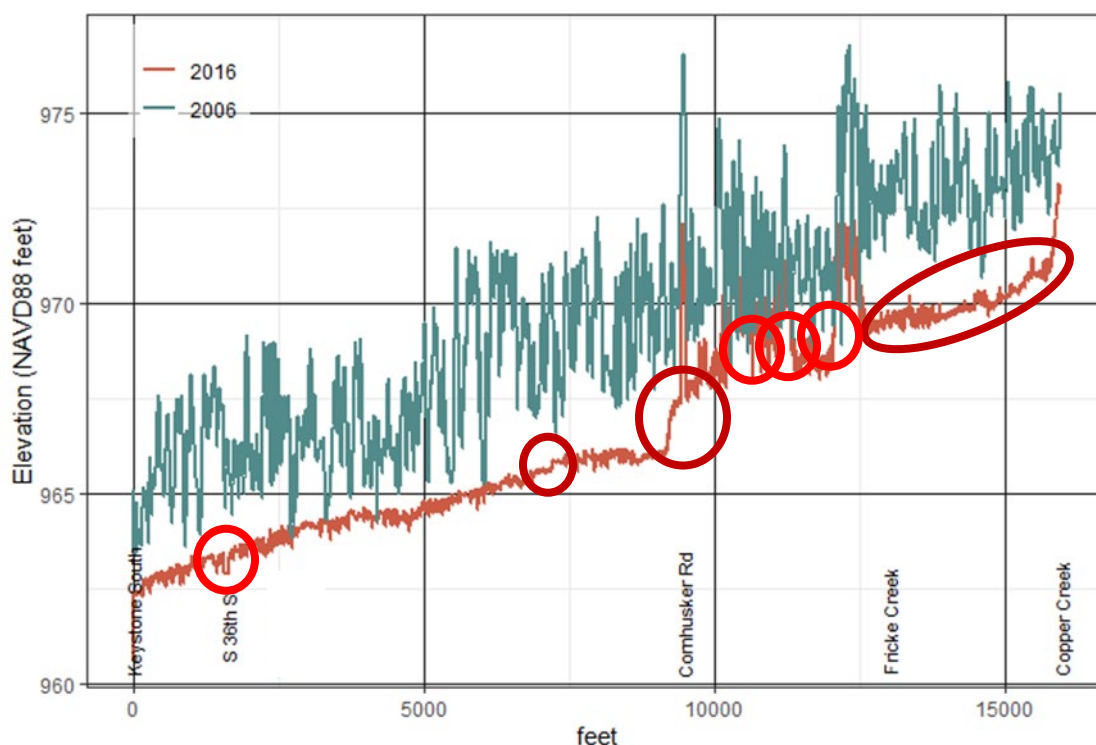
**Figure 5-4: Big Papillion Creek FG – Reach 1**

- GCSs are present at two main bridge locations and other locations between. The largest GCS is located at Cornhusker Road approximately 9,000 feet upstream of the confluence with West Papillion Creek. The GCS is part of an over-steepened section with other GCSs located upstream and downstream with an approximate elevation drop of four feet (Figure 5-4).

- There is a substantial portion of the reach containing bank erosion control revetments, the likely source of bed stabilizing materials (Figure 5-4).
- There are areas within the reach that have active bank erosion and others that have been stabilized with revetment. This reach would be considered a sediment pathway and source.

*Note: GCSs (red circles) or erosion resistant bed materials present.*

- There are many locations within Reach 1 that would have access to an active floodplain if levees could be setback to provide more room for flood flows. This is still possible in areas where agriculture is present.

- Establishment of floodplain access areas to dissipate and store floodwater would be a great alternative to establish where applicable to the upstream reaches.

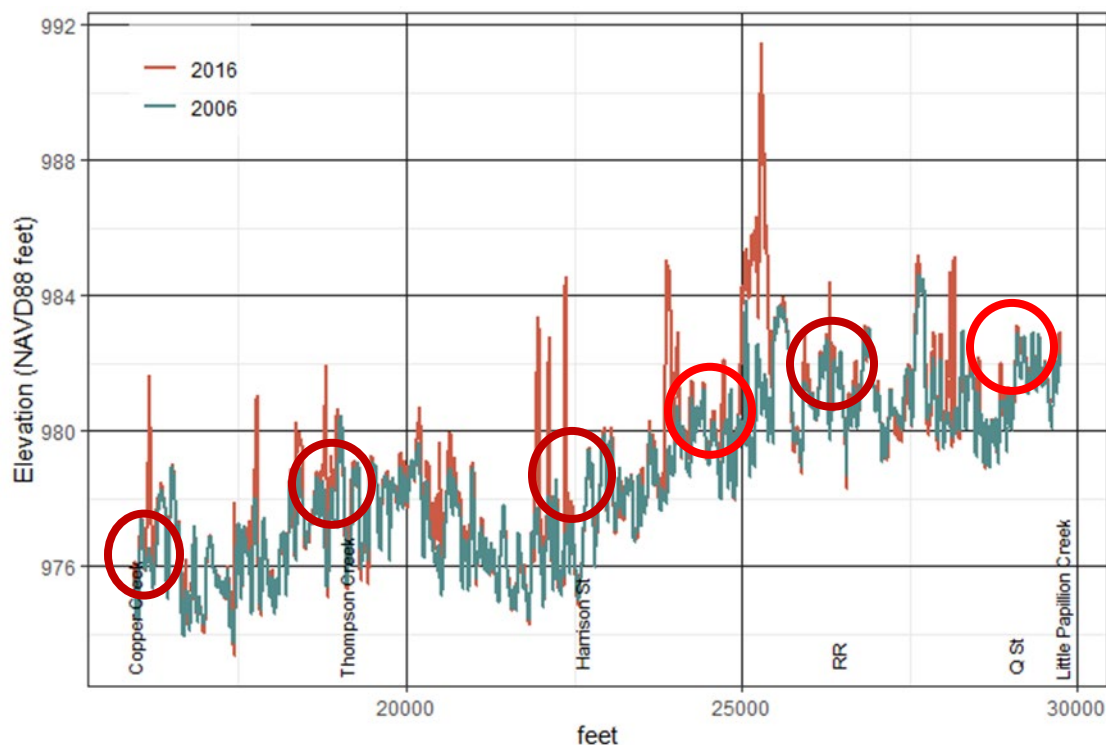
**Figure 5-5: Big Papillion Creek FG – Reach 2**

- GCSs are spaced relatively evenly throughout (Figure 5-5). The structures are likely reworked revetment material or placed to protect utility crossings.
- Based on the FG cross-sectional analysis, there are areas where floodplain berms are building within the confined (by levees) floodplain. There are other areas where there has been substantial channel erosion. This reach is a mix of sediment source and some minimum sediment sink locations.
- The reach could be enhanced for flood water storage by increasing floodplain connection and access through series of levee setbacks. There are still some areas of agriculture that could be targeted. If sediment delivery to downstream reaches is a priority, then installation of additional bank erosion revetments is recommended.

*Note: GCSs (red circles) or erosion resistant bed materials present.*
