# **Papillion Creek Watershed**

## **Streambed Degradation Study**

### **Section 22: Planning Assistance to States**

#### **Final Report**

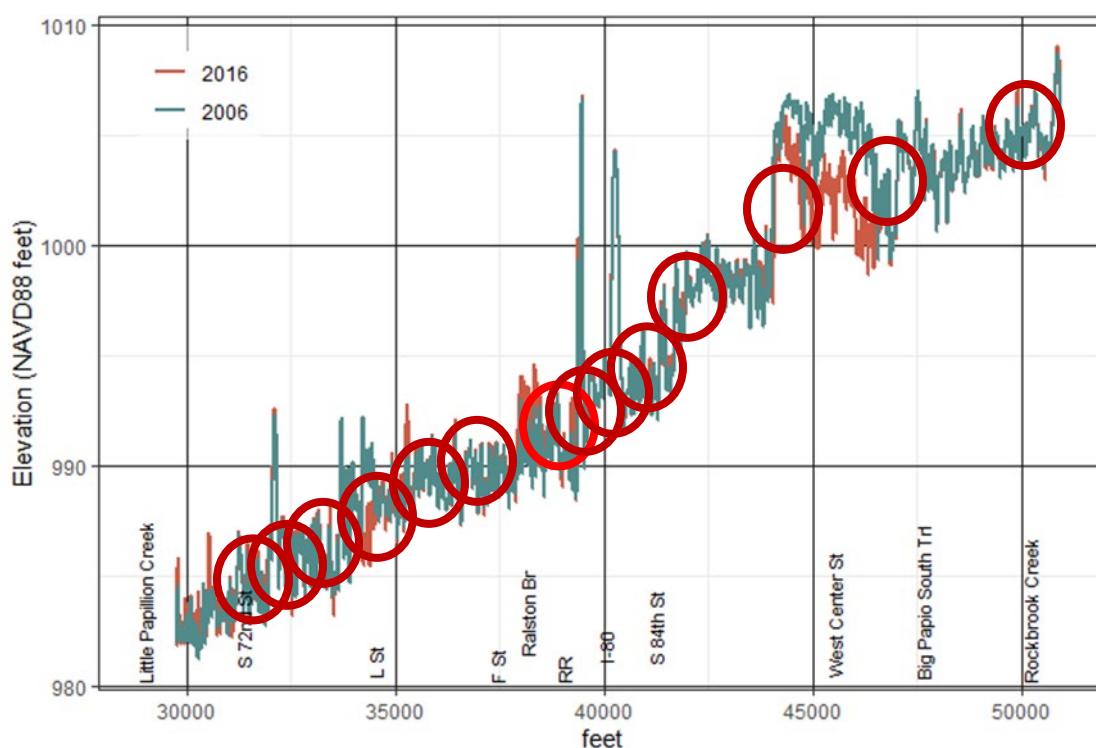
**Figure 5-6: Big Papillion Creek FG – Reach 3**

- Based on the FG cross-section analysis, there is bank erosion in many sections of the reach. Additional bank protection revetments and developing a better understanding of the channel bed stability would be recommended. This reach would be considered a sediment source and areas with little or no erosion a sediment pathway.

*Note: GCSs (red circles) or erosion resistant bed materials present.*

- There are no locations available within the reach to expand access to floodplain areas behind the existing levees.

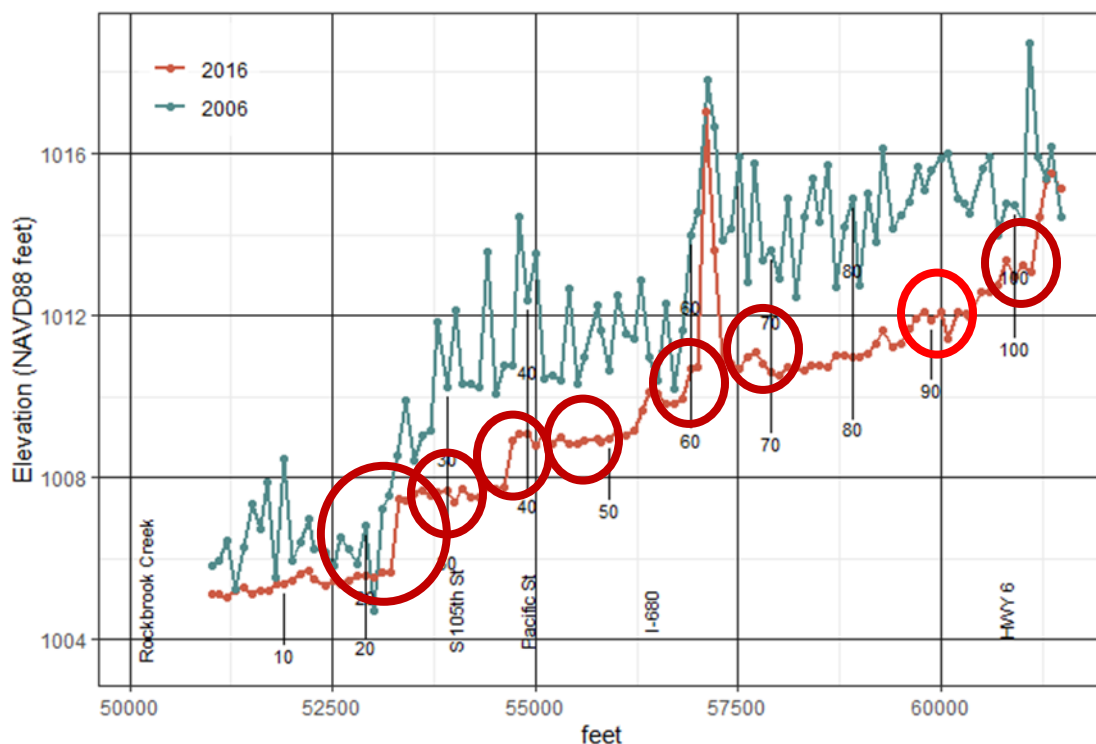
**Figure 5-7: Big Papillion Creek FG – Reach 4**

- GCSs are present at bridge locations and other locations within the reach likely from launching revetment materials (Figure 5-7).
- The largest GCS (series) is located downstream of South 105<sup>th</sup> Street and runs upstream to the Pacific Street vicinity. The approximate elevation drop is four feet (Figure 5-7).

- Like Reach 3, there are many locations with limited floodplain berms based on a smaller greenspace width and bank revetments locking the banks in place and not allowing natural alluvial processes to occur. Based on the FG cross-section analysis, there is bank erosion in many sections of the reach. Additional bank protection revetments and developing a better understanding of the channel bed stability would be recommended. This reach would be considered a sediment source and areas with little or no erosion a sediment pathway.

*Note: GCSs (red circles) or erosion resistant bed materials present.*

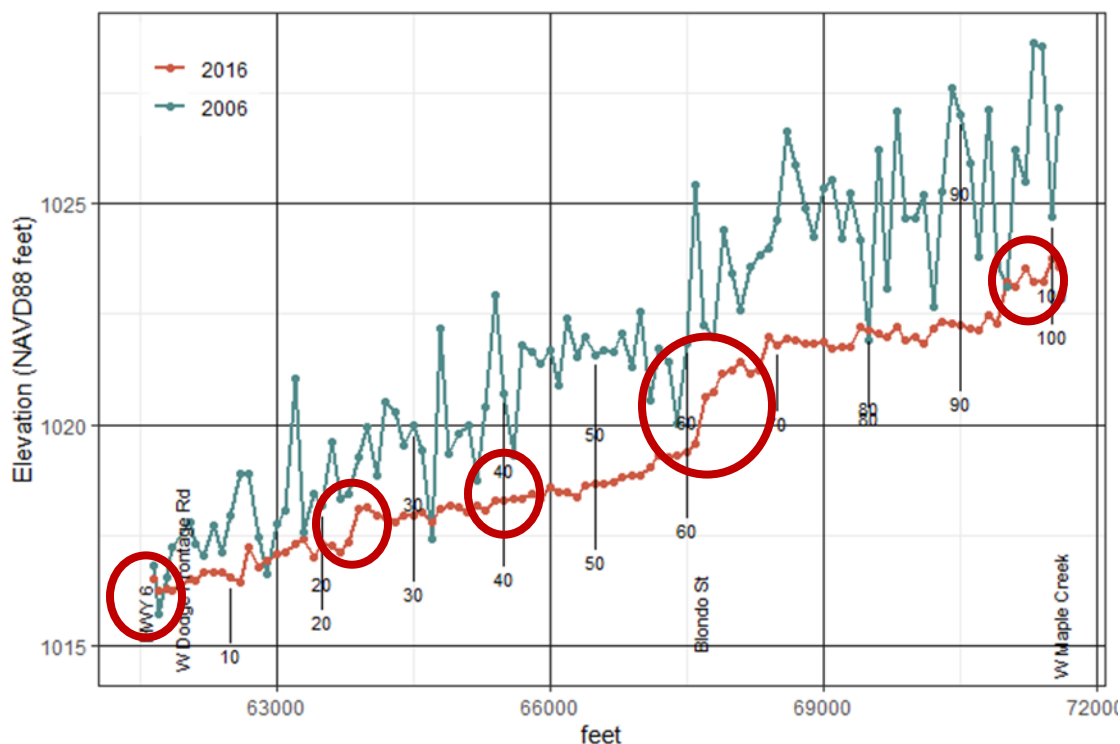
**Figure 5-8: Big Papillion Creek FG – Reach 5**

- GCSs are present throughout the reach with the largest at the Blondo Street Bridge (Figure 5-8).
- There are additional GCSs or other resistant bed materials located within the reach based on the 2016 LiDAR and aerial photo interpretation. Specific GCS locations should be field-verified (Figure 5-8).
- The reach has a substantial amount of bank sloughing and erosion. Some of the erosion is threatening pipe outlets, pedestrian trails, and possibly the levee system.
- Based on the limited FG analysis, this reach would be considered partially a sediment source and pathway.
- There are no locations available within the reach to expand access to floodplain areas behind existing levees.

*Note: GCSs (red circles) or erosion resistant bed materials present.*

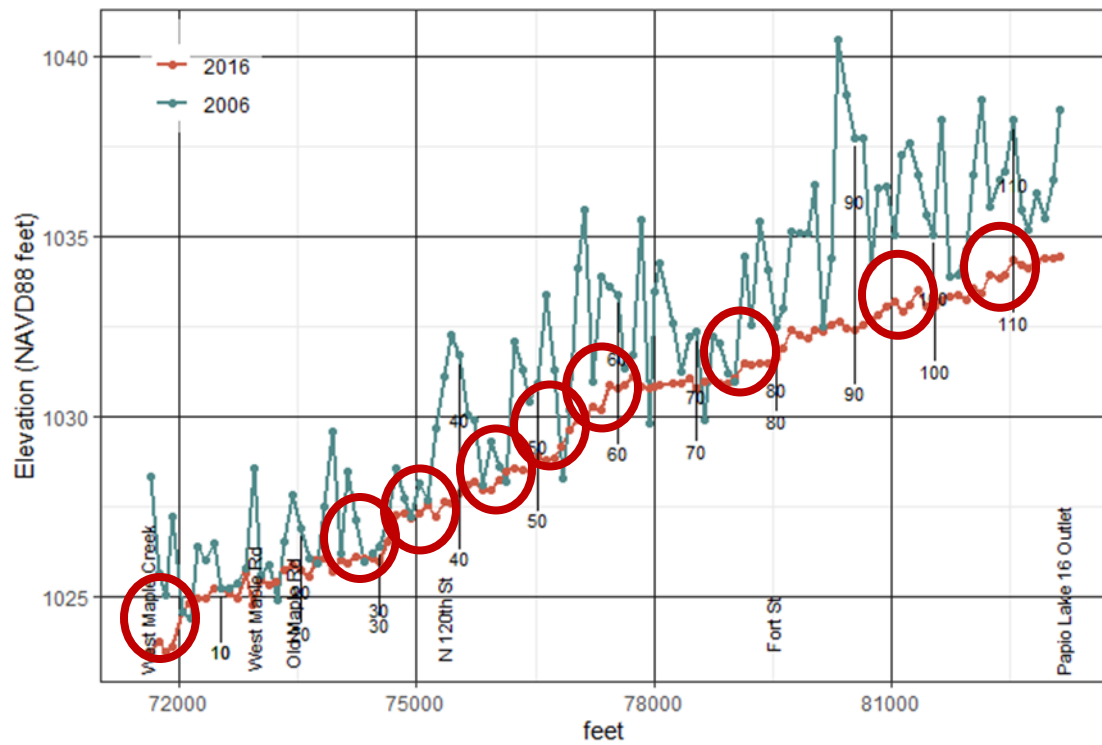
**Figure 5-9: Big Papillion Creek FG – Reach 6**

- Based on the FG cross-section analysis, there are areas where floodplain berms are building within the incised channel margins. There are other areas where there has been substantial channel erosion. This reach is a mix of sediment source and sink.

*Note: GCSs (red circles) or erosion resistant bed materials present.*

- Land-use transitions moving upstream range from highly urbanized to agricultural. Targeting areas for additional greenspace and streambank erosion (additional geomorphic study required to determine severity) within this reach will provide sediment reduction benefits to the downstream reaches.

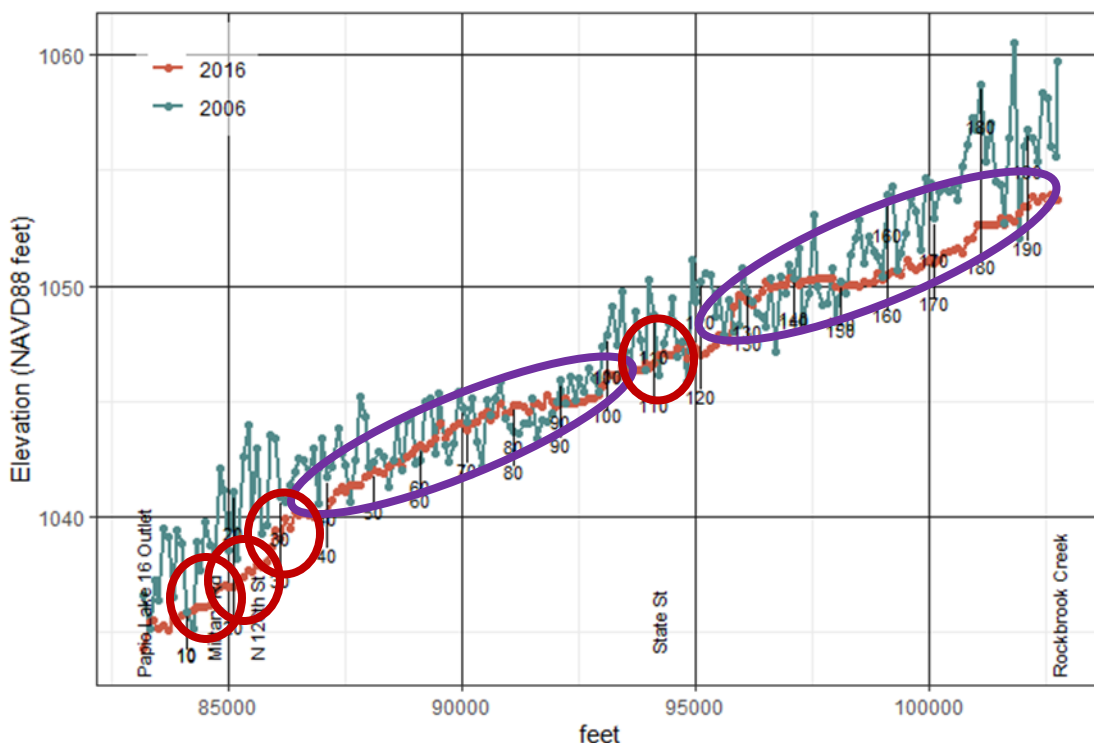
**Figure 5-10: Big Papillion Creek FG – Reach 7**

- GCSs are present at bridge locations and two other locations (Figure 5-10).
- Comparisons of the FG LiDAR profiles (Figure 5-10) illustrate relatively similar profiles. This reach appears to have a stable bed.

- There are resistant bed materials located within the reach based on the 2016 LiDAR and aerial photo interpretation (Figure 5-10). What makes up these areas is unknown and should be determined through additional field investigations.

*Note: GCSs (red circles) field verified, unknown erosion resistant bed materials (Purple circles) either formed from revetment materials or, likely, glacial till.*

- Land-use in this reach is likely to see more pressure to urbanize, so enhanced zoning rules with limiting restrictions on land-use and impingements upon the channel are good ideas.

- Concentrating upland runoff reduction practices would assist in this reach to reduce sediment delivery from overland and tributary streams.

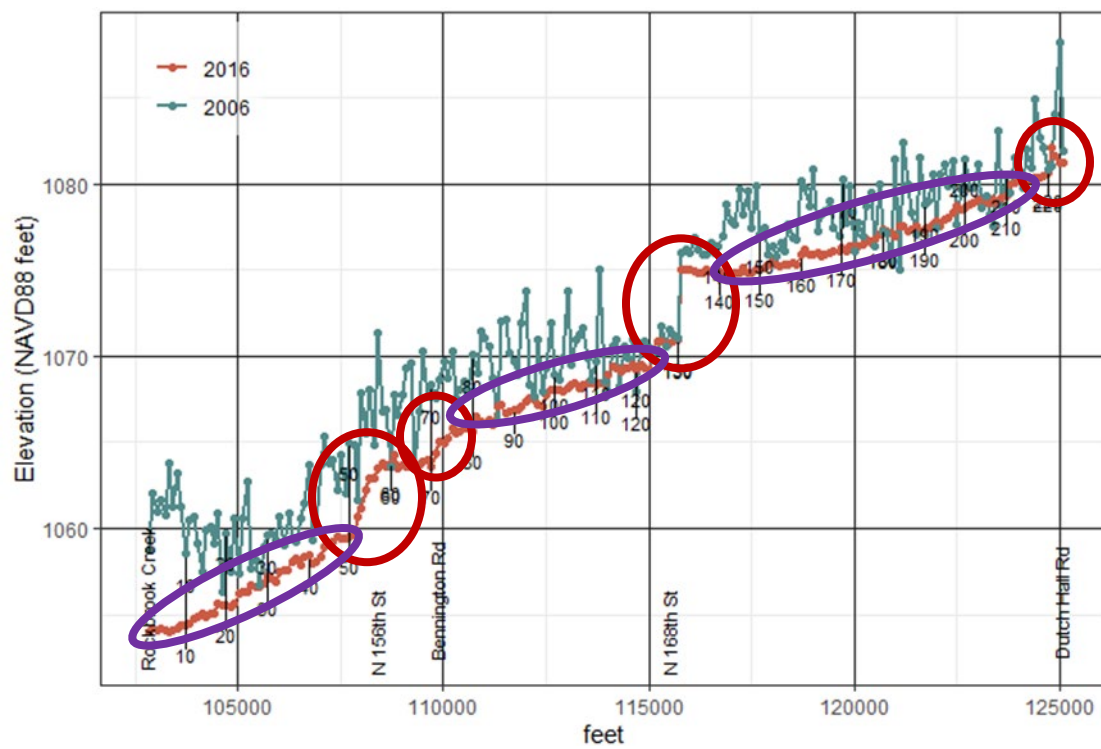
**Figure 5-11: Big Papillion Creek FG – Reach 8**

- GCSs are present at bridge locations and one other location (Figure 5-11). The largest GCS is located at North 156<sup>th</sup> Street Bridge and upstream to Bennington Road. The GCSs are part of an over-steepened section with an approximate elevation drop of seven feet (Figure 5-11).

- There is revetment at bridge locations but it's not evident in other areas as compared to the downstream reaches 1-5. There are resistant bed materials located within the reach based on the 2016 LiDAR and aerial photo interpretation. Specific GCS locations need to be verified in the field (Figure 5-11).

*Note: GCSs (red circles) field verified, unknown erosion resistant bed materials (Purple circles) either formed from revetment materials, culverts or -likely glacial till.*

- Land-use in this reach is likely to see more pressure to urbanize, so enhanced zoning rules with limiting restrictions on land-use and impingements upon the channel are good ideas.

- Concentrating upland runoff reduction practices would assist in this reach to reduce sediment delivery from overland and tributary streams.

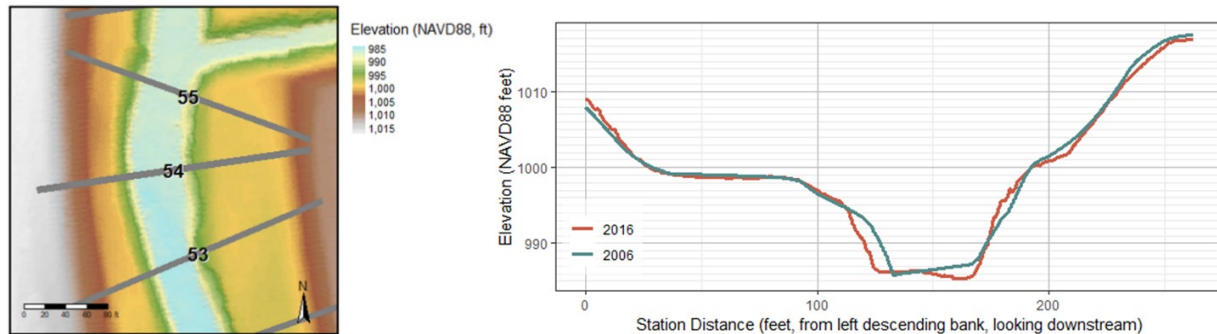
There are many sections of the creek that have some form of revetment, riprap or other materials present in the channel bed or banks. In most cases, these materials are providing bed or bank stability. It is not known whether these structures and revetments were designed, or materials were placed in stream to protect utility crossings. Some of the material has undoubtedly launched and formed GCSs, stabilizing the channel bed in these locations. Upstream of a GCS in Reach 1, floodplain berms (Figure 5-13) have developed. Compared to

an incised channel (high banks with no floodplain), the berms provide access to the frequent flood events dissipating flow energy across a wide cross-sectional area. It was noted during the site visit, that these floodplain berms developed upstream of GCSs. This is a common feature in the urbanized Papillion Creek watersheds seen during the limited site visits. The next section provides the overall profile and individual Reach information developed for this study. The FG study reaches are defined in Figure 5-14 with individual FG Reach profile plots (2004 and 2016 LiDAR) in each individual reach writeup. Some of these locations were field-verified but many were not due to time restrictions on fieldwork. Each reach has bulleted descriptions based on geomorphic information collected from the field site visits and FG Level I analysis.

**Figure 5-13: Floodplain Berms Developed Upstream of GCS-Little Papillion Creek**

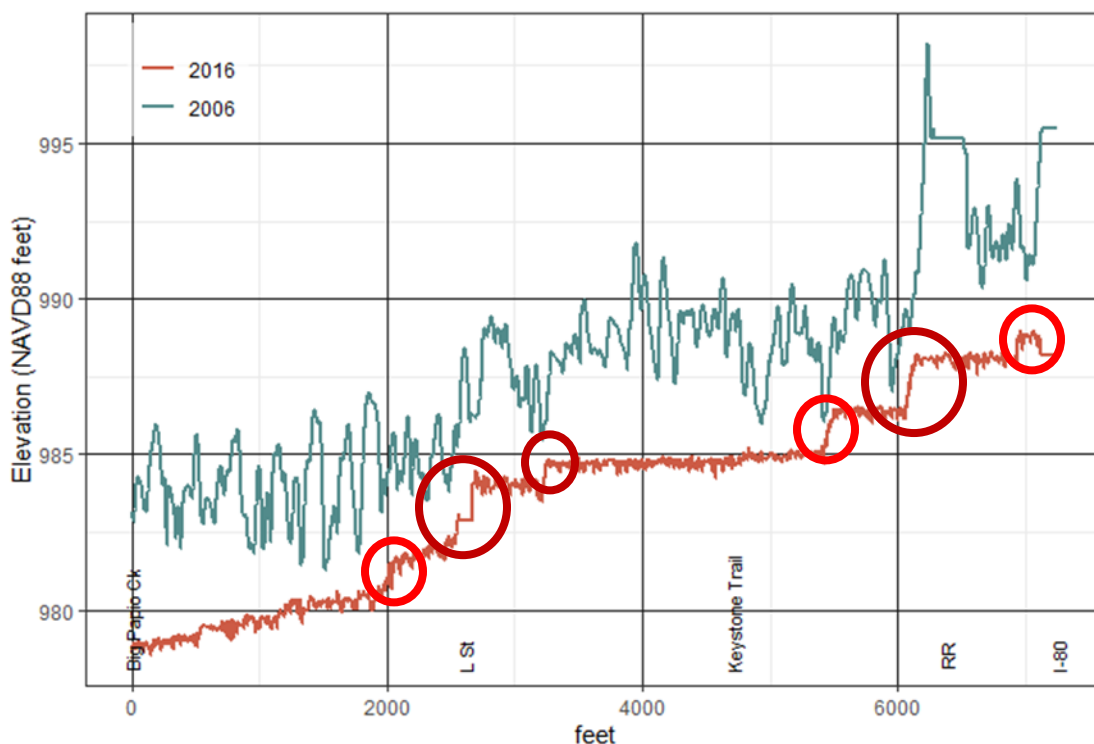
**Figure 5-15: Little Papillion Creek FG Reach 1**

- GCSs are present at three main bridge locations. The largest GCS is located at L Street approximately 2500 feet upstream of the confluence with Big Papillion Creek. The GCS is part of an over-steepened section with two other GCSs located upstream and downstream with an approximate elevation drop of five feet (Figure 5-15).

- There are additional GCS and other resistant bed materials located within the reach based on the 2016 LiDAR and aerial photo interpretation. Specific GCS locations need to be verified in the field (Figure 5-15).

*Note: GCSs (red circles) or erosion resistant bed materials present.*

- Establishment of floodplain access areas to dissipate and store floodwater would be a great alternative to establish where applicable to the upstream reaches.

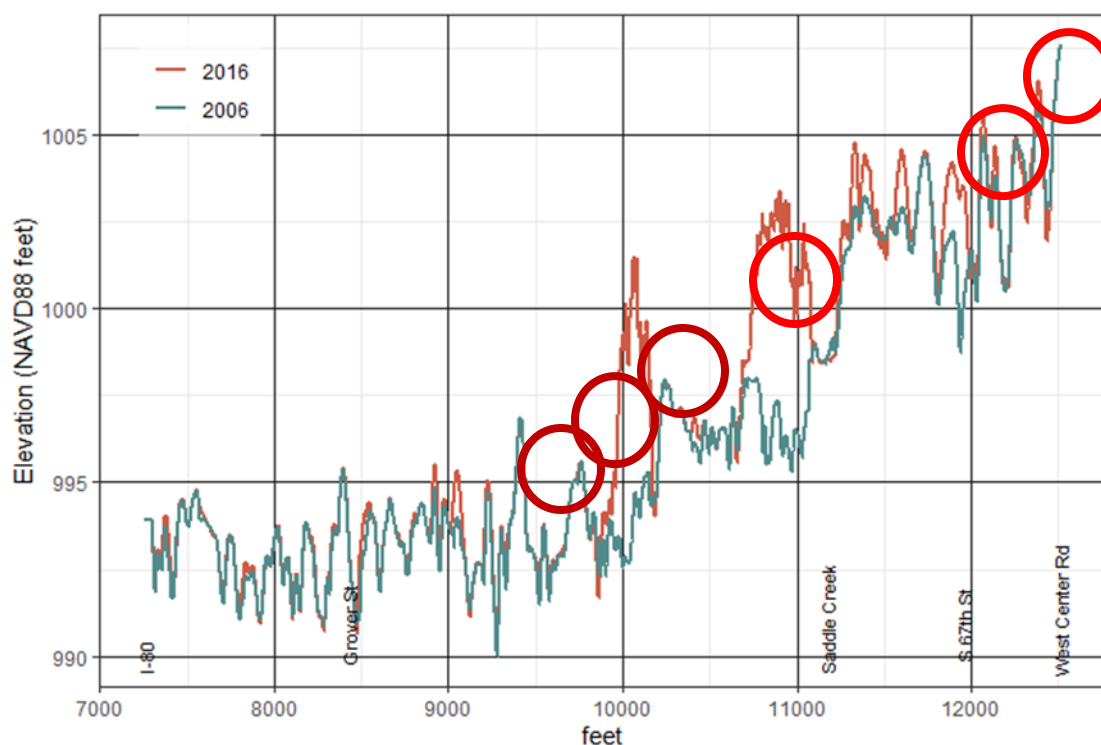
**Figure 5-16: Little Papillion Creek FG – Reach 1**

- GCSs are present in the upper half of the reach as there appears to be multiple bank erosion control revetments present through a meandering section of the creek downstream of Saddle Creek outlet (Figure 5-16). There are two more GCSs located upstream of South 67<sup>th</sup> Street Bridge and West Center Road that may have been created when the bridges were constructed.

- The lower area of the reach has little or no access to an active floodplain, however upstream of the GCSs there are floodplain berms that have formed that illustrate a channel stabilization trend. This reach would be considered a sediment pathway.

*Note: GCSs (red circles) or erosion resistant bed materials present.*

- The reach could be enhanced by establishing increased floodplain connections to the lower area of the reach. Options could include additional GCS construction to re-establish floodplain berms or cutting floodplain berms into the existing bank lines or a combination of both. If any work is done, hydraulic analysis would need to be completed to assess potential impacts to flood flow and increasing flood stages.

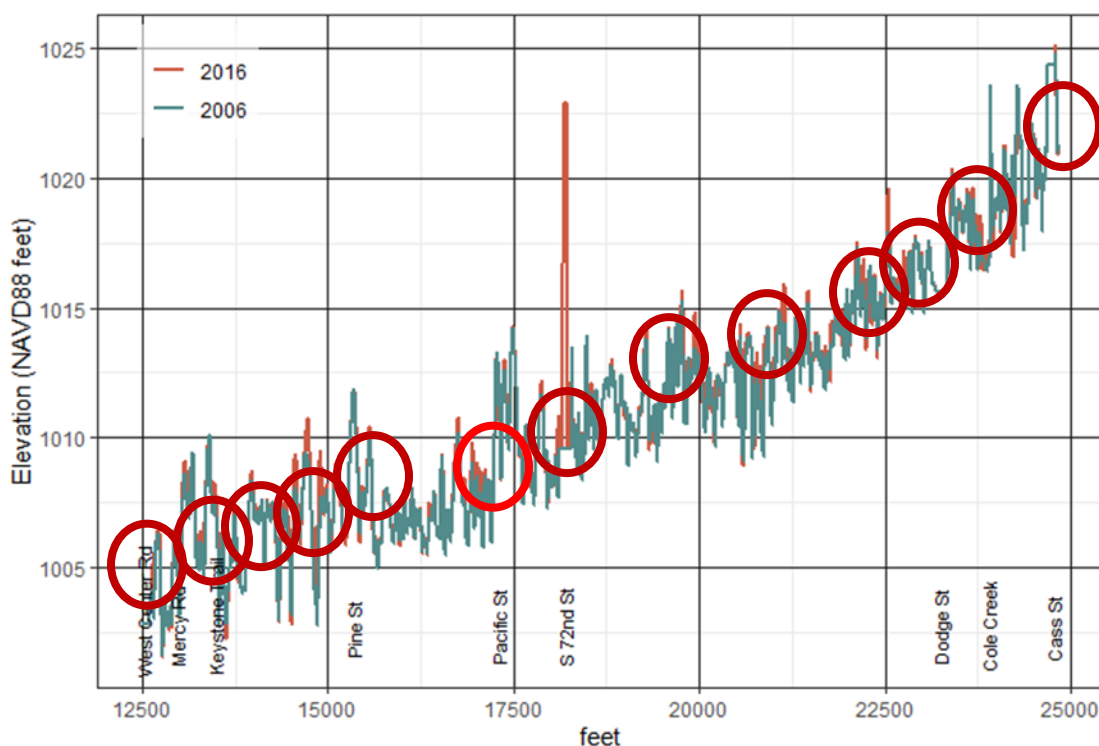
**Figure 5-17: Little Papillion Creek FG – Reach 1**

- GCSs are present at bridge locations and throughout the reach (Figure 5-17).
- Based on the number of GCSs within this reach, each location should be investigated further to determine stability of structure and potential need for enhancements. This may be a reach to further study to determine if some form of natural riffle pool development has occurred. There are a lot of bank revetments within this reach and likely a lot of launched riprap in the channel.
- There are many locations where limited floodplain berms have developed. This is likely limited based on a smaller greenspace width and bank revetments locking the banks in place and not allowing natural alluvial processes to occur. This reach would be considered a sediment pathway.
- Similar to Reach 2, exploring options to widen the greenspace and provide more floodplain access would be desirable.

*Note: GCSs (red circles) or erosion resistant bed materials present.*

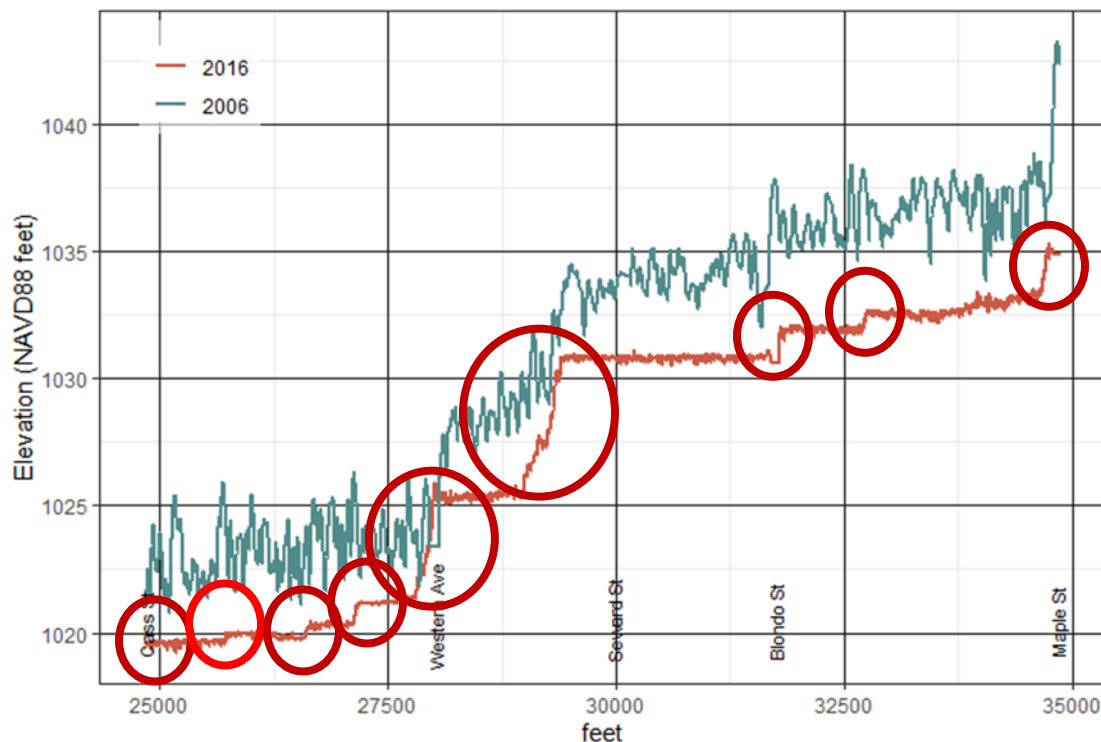
**Figure 5-18: Little Papillion Creek FG – Reach 1**

- GCSs are present at bridge locations and six other locations within the reach (Figure 5-18). The small upstream elevation increases in the FG 2016 LiDAR profile show locations where GCSs or some form of erosion-resistant bed material may be present. These are likely from launched revetment materials within the reach.

- The largest GCS (series) is located at Western Avenue and upstream to Seward Street. The GCS is part of an over-steepened section with other GCSs located upstream and downstream. The approximate elevation drop is 10 feet (Figure 5-18). This area should be investigated further due to the excessive channel slope change and designs should be reviewed to determine if channel stability will continue.

- Like Reach 3, there are many locations with limited floodplain berms based on a smaller greenspace width and bank revetments locking the banks in place and not allowing natural alluvial processes to occur. This reach would be considered a sediment pathway.

*Note: GCSs (red circles) or erosion resistant bed materials present.*

- Like Reaches 2 and 3, exploring options to widen the greenspace and provide more floodplain access would be desirable.

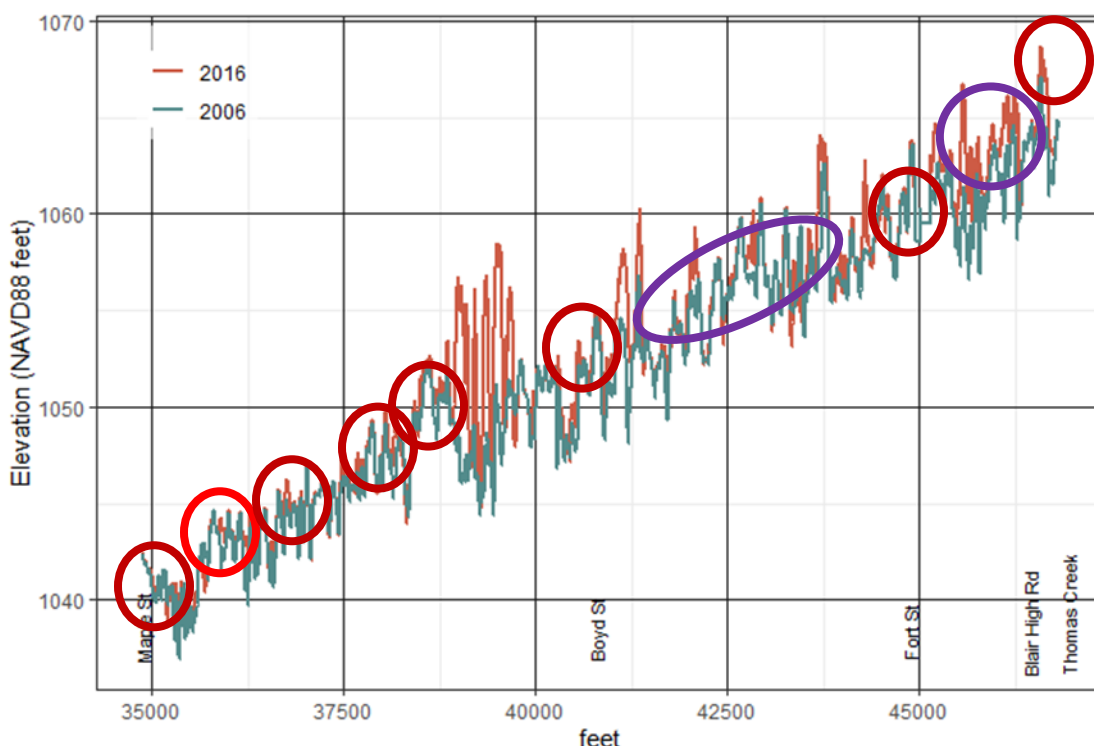
**Figure 5-19: Little Papillion Creek FG – Reach 5**

- GCSs are present at four main bridge locations (Figure 5-19).
- Comparisons of the FG LiDAR (Figure 5-19) illustrate relatively similar profiles. This reach appears to have a stable bed.

- There is an additional GCS and other resistant bed materials located within the reach based on the 2016 LiDAR and aerial photo interpretation (Purple Circles in Figure 5-19). Specific GCS locations need to be verified in the field.

- The reach has greenspace, bank revetments and GCSs downstream of Keystone Park. This is likely stabilizing the natural meandering channel through the park. The riparian areas should be further assessed with field investigations to determine channel stability. These areas should be targeted to prevent future encroachment on the greenspace.

- Based on the limited FG analysis, this reach would be partially considered a sediment source/pathway.
- Land-use in this area is mostly urban with some agricultural in the upstream area so there are some limited opportunities to provide flood storage and erosion control.

*Note: GCSs (red circles) field verified, unknown erosion resistant bed materials (Purple circles) either formed from revetment materials, culverts or -likely glacial till.*

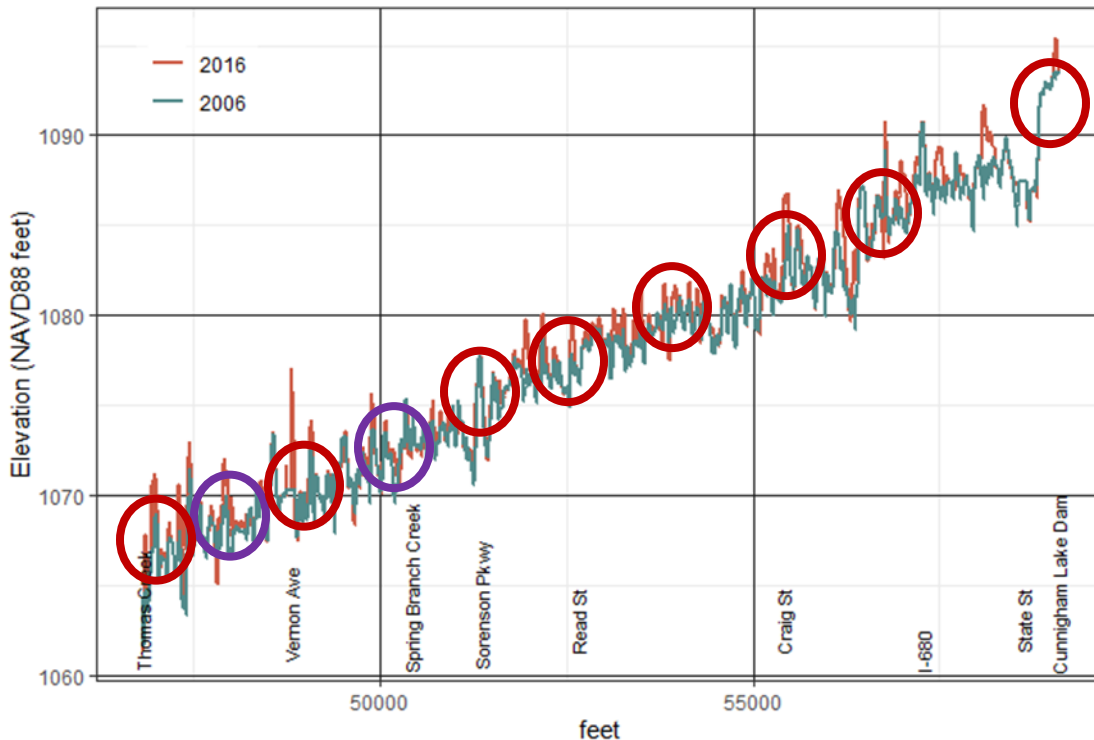
**Figure 5-20: Little Papillion Creek FG – Reach 6**

- GCSs are present at bridge locations and two other locations (Figure 5-20).
- Comparisons of the FG LiDAR (Figure 5-20) illustrate relatively similar profiles. This reach appears to have a stable bed.

- There are resistant bed materials located within the reach based on the 2016 LiDAR and aerial photo interpretation. Specific GCS locations need to be verified in the field (Figure 5-20).

- FG cross-sectional analysis comparisons show the most lateral channel movement in this reach. Based on the limited FG analysis, this reach would be partially considered a sediment source.

*Note: GCSs (red circles) field verified, unknown erosion resistant bed materials (Purple circles) either formed from revetment materials, culverts or, likely, glacial till.*

- Land-use in this area has transitioned from mostly agricultural to highly urbanized. Targeting areas for additional greenspace and streambank erosion (additional geomorphic study required to determine severity) within this reach will provide sediment reduction benefits to the downstream reaches.

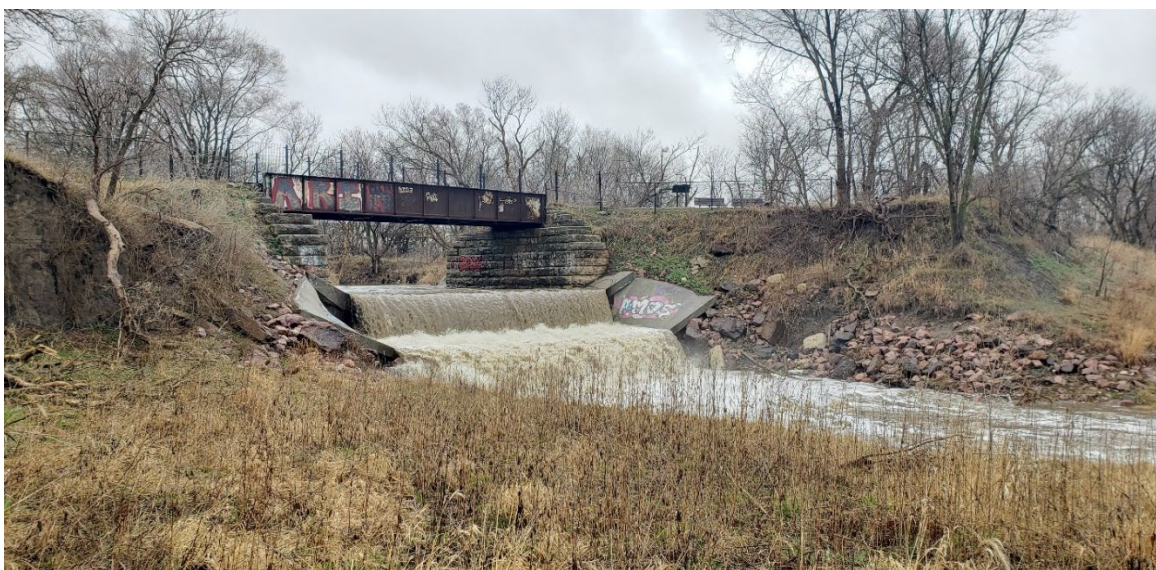
in these locations. One example of a constructed concrete grade control is in Reach 1 at the confluence with West Papillion Creek (Figure 5-22). This is a common feature in the urbanized Papillion Creek watersheds seen during the limited site visits. The next section provides the overall profile and individual Reach information developed for this study. The FG study reaches are defined in Figure 5-23 with individual FG Reach profile plots (2004 and 2016 LiDAR) in each individual reach writeup. Some of these locations were field verified but many were not due to time restrictions on fieldwork. Each reach has bulleted descriptions based on geomorphic information collected from the field site visits and FG Level I analysis.

**Figure 5-22: Concrete GCS at the Mouth of Hell Creek**

- There are very few locations within Reach 1 that have access to an active floodplain which is typical of urban incised channels. One location is immediately upstream of the confluence of Hell Creek and West Papillion Creek. Upstream of the concrete GCS there is a wide terrace (previous floodplain) that could potentially provide floodplain access and storm water storage. This would need to be studied in much more detail to determine what benefits would be gained for the downstream West Papillion Creek reaches.

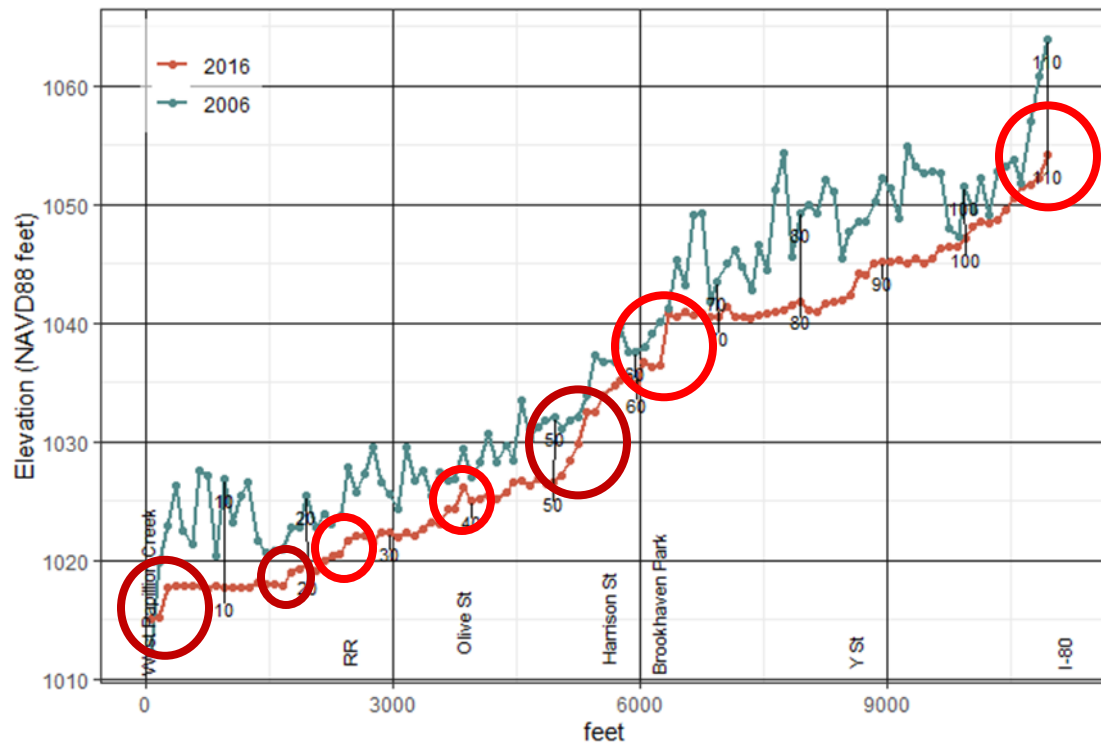
**Figure 5-24: Hell Creek FG LiDAR Water Surface Reach 1 Profiles**

- GCSs are present at four main bridge locations (Railroad Crossing, Olive Street, Harrison Street, I-80 culverts) and a low-water crossing in Brookhaven Park. The largest series of GCSs and elevation drops in the reach are located approximately 350 feet downstream of Harrison Street, continuing upstream approximately 700 feet at a concrete and riprap structure in Brookhaven Park. The upstream structure is part of a sewer outfall inlet structure from the east. The approximate elevation drops are 15 feet (Figure 5-24).

*Note: GCSs (red circles) or erosion resistant bed materials present.*

- Additional study should be completed to assess the existing GCS locations to determine stability of structure and potential need for enhancements.
- There are additional GCSs located within the reach based on the 2016 LiDAR and aerial photo interpretation. Specific GCS locations need to be verified in the field (Figure 5-24).

- This reach would be considered a sediment source as there is bank line erosion in many locations, some threatening the existing pedestrian trails.
- Establishment of floodplain access areas to dissipate and store floodwater would be a great alternative to establish, where applicable for the upstream reaches.

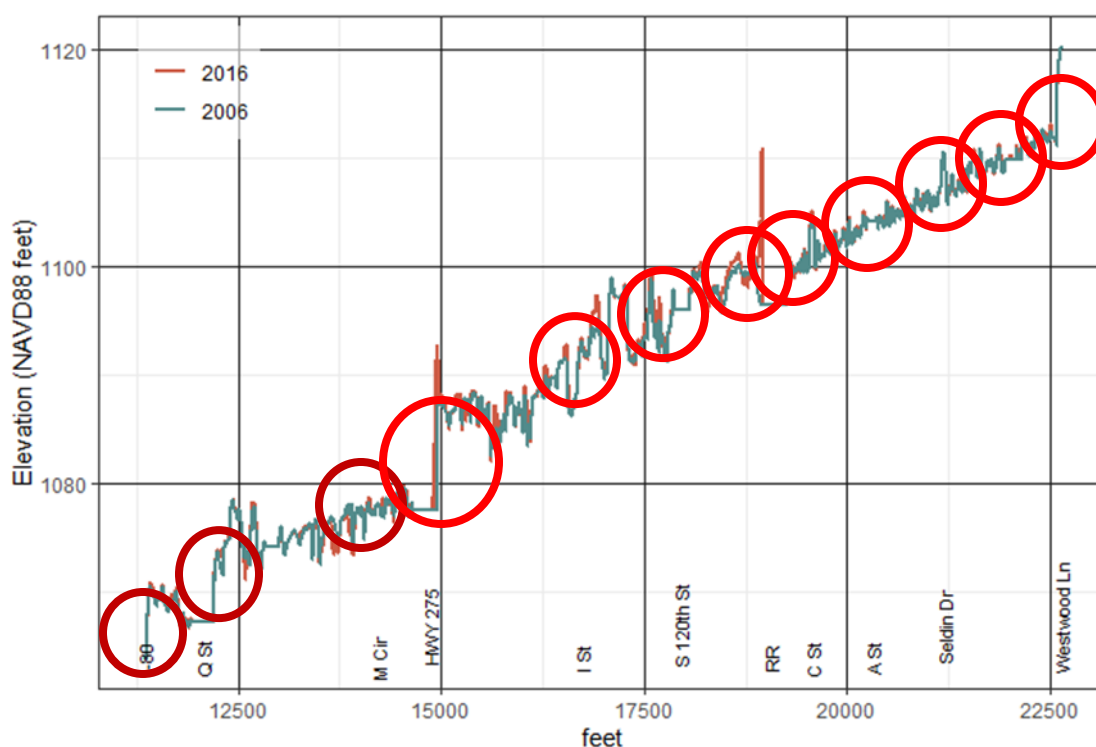
**Figure 5-25: Hell Creek FG LiDAR Water Surface Reach 2 Profiles**

- GCSs are present at all bridge crossings, with some very large culverts also present at I-80 and Highway 275 (Figure 5-25). There is a large concrete GCS located at the upstream terminus of the reach under Westwood Lane. From Westwood Lane downstream to the Railroad crossing culverts, the stream channel was concrete lined until approximately 2015-2016. The concrete lining was removed, and riprap was used to stabilize the reaches through what appears to be a series of loose rock riffle GCSs and riprap bank revetments. This area, while not in a state of natural stream conditions, appears to be naturalized (limited) and should be monitored and potentially used as a template for implementation in other watersheds where applicable conditions exist.

- Based on the FG profiles, there has been little or no change to the channel gradient and while there are some major elevation drops within the reach, they are largely controlled by rigid materials (culverts and revetments).

- Based on FG cross-sections, there has been little bank erosion. This reach would be considered a sediment pathway.

*Note: GCSs (red circles) or erosion resistant bed materials present.*

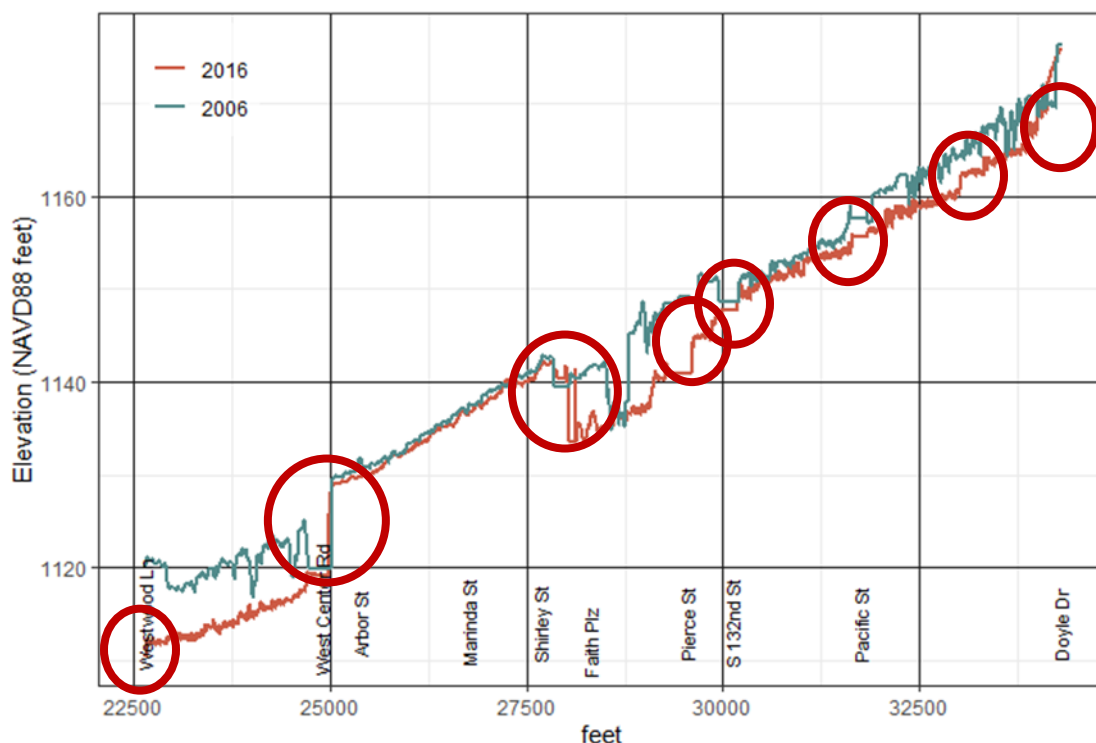
**Figure 5-26: Hell Creek FG LiDAR Water Surface Reach 3 Profiles**

- GCSs are present at some bridge locations and throughout the reach (Figure 5-26).
- Hell Creek is piped underground from Faith Place Road to West Center Road.

- The channel downstream of West Center Road has degraded through the Westwood Golf Course reach. The channel degradation may be a result of changes to the Westwood Lane GCS or continued channel adjustments from past system-wide instability.

- This reach of the watershed is largely developed and managed for stormwater storage. There is minor erosion on some sections of banks, but no major issues, based on the FG cross-section analysis. This reach would be considered a sediment pathway.

*Note: GCSs (red circles) or erosion resistant bed materials present.*

- It appears that all the widening and channel alteration options for greenspace and potential for providing more floodplain access have been developed for this reach.

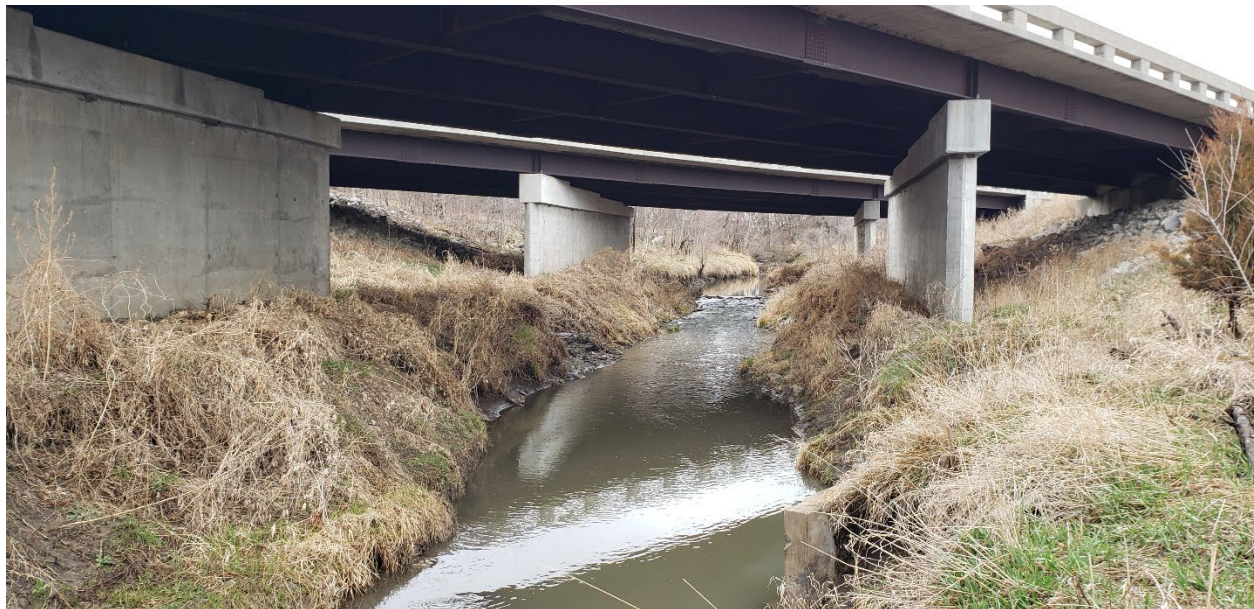
There are many sections of the creek that have riprap or other materials present that are providing bed or bank stability. It is not known whether these structures and revetments were designed, or materials were placed in stream, or they have launched and formed GCSs as illustrated in Figure 5-28. This figure illustrates the rock riprap GCS located in the center of the channel providing bed stability (upstream bank stability) between the Blair High Road Bridges marking the transition between Reach 2 and 3. This is a common feature in all the Papillion Creek watersheds seen during the limited site visits completed for this study.

**Figure 5-28: Grade Control Structure Located Under Blair High Road Bridge – Thomas Creek**

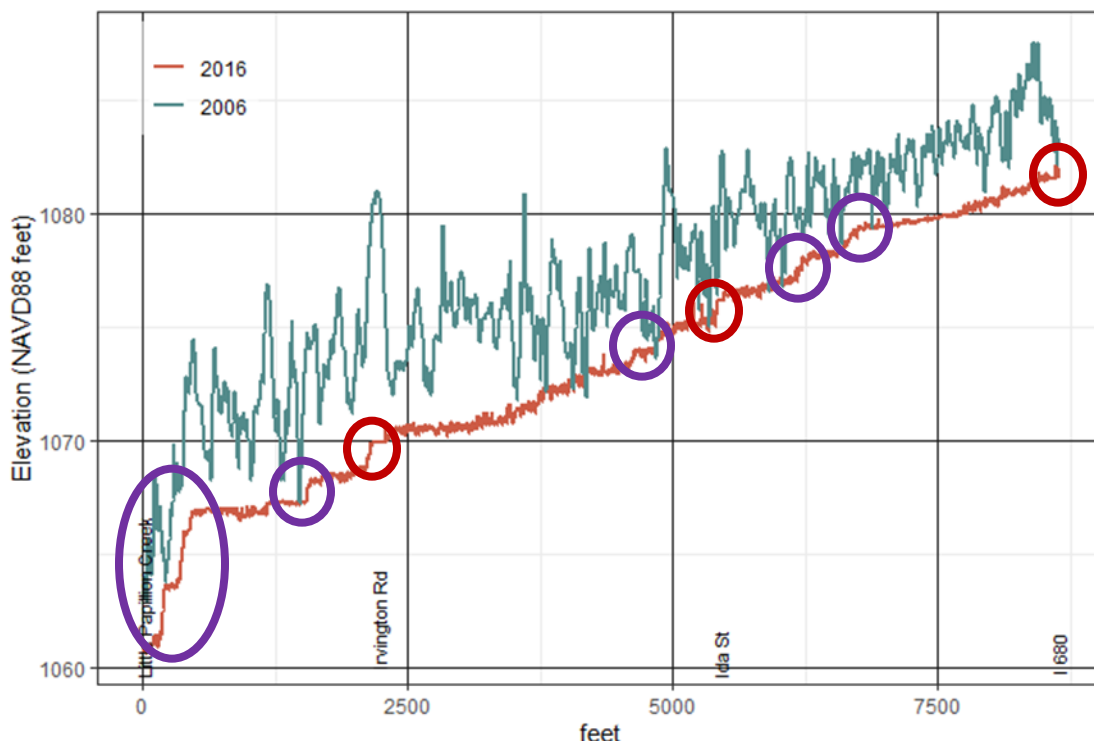
**Figure 5-30: Thomas Creek FG – Reach 1**

- GCSs are present at three main bridge locations possibly from encroachment and infilling of the floodplain and channel margins from land-use practices. The largest GCS is located at the mouth of Thomas Creek where it meets Little Papillion Creek. The GCS is located upstream of station 0+00 and has approximately seven feet of elevation drop (Figure 5-30).

*Note: GCSs (red circles) field verified, unknown erosion resistant bed materials (purple circles) either formed from revetment materials, culverts or likely, glacial till.*

- The reach could be enhanced with limiting restrictions on land-use and impingements upon the channel. Land-use in this area is unlikely to change so there is little value in concentrating restoration funding in this reach.

- There are additional GCSs and other resistant bed materials located within the reach, based on the 2016 LiDAR and aerial photo interpretation. Specific GCS locations need to be verified in the field (Figure 5-30).

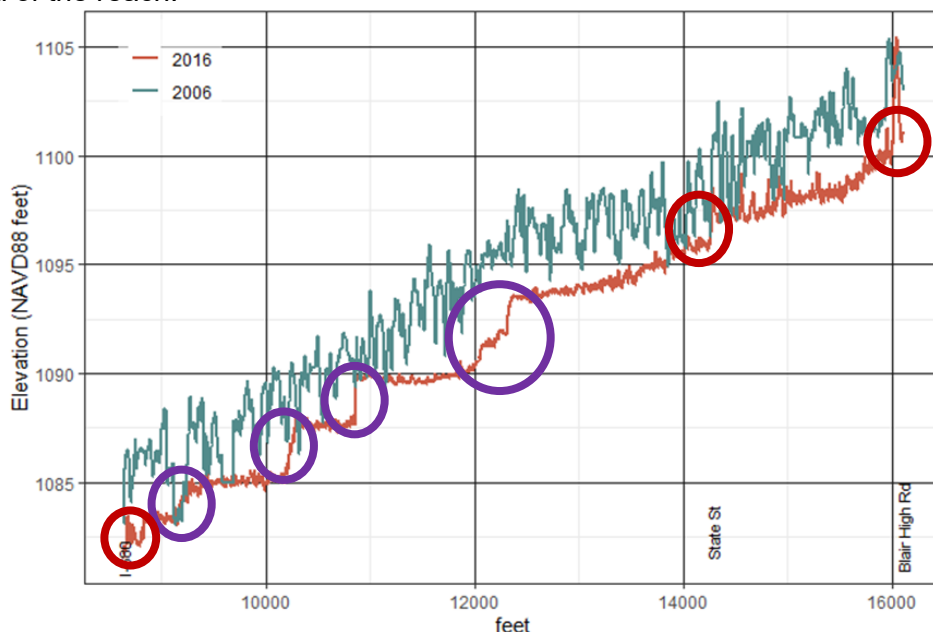
**Figure 5-31: Thomas Creek FG – Reach 2**

- GCSs are present throughout the reach possibly from encroachment and infilling of the floodplain and channel margins from land-use practices (Figure 5-31). The Blair High Road Bridge has a GCS under the upstream bridge that appears to have been constructed during construction of the bridges (Figure 5-31).

- The lower area of the reach has little or no access to an active floodplain due to a residential neighborhood on the left bank and an industrial area on the right. There is an opportunity to provide floodplain access thereby providing for flood storage in the upstream area of the reach. This would need to be weighed against the pressure for development and the increase to channel velocities and increasing runoff rates to the downstream Reach 1 and South Papillion Creek areas. This reach would be considered a sediment pathway.

*Note: GCSs (red circles) field verified, unknown erosion resistant bed materials (purple circles) either formed from revetment materials, culverts or likely, glacial till.*

- Existing GCS locations should be investigated further to determine stability of structure and potential need for enhancements.
- There are additional GCSs and other resistant bed materials located within the reach, based on the 2016 LiDAR and aerial photo interpretation. Specific GCS locations need to be verified in the field (Figure 5-31).

- The reach could be enhanced with limiting restrictions on land-use and impingements upon the channel. Land-use in this area is unlikely to change so there is little value in concentrating restoration funding in this reach could be most effective in the upstream area of the reach.

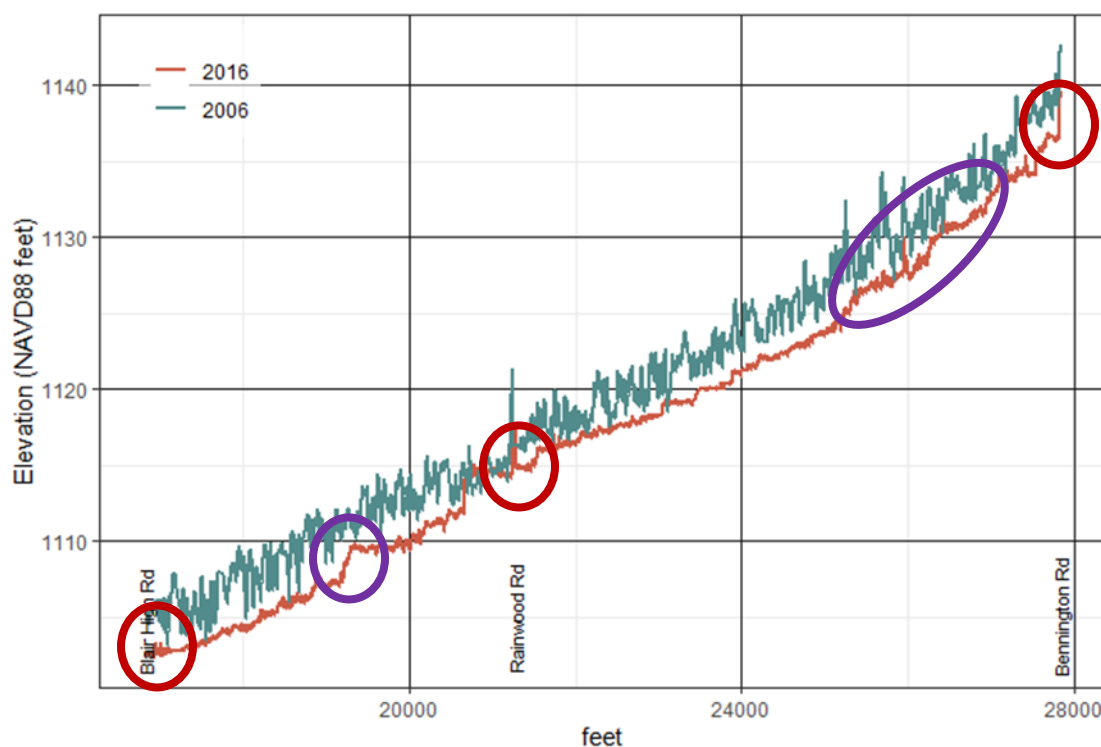
**Figure 5-32: Thomas Creek FG – Reach 3**

- GCSs are present at three main bridge locations (Figure 5-32).
- Existing GCS locations should be investigated further to determine stability of structure and potential need for enhancements.

- The reach has little-to-no urban area developments so access to an active floodplain is possible, but it is unknown if the frequent storm and resulting flow events access the floodplain areas within the reach. Because of the limited urbanized areas, there is an opportunity to provide floodplain access thereby providing for flood storage to the downstream reaches and South Papillion Creek watershed. This reach would be considered a sediment pathway.

*Note: GCSs (red circles) field verified, unknown erosion resistant bed materials (Purple circles) either formed from revetment materials, culverts or likely glacial till.*

- There are additional GCS and other resistant bed materials located within the reach based on the 2016 LiDAR and aerial photo interpretation. Specific GCS locations need to be verified in the field (Figure 5-32).

- Land-use in this area is mostly agricultural so there is high value in concentrating restoration funding in this reach.
