# **Papillion Creek Watershed**

## **Streambed Degradation Study**

### **Section 22: Planning Assistance to States**

#### **Final Report**

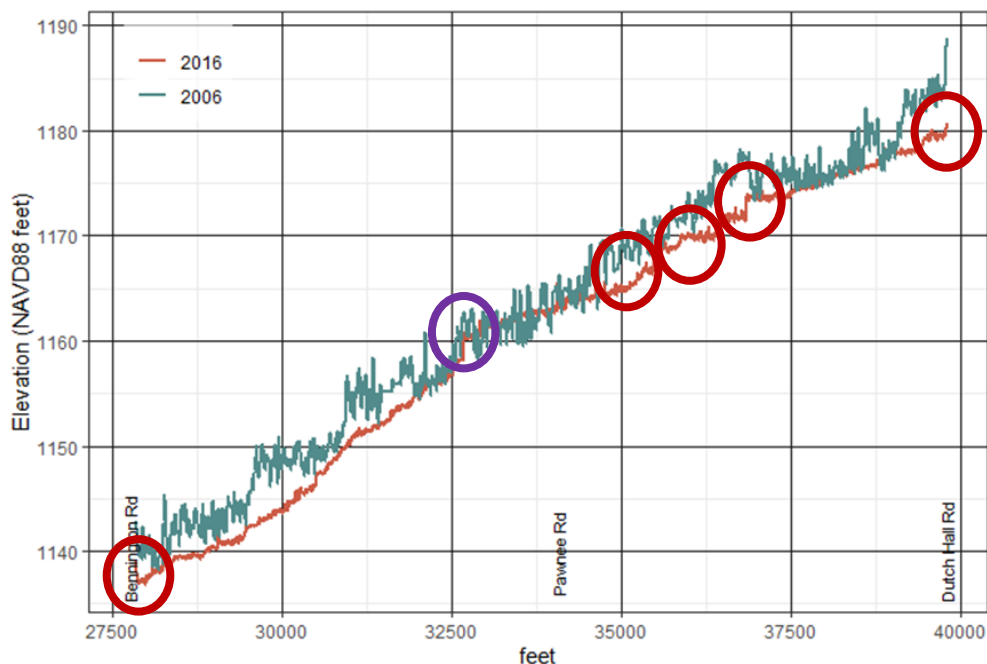
**Figure 5-33: Thomas Creek FG – Reach 4**

- GCSs are present at two main bridge locations and three driveway crossings in the upstream area of the reach (Figure 5-33). The driveway crossings are bridges, likely with riprap or some other erosion-resistant materials providing bed stability to the upstream channel.

- Comparisons of the FG LiDAR profiles (Figure 5-33) illustrate a likely channel degradation pattern upstream of Bennington Road and again upstream of Pawnee Road.

- The reach has no urban area developments so access to an active floodplain is likely in most of the reach. It is unknown if frequent storm events and resulting stream flows access floodplain areas. Because of this reach being agricultural, if there is currently no access for floodplain storage, there are opportunities to enhance flood storage to the downstream reaches and South Papillion Creek watershed. Based on the limited FG analysis, this reach would be considered a sediment source.

*Note: GCSs (red circles) field verified, unknown erosion resistant bed materials (Purple circles) either formed from revetment materials, culverts or likely, glacial till.*

- Existing GCS locations should be investigated further to determine stability of structure and potential need for enhancements.
- There are additional GCSs and other resistant bed materials located within the reach based on the 2016 LiDAR and aerial photo interpretation. Specific GCS locations need to be verified in the field (Figure 5-33).

- Land-use in this area is mostly agricultural so there is high value in concentrating restoration funding in this reach where applicable.

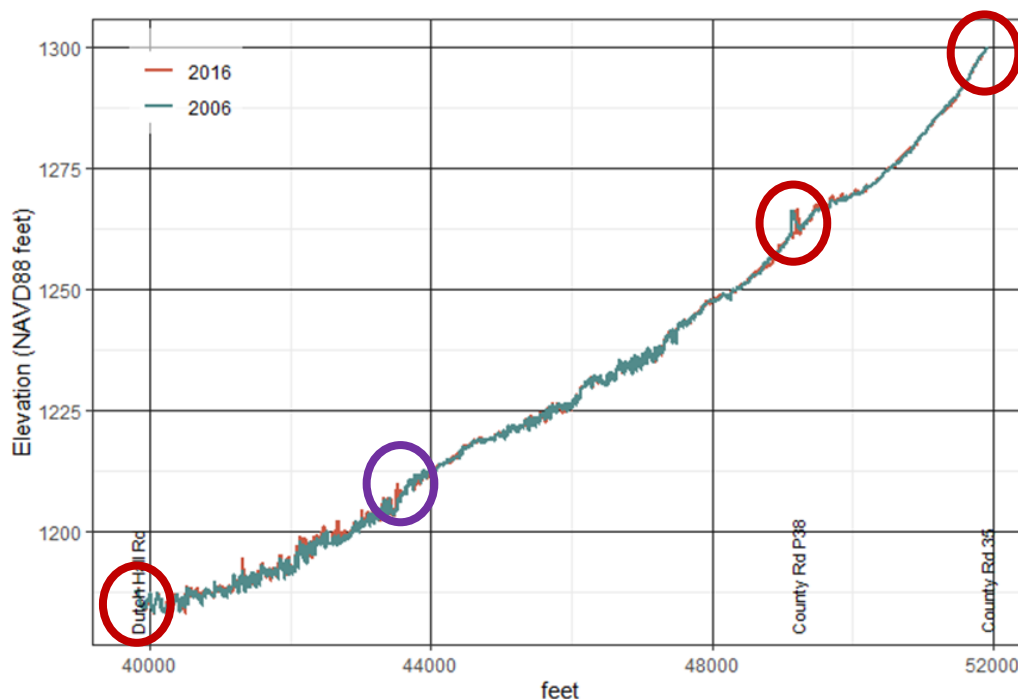
**Figure 5-34: Thomas Creek FG – Reach 5**

- GCSs are present at three main bridge locations (Figure 5-34).
- Comparisons of the FG LiDAR profiles (Figure 5-34) illustrate relatively similar profiles. This reach appears to have a stable bed.

- There are opportunities to enhance flood storage in this reach and reduce runoff from the airport to the downstream reaches and South Papillion Creek watershed. Based on the limited FG analysis, this reach would be considered partially a sediment source/pathway.

*Note: GCSs (red circles) field verified, unknown erosion resistant bed materials (purple circles) either formed from revetment materials, culverts or likely, glacial till.*

- Existing GCS locations should be investigated further to determine stability of structure and potential need for enhancements.
- There is an additional GCS and other resistant bed materials located within the reach based on the 2016 LiDAR and aerial photo interpretation. Specific GCS locations need to be verified in the field (Figure 5-34).

- Land-use in this area is mostly agricultural so there is high value in concentrating restoration funding in this reach where applicable.

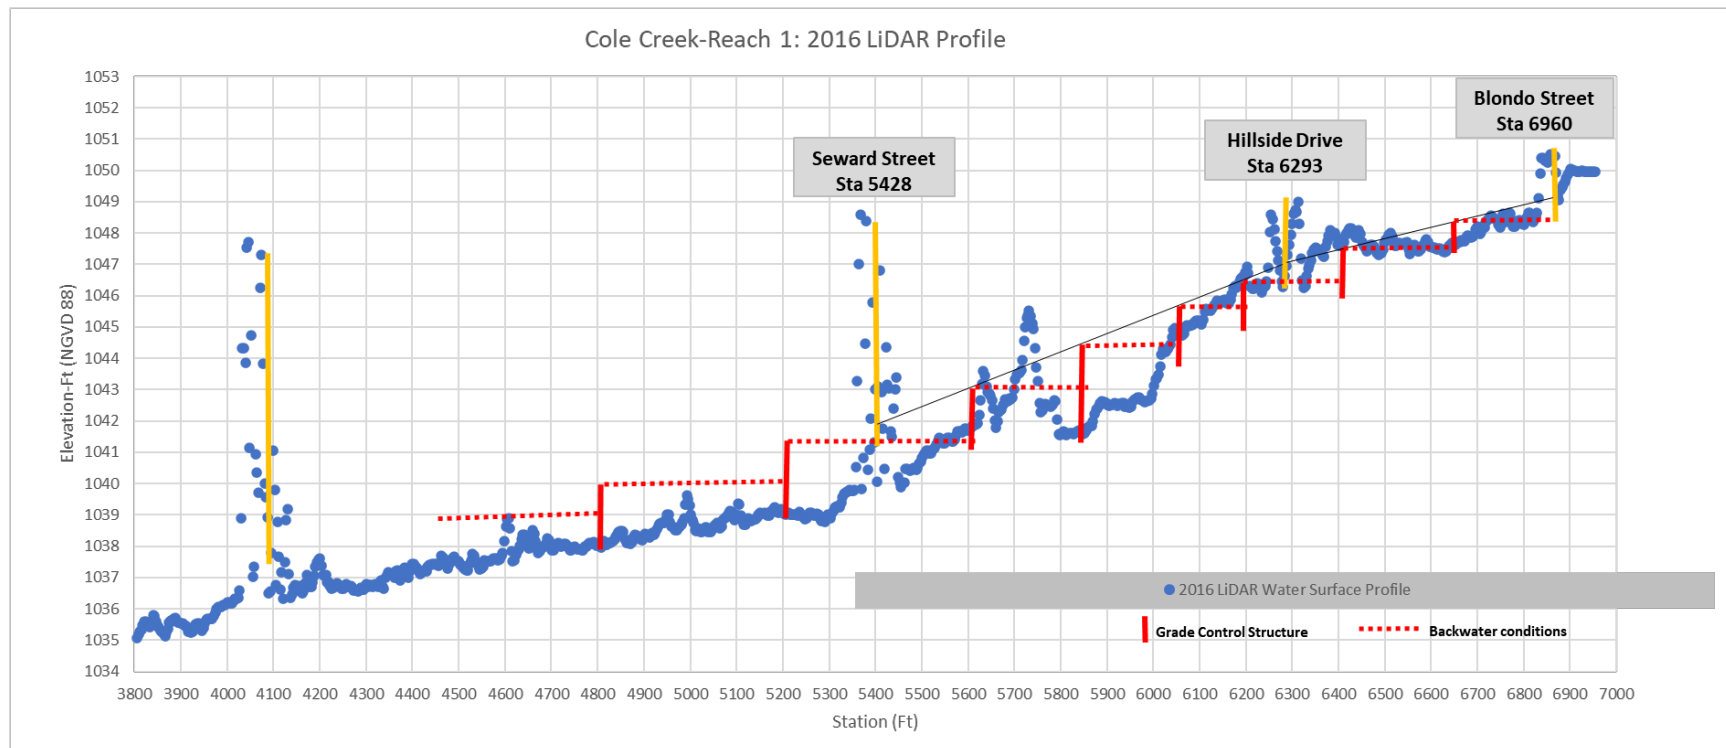
**Figure 6-19: Initial Layout of GCS Based on 2016 Survey Data**

The final HEC-RAS model for this analysis extends from Sorensen Parkway at the upstream end to the confluence with Little Papillion Creek which is between Cass Street and Dodge Street. The area of interest is between Blondo Street and Western Avenue. The model was updated with new survey data from the City of Omaha from cross section 7764 (just upstream of Blondo Street) to 4190 (Western Avenue). Figure 6-19 shows the original thalweg elevation and initial proposed structure elevations based on the 2016 survey data.

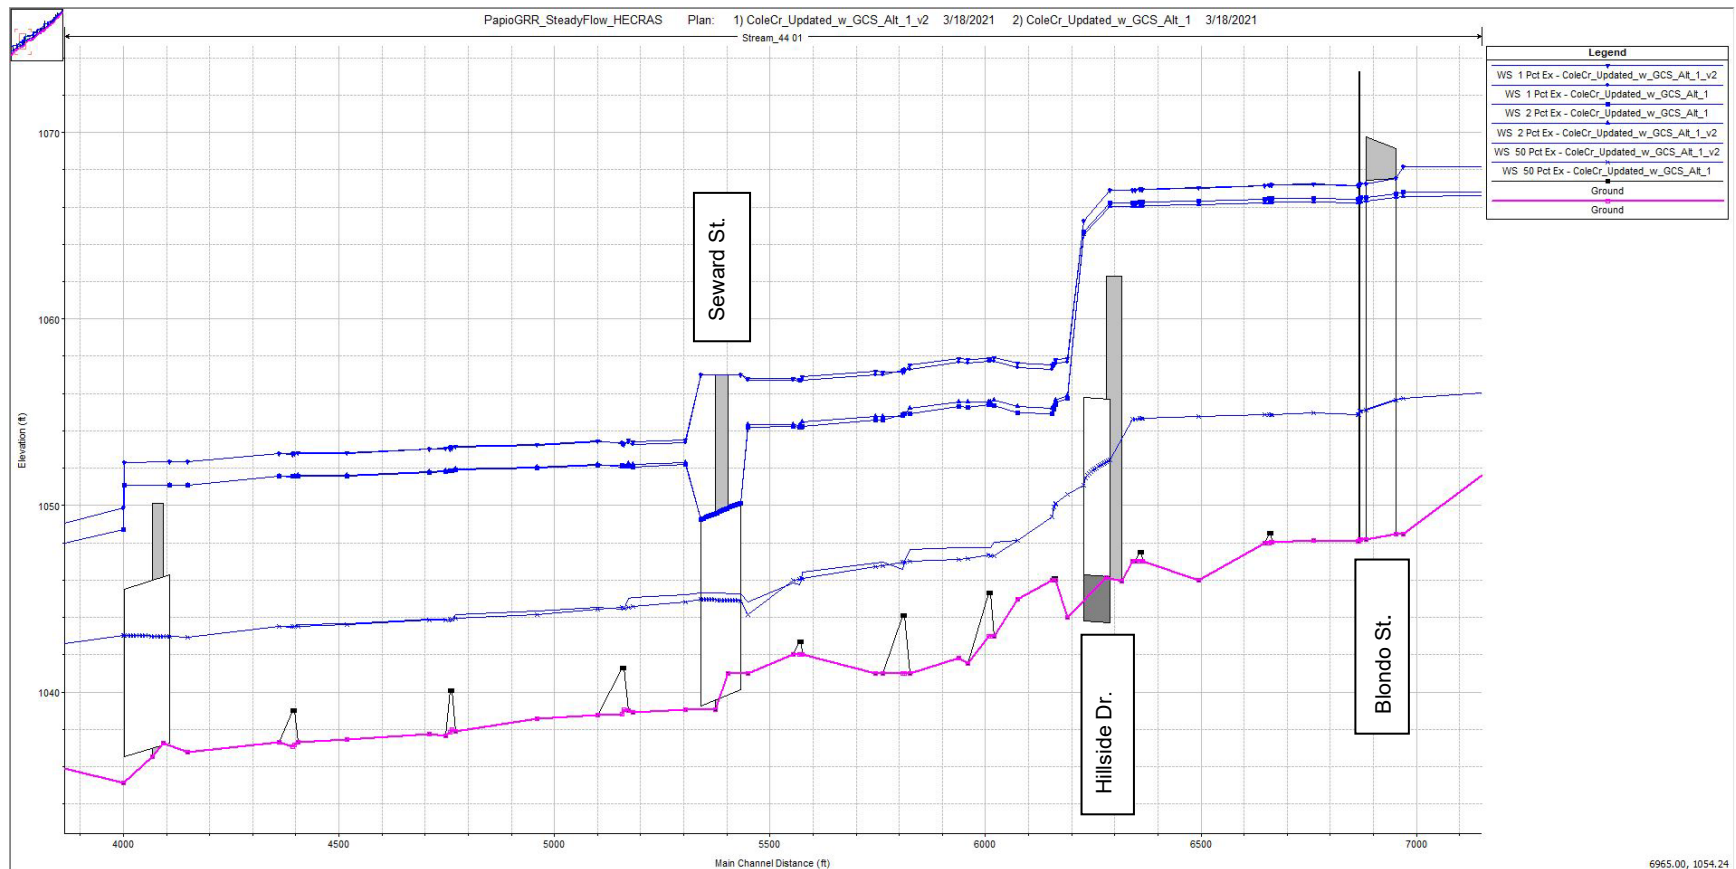
**Figure 6-20: HEC-RAS Hydraulic Model Water Surface Profiles in Cole Creek Design Reach (2020 Surveys)**

The model results of the existing conditions show that while some degradation has occurred that results in the two-year (50-percent AEP) being less than the bankfull condition, the 50-year (two-percent AEP) and higher flow event overtop the culvert at Hillside Drive and result in flooding in the area. Figure 6-20 also shows the inclusion of the GCSs for the design. Their height above the bed ranges from one to three feet depending on local bed conditions.

The results show that there is a minor increase off less than 0.5 feet at the 50- and 100-year (two-percent and one-percent AEP) events. The area with the highest change is around the Hillside Drive culvert crossing. Previous channel work in the lower reaches, including the new culvert and bank setback to increase capacity result in a lower stage impact with the addition of the GCS.

The updated 2020 survey data was used to determine quantities as part of the design; however, this area appears to be actively degrading, and the quantities and costs should be considered conceptual in nature. A new survey and updated design should be completed before construction.

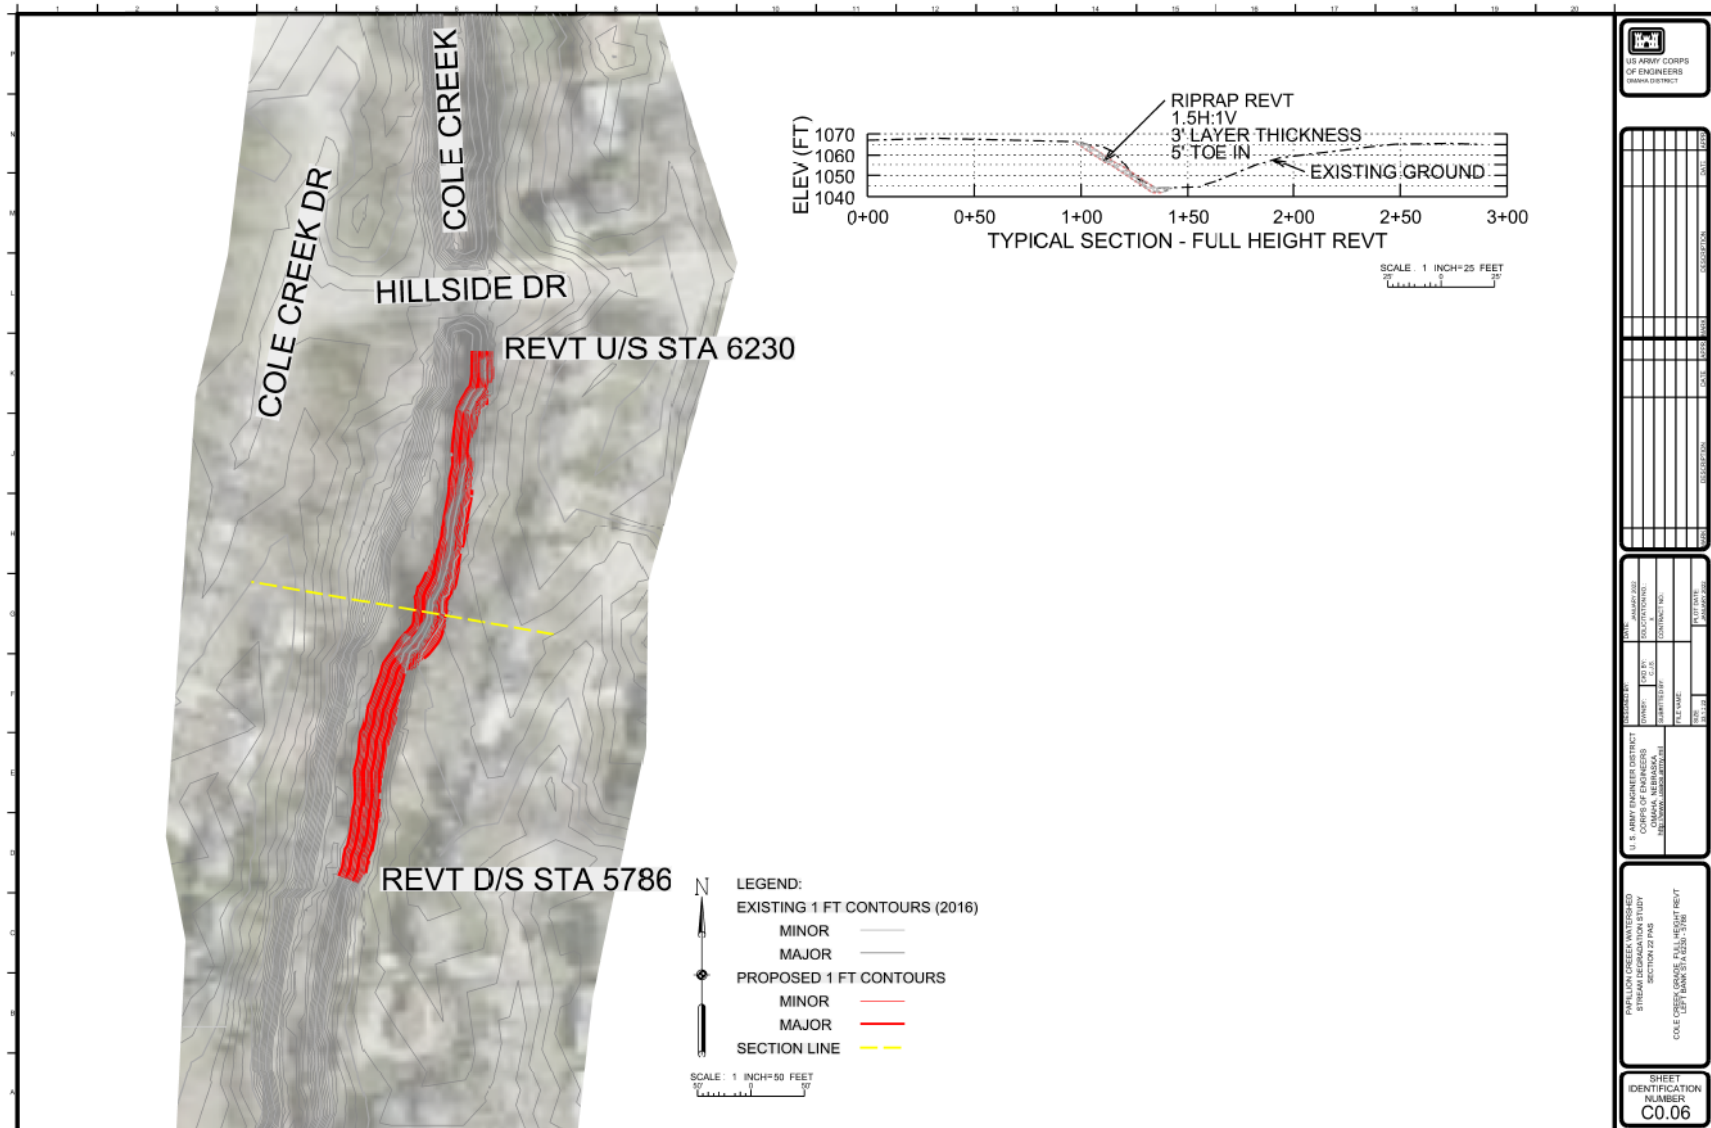
**Figure 6-24: Elevation View of the Left Bank Rock Wall Below Hillside Dr. on Cole Creek**

The design area covers only the high left bank of Cole Creek from Hillside Drive to approximately 500 feet downstream. The bank itself would need to be shaped back to a 1.5:1 slope for rock wall and earthen fill stability, and then covered with a three-foot-thick layer of Type-B riprap, with a five-foot toe-in. Figure 6-24 shows the plan view of the design.

The bank shaping would require additional loss of backyard real estate for eight landowners along the length of the rock wall. Adjustments to the location of the wall could be made to move the toe farther into the channel, reducing impacts to the backyards, if equivalent adjustments are made on the right bank.

Any large bank project like the riprap rock wall involves increased risk of affecting stages in the channel. Additional hydraulic analysis would need to be completed to evaluate the ability to construct a design that causes little to no rise in stage.

The portion of the rock wall above the elevation of the two-year event would be covered with topsoil. It is important that care is taken to push the topsoil into the voids in the rock to provide the necessary soil depths for vegetation plantings to be successful. Sod forming grasses such as smooth brome could be planted in the topsoil to hold the soil in place and screen the riprap from view; however, a native grass mix that includes pollinator-friendly forbs would be environmentally preferable.

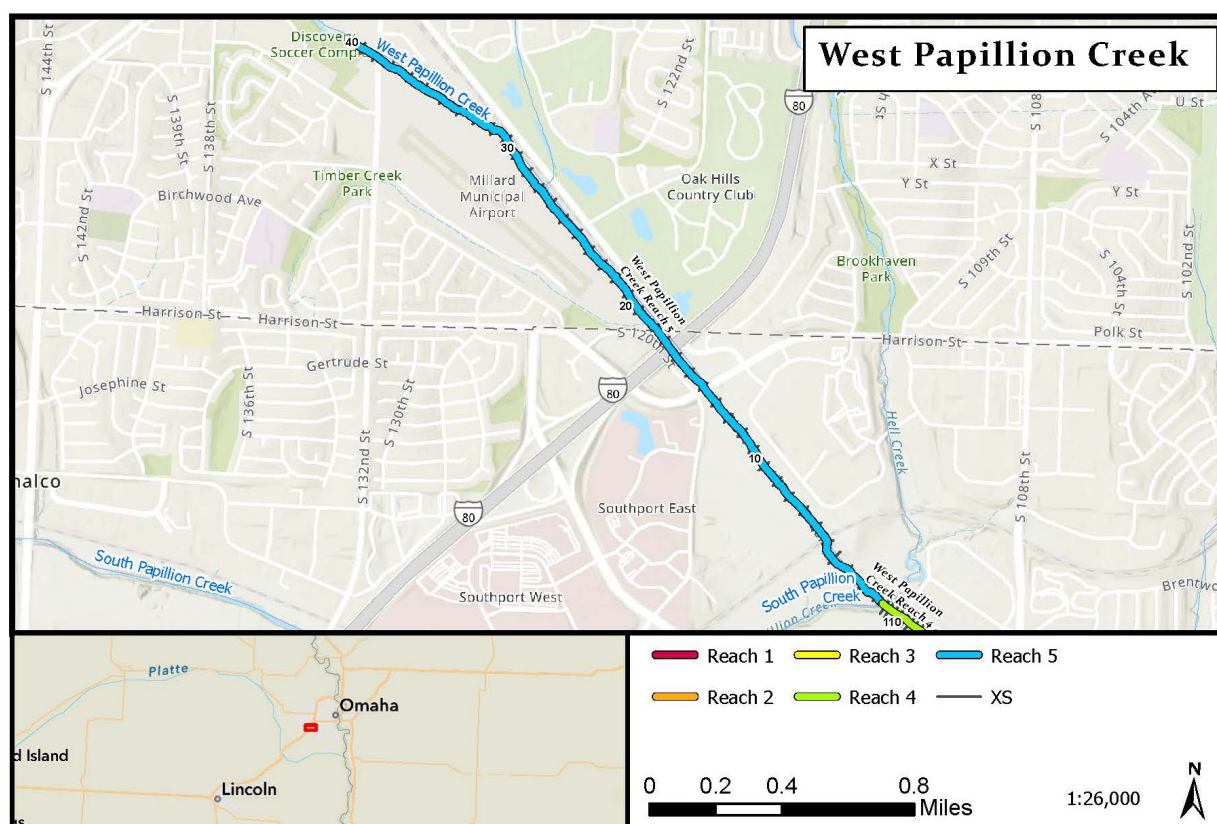
**Figure 7-1: FG Reach 5 – West Papillion Creek**

Bank protection and bed stabilizing measures were considered to stabilize the FG Reach 5 (Figure 7-1). Typical structural measures were considered in addition to EWN measures. Measures were developed into alternatives, based on preliminary information and best professional engineering judgement, and described below.

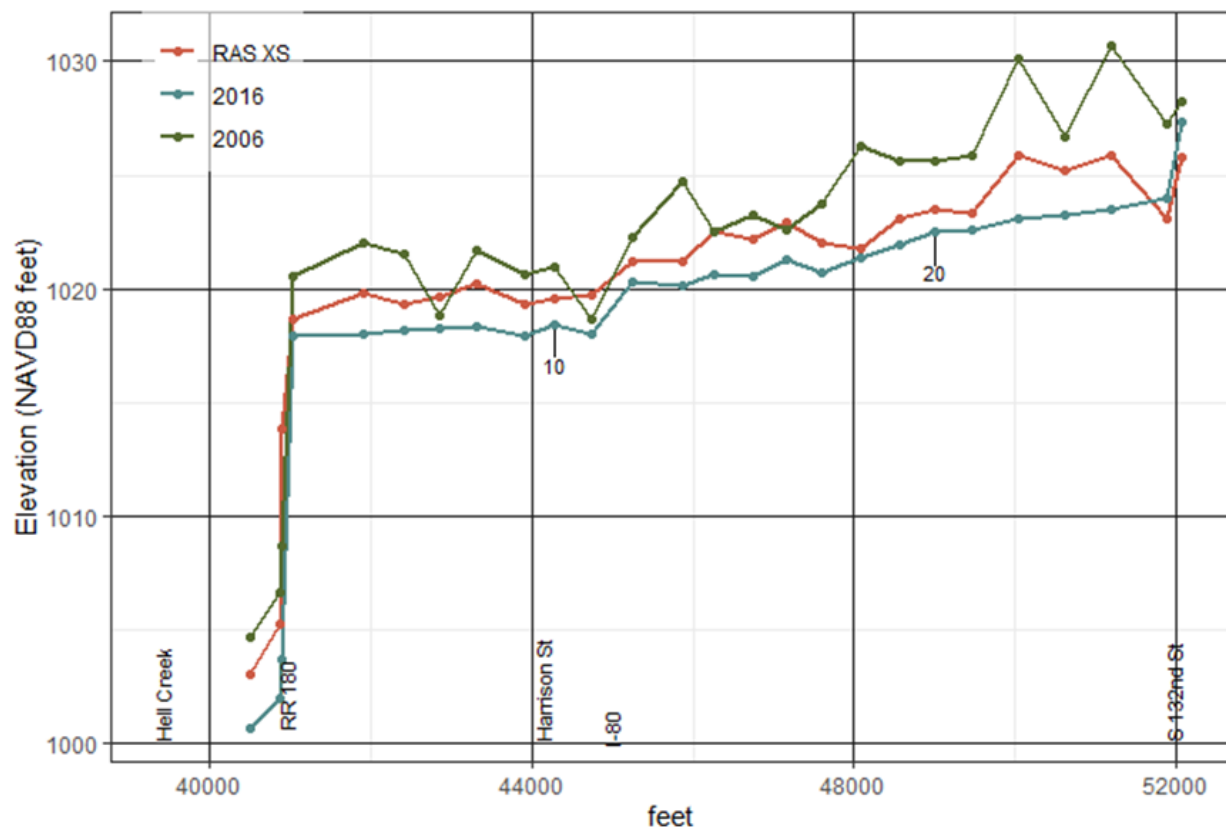
**Figure 7-3: FG Reach 5 West Papillion Creek Profiles Illustrating a Channel Degradation Trend**

At the 132<sup>nd</sup> Street Bridge location there is bed scour and local bank erosion with 15-to-20-foot bank heights. The existing HEC-RAS (2016 geometry) model profiles were compared to FG-LiDAR profiles (2004 and 2016) and show channel bed degradation occurring throughout the reach upstream of the Railroad Bridge (Figure 7-3). To effectively treat channel degradation,

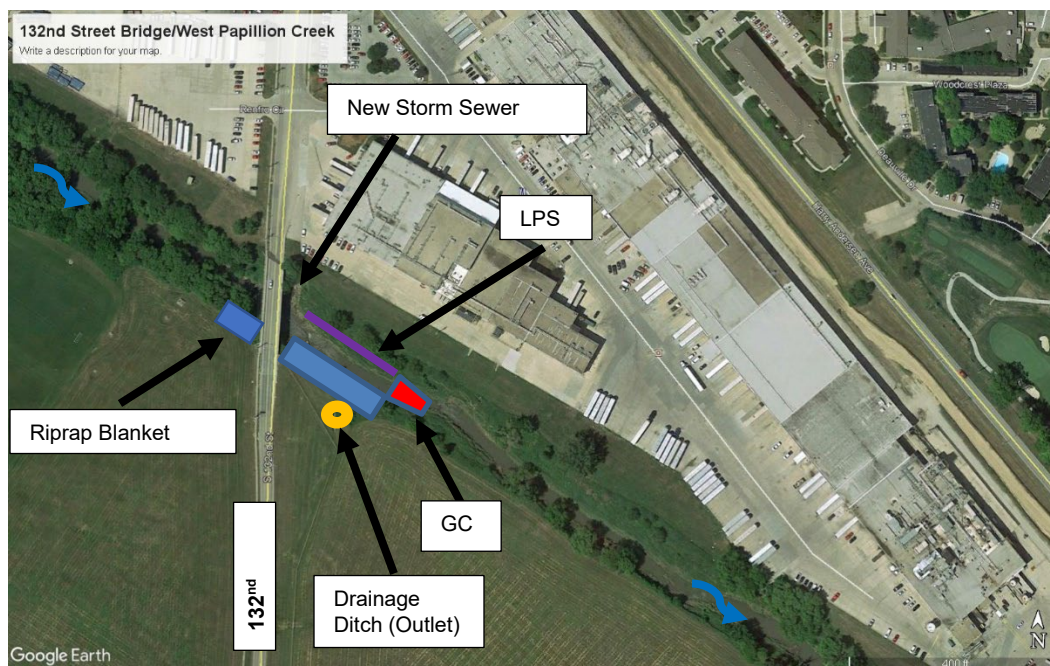
**Figure 7-5: Option 1-132<sup>nd</sup> Street/West Papillion Creek Stabilization Project**

There is a left bank erosion site just downstream of the proposed GCS; the location of the GCS could be adjusted downstream another 250 feet to stabilize the additional area. The left bank erosion may be partially caused from runoff of the adjacent parking area. This should be investigated further as additional upper terrace erosion control practices may need to be considered.

Place a loose rock riffle grade control structure 250 feet downstream of 132<sup>nd</sup> Street Bridge (Figure 7-5, red trapezoid). The crest elevation of the GCS is set at 1025.0 feet, which is one foot lower than the newly constructed upstream left bank storm sewer outfall pipe. Construction of the loose rock riffle GCS includes a 4:1 front slope, 20:1 backslope, keys tied into high bank terraces (Figures 6-14 and 6-15). The backslope apron tied into existing banks from upstream key to downstream apron outlet.

A riprap blanket with toe protection will be tied into existing revetment materials upstream of the bridge and continued downstream to the right bank drainage ditch (Figure 7-5, blue rectangles). The drainage ditch will be shaped, and riprap used to provide a stable outlet from the high terrace to the lower elevation Papillion Creek. Another option for this location is to treat the drainage ditch erosion by constructing a Water and Sediment Control Basin (WASCOB). WASCOBs catch and store small drainage areas and outlet the flow through a pipe to a lower stable stream outlet. Figure 7-6 illustrates an example of a WASCOB.

LPSTP (Figure 7-5, purple line) is used to establish bank protection on the left bank, downstream of the bridge, tying the new left bank storm sewer outfall into the downstream GCS. The length of the LPSTP is approximately 220 feet.

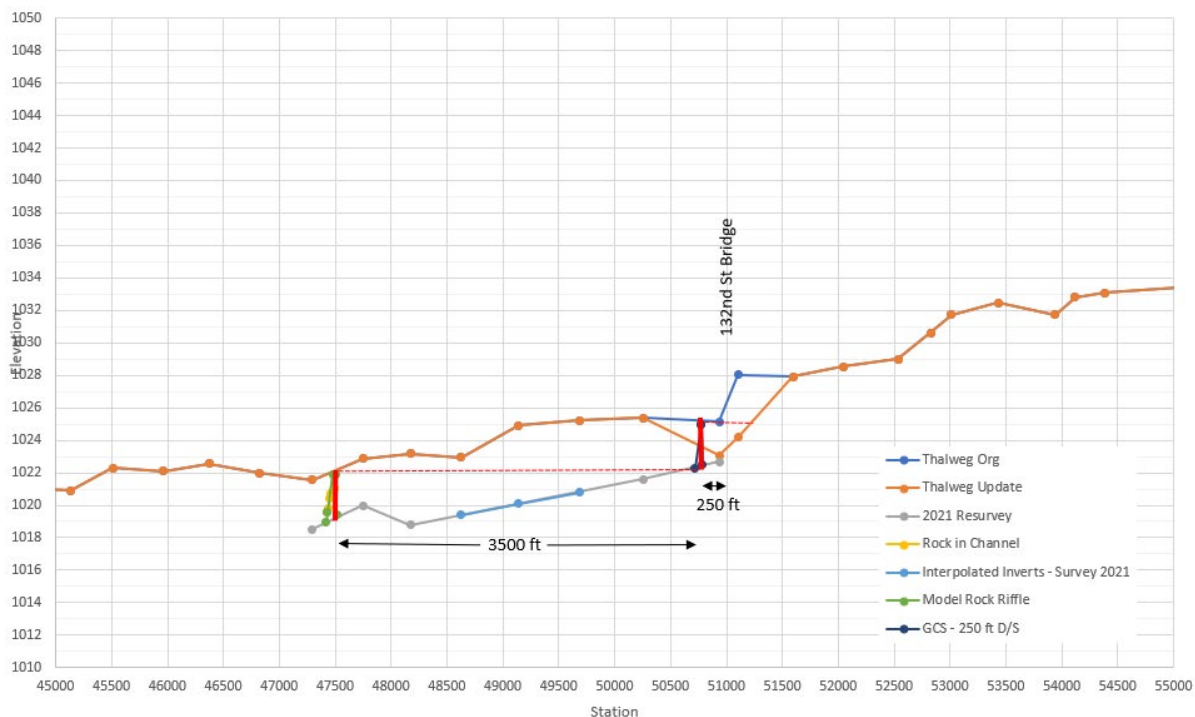
**Figure 7-9: HEC-RAS Hydraulic Model Thalweg Profile of West Papillion Creek Near 132<sup>nd</sup> Street**

To additionally reduce uncertainty in the water surface profile estimates made in the model, USACE Omaha District conducted a brief survey in April 2021 to determine new estimates of the channel thalweg through the reach and at the GCS at the tributary outlet downstream. Figure 7-

9 plots the original 2016 survey thalweg as well as the 2021 update showing up to four additional feet of degradation in the reach near the bridge.

The updated 2021 thalweg geometry was used to determine quantities as part of the design; however, this area appears to be actively degrading, and the quantities and costs should be considered conceptual in nature, and a new survey and updated design should be completed before construction.

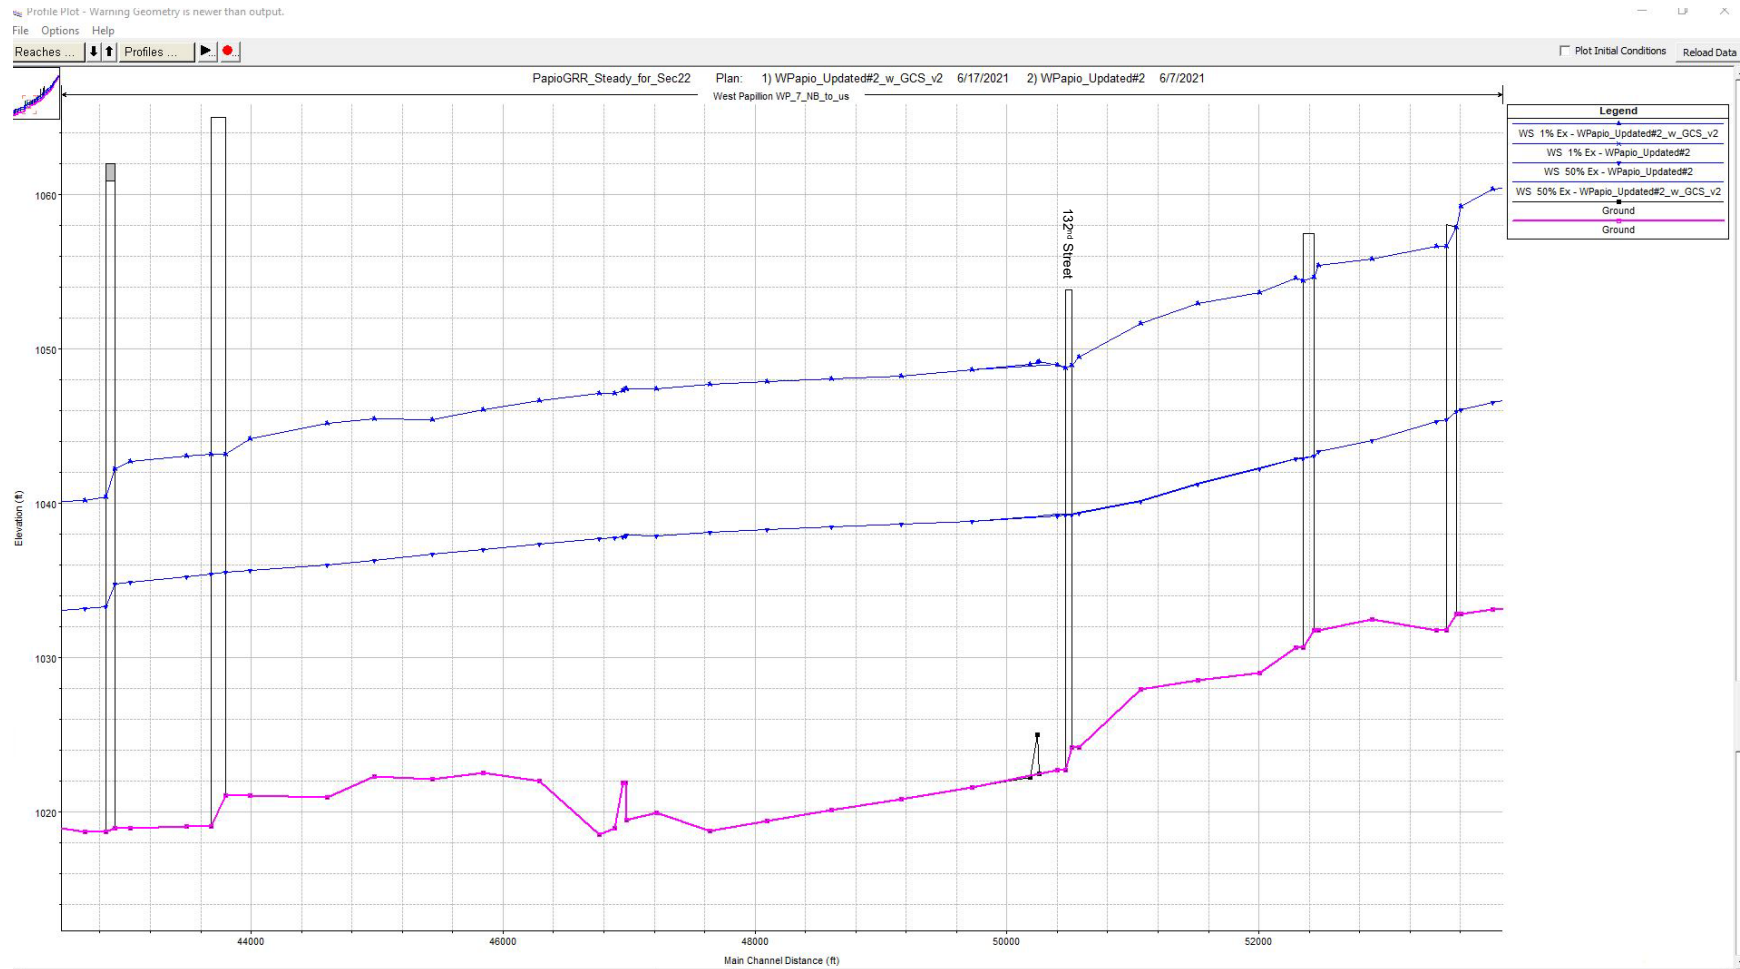
Figure 7-10: Change in Water Surface Elevations at 1% and 50% AEP Flows from GCS

The HEC-RAS model was run with the updated geometry to assess the current flow frequency stages and those that would be expected with the construction of the two GCSs in the design. Figure 7-10 shows that there is a minor increase of less than 0.5 feet at the one-percent AEP event. Due to the highly degraded nature of the reach, the one-percent event does not exceed channel capacity. Continued degradation would result in even lower frequency events staying in the channel.

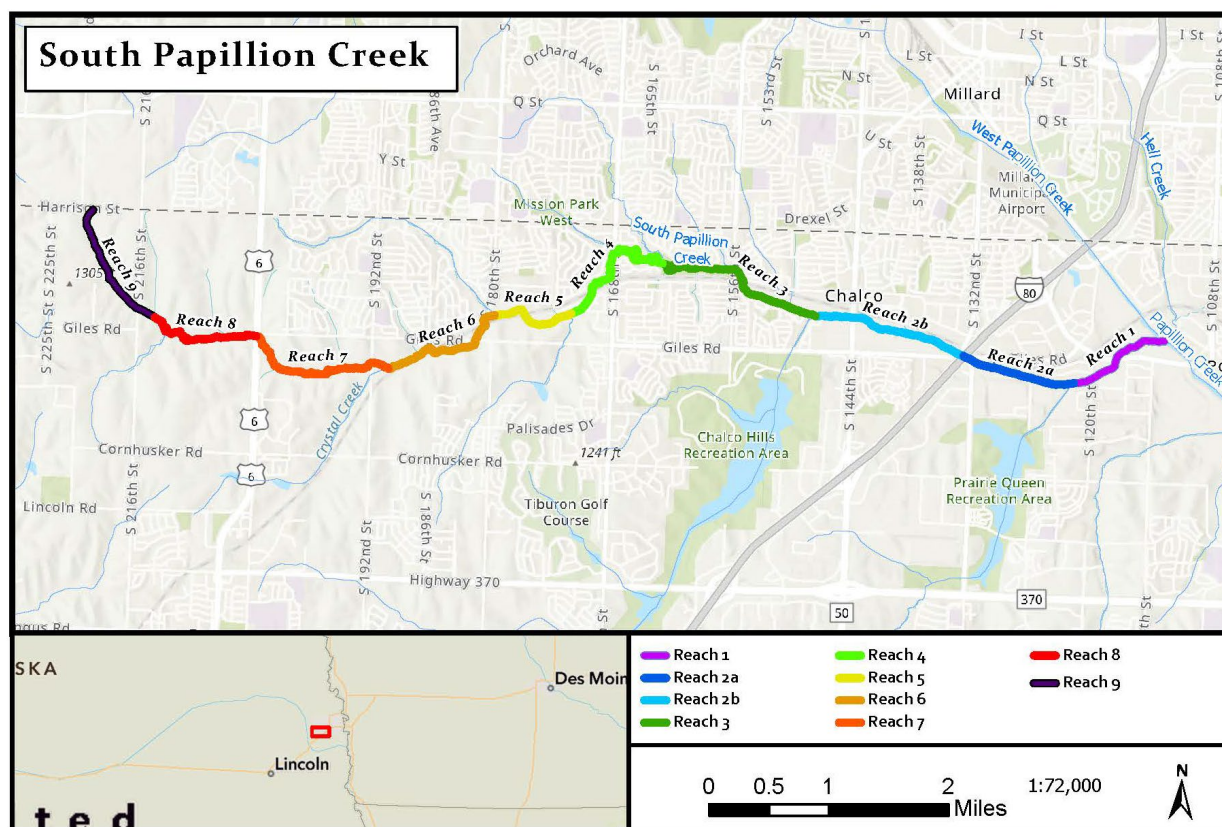
Figure 8-1: FG South Papillion Creek Watershed, Reaches 1 – 9

The study reaches were developed from natural watershed divisions where tributary streams enter the mainstem South Papillion Creek. From a watershed perspective, stabilizing measures should include a combination of EWN measures with bed and bank stabilization recommended to stabilize the South Papillion reaches depicted in the watershed map (Figure 8-1) and corresponding LiDAR profiles. The next section provides more detailed information about individual reaches.

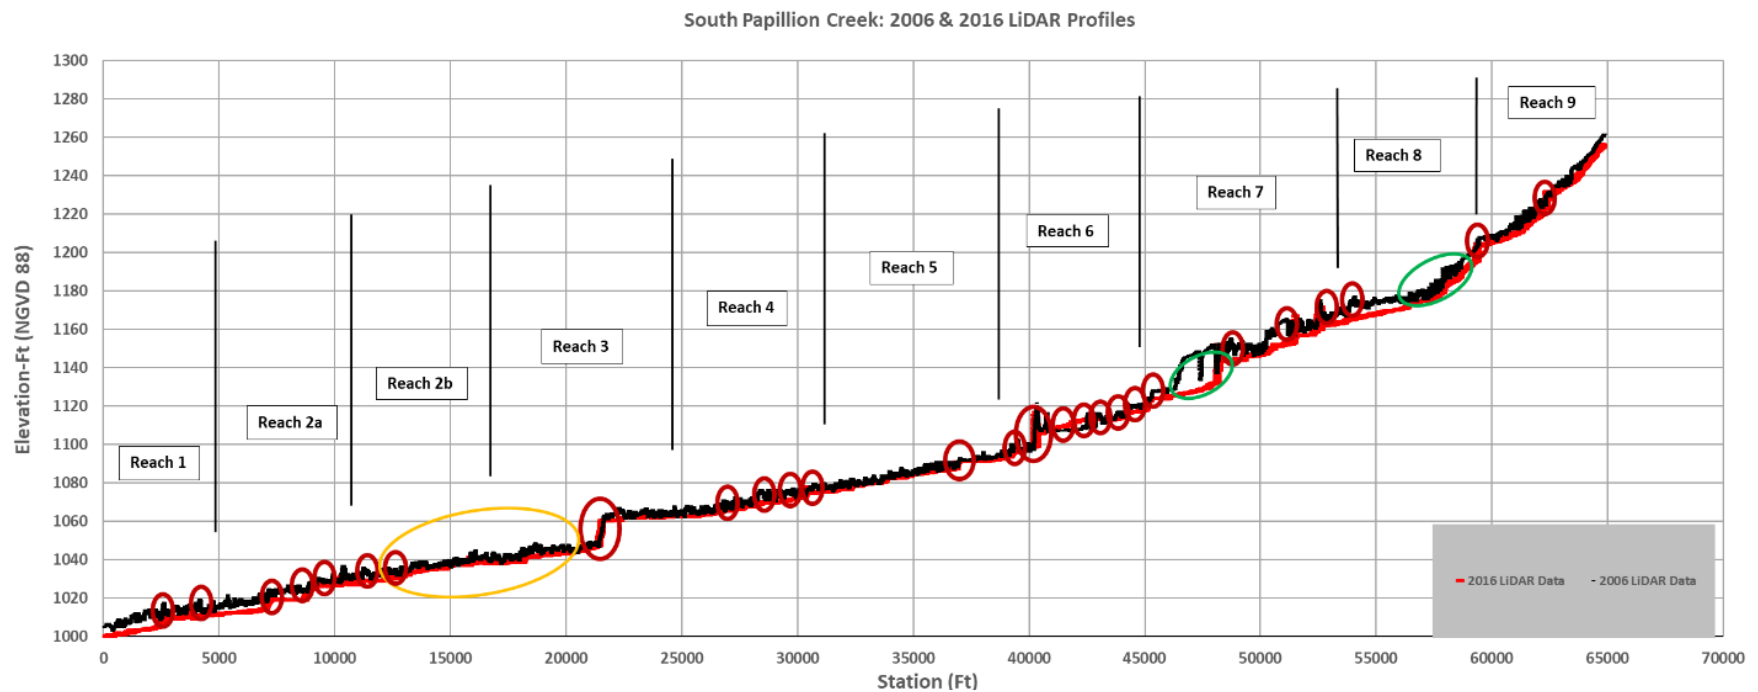
Based on LiDAR profile slope comparisons, channel degradational trends appear in Reaches 1, 2, 7, 8 and 9 (Figure 8-3). The upstream limit of Reach 9 illustrates channel degradation at the Harrison Road culvert (Figure 8-4) and the downstream end at South 216<sup>th</sup> Street culvert (Figure 8-5). The structures are providing grade control to the channel upstream of the structure; if they are undercut and fail, then large amounts of sediment and initiation of channel degradation will propagate to the upstream reach. Degradation trends in reaches 7, 8 and 9 have some bed control (Figure 8-3, green circles) with a somewhat erosion-resistant glacial till in the channel bed (Figure 8-4). The glacial till (clay layer) is providing some bed stabilization benefits to the reaches.

**Figure 8-3: FG South Papillion Creek LiDAR Profiles (2004 and 2016), Reaches 1 – 9, Illustrating Existing GCSs (red circles), Erosion-Resistant Materials (green circles), and Potential Equilibrium Slope (orange circle)**

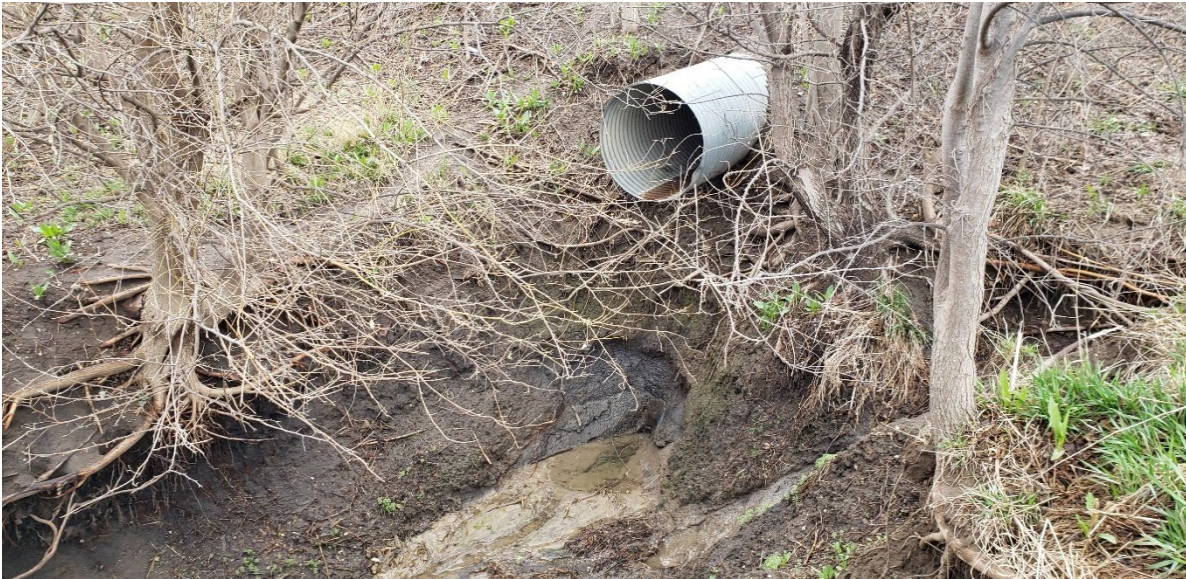
**Figure 8-4: South Papillion Creek FG, Reach 9 – Perched Culvert at Harrison Street, Upstream End of Reach 9**

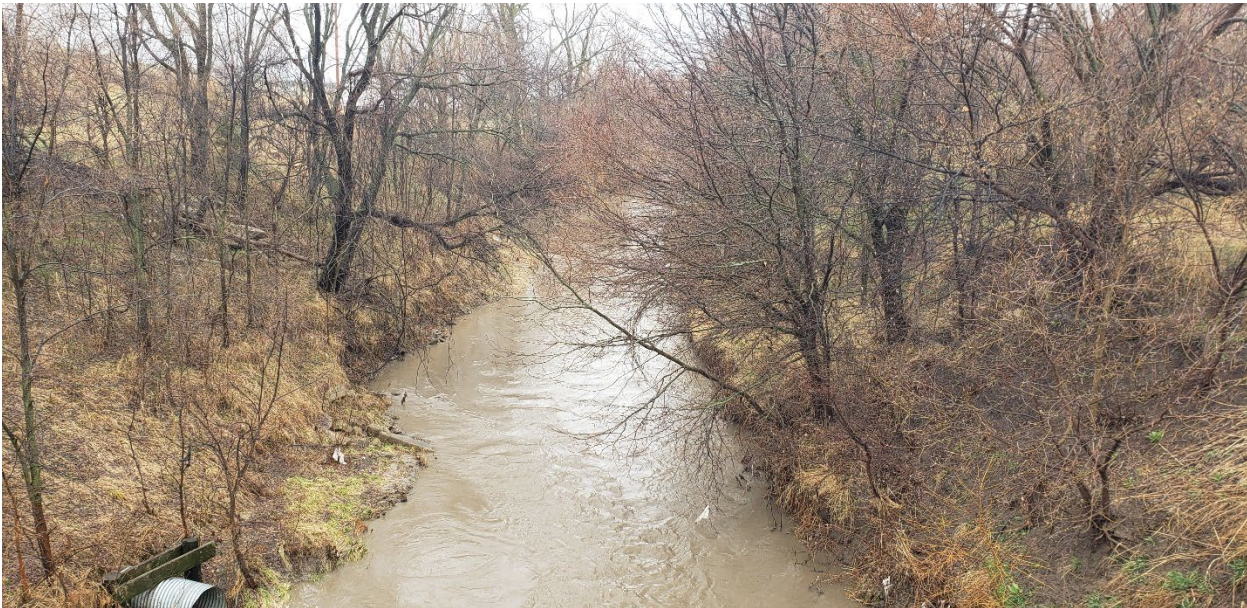
From the FG analysis and site visits, multiple locations within the nine reaches (Figure 8-3, red circles) were identified that are providing grade control and bank stabilization benefits to the channel; however, these structures were not designed to prevent channel degradation so many of them are adjusting and are in possible failure condition (Figure 8-6). Many of the bridges within the reaches have existing rock or riprap materials that are acting as GCSs as rock launches from scour protection, such as at South 126<sup>th</sup> Street Bridge (Figure 8-6). Undercut filter fabric at many locations is acting as a slide moving riprap material downslope as the scour protection is being undercut. The structures are providing substantial bed stabilization benefits as illustrated in Figure 8-7.

**Figure 8-7: FG Reach 2b –South Papillion Creek: Illustrating the Benefits of GCS Upstream of South 126<sup>th</sup> Street Bridge**

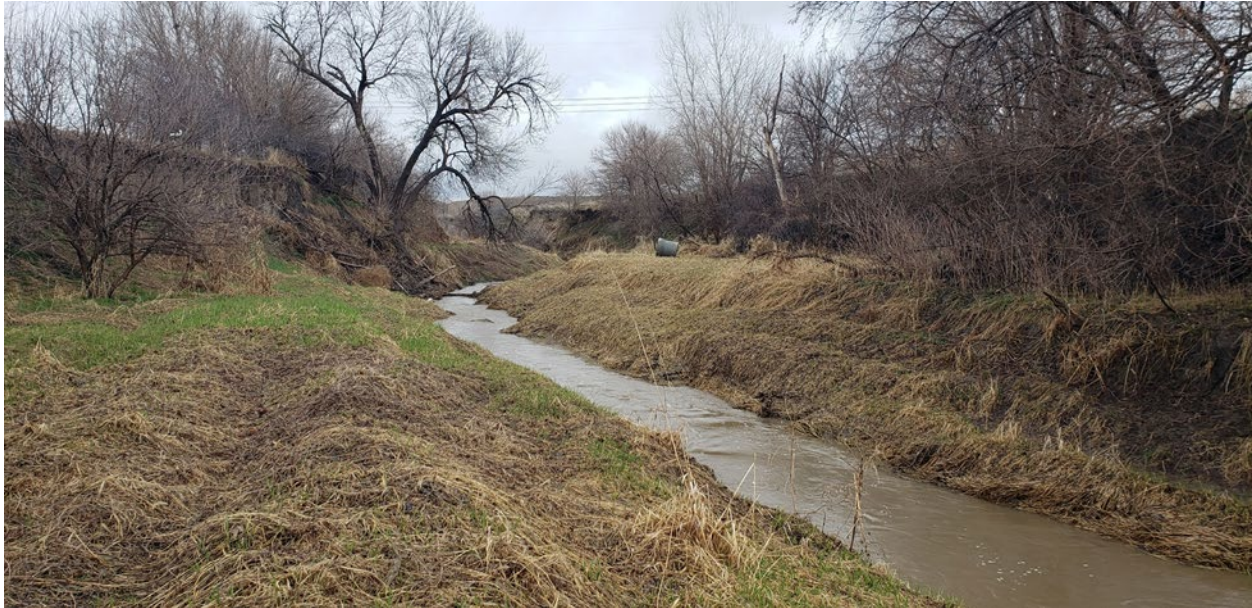
Other road culverts provide bed and bank stabilizing benefits within the watershed. For example, the Giles Road culverts (Figure 8-9) provide bed and bank stabilizing benefits upstream in one of the only reaches (Reach 6) that illustrates aggradation, where sediment has redeposited in the previous degraded channel and built new floodplains (Figures 8-10 and 8-11). Downstream of the culverts, the channel has degraded and has eroding vertical left banks (Figures 8-11 and 8-12). If the Giles Road culverts are replaced, careful consideration needs to be considered when designing a replacement as changing the culverts size and invert elevations will cause de-stabilization to the reach upstream.

**Figure 8-10: FG Reach 6, South Papillion Creek – Upstream of Giles Road Culverts  
Showing Aggraded, Stable Channel Reach**

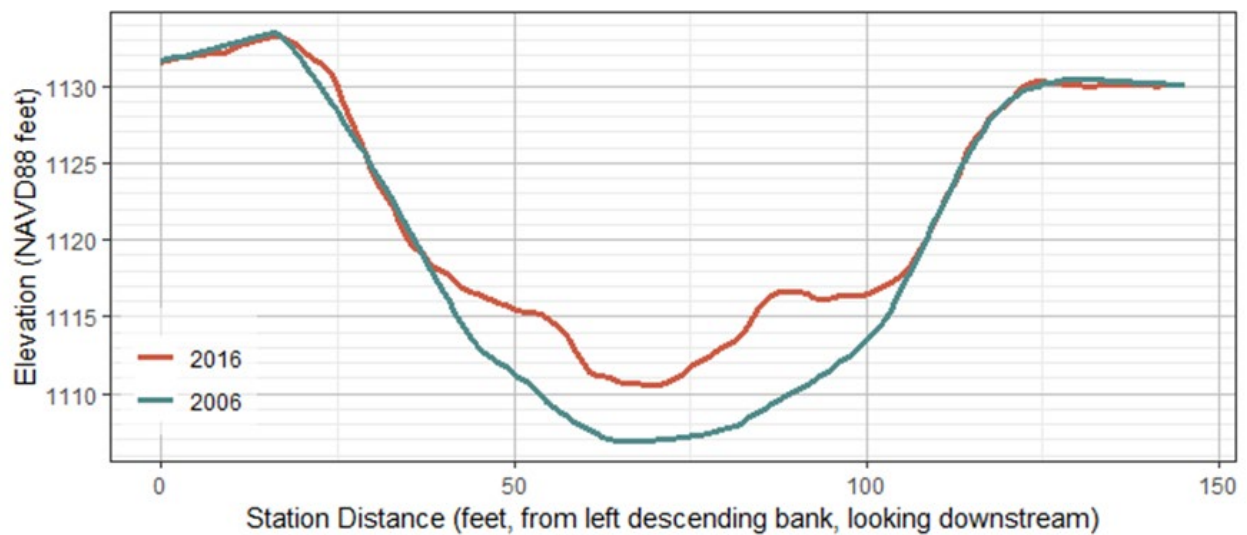
**Figure 8-11: FG Reach 6, South Papillion Creek – LiDAR Cross-sections Illustrating  
Channel Aggradation and Floodplain Building in a Previously Incised Channel**

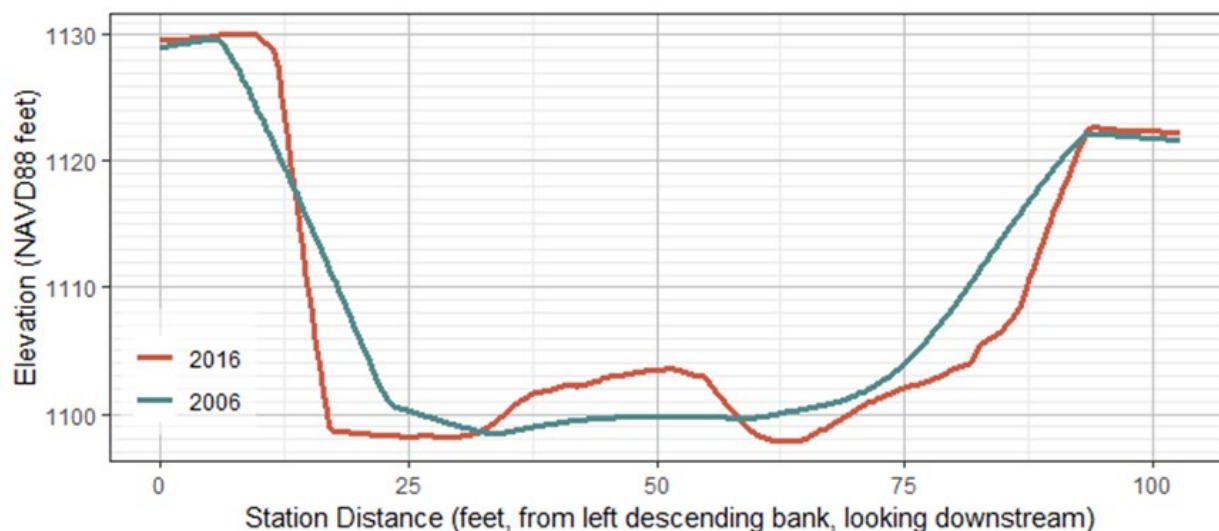
**Figure 8-13: FG Reach 6, South Papillion Creek Creek – LiDAR Cross-sections Illustrating Relatively Stable Channel with Left Bank Erosion**

Based on the LiDAR analysis for Reach 6, there is a degradation trend upstream of the aggrading section upstream of the Giles Road culverts. During the site visit, this was verified by visiting the upper section of Reach 6. The railroad bridge crossing in this location does not have any GCSs under it and there appears to be channel lowering, local pier scour or possibly a combination of both. Whatever the exact cause, this location should be investigated further as the wood footing for the center pier span is threatening to be undercut.

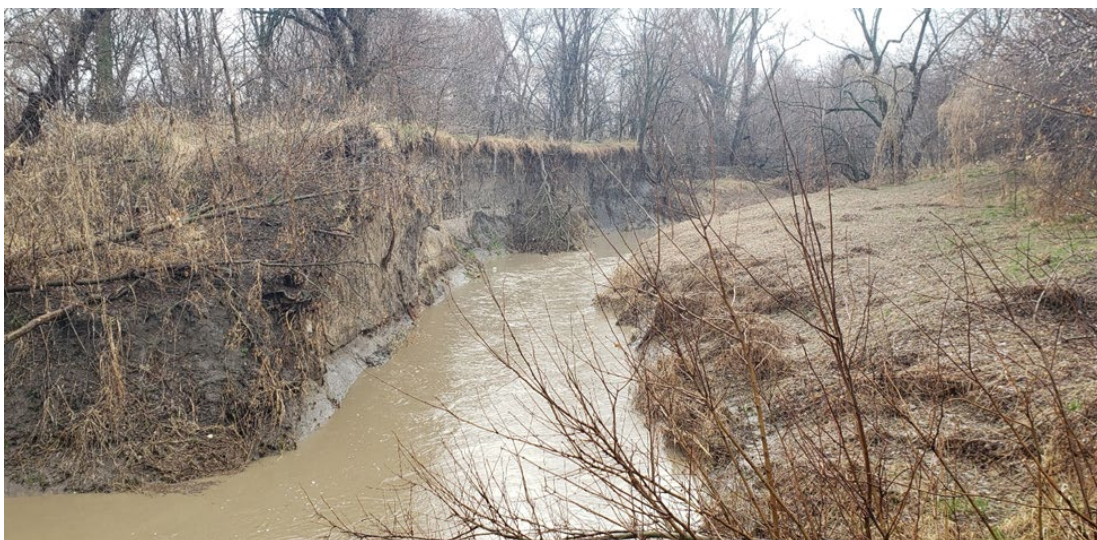
Local bank erosion throughout the nine reaches was located using FG and the associated metrics and was field verified in some locations. The more sinuous channel reaches show the most extensive bank erosion problems. Reach 4 has a lot of channel meanders that are assumed to be natural and are likely the only un-straightened channel areas left within the watershed. In many locations seen during field visits, some erosion-resistant lower bank materials were encountered (Figure 8-15). The banks are eroding but would likely erode faster without some of the lower bank toe erosion-resistant materials.

**Figure 8-15: FG Reach 4, South Papillion Creek – Channel Section Immediately West of South 167<sup>th</sup> Court Showing Vertical Right Banks in a Meandering Incised Channel**

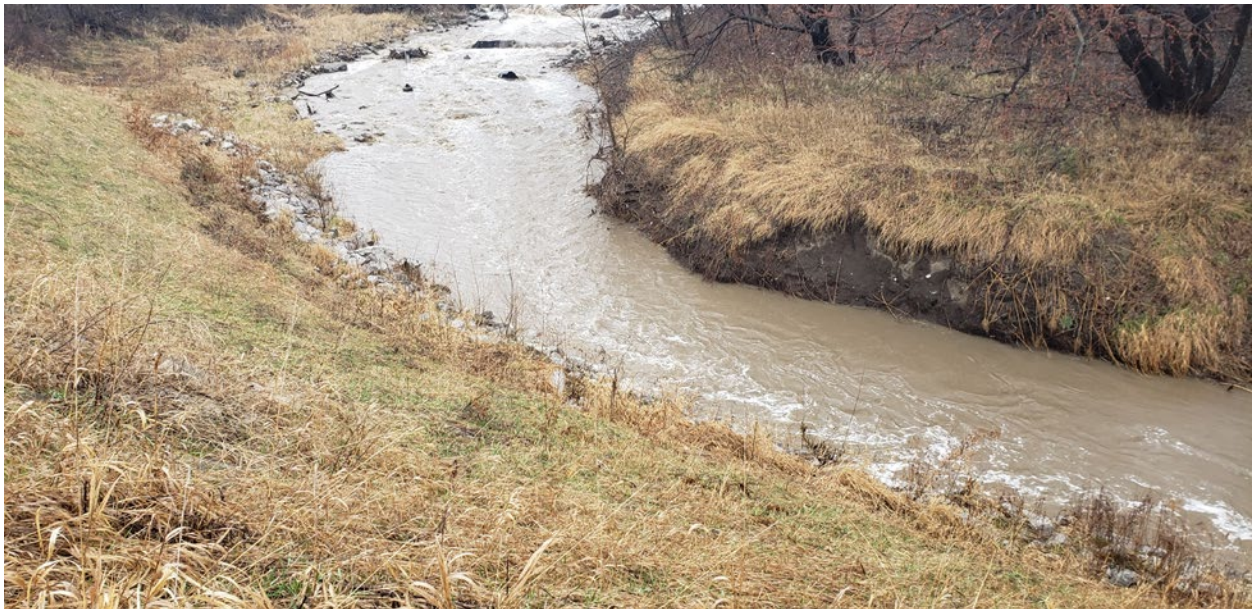
**Figure 8-17: EWN LPSTP Project Completed on South Papillion Creek-Reach 3**

See description in Section 6.1.1 and Figures 6-6 through 6-9. Another example is shown in Figure 8-17 below.
