# **Papillion Creek Watershed**

## **Streambed Degradation Study**

### **Section 22: Planning Assistance to States**

#### **Final Report**

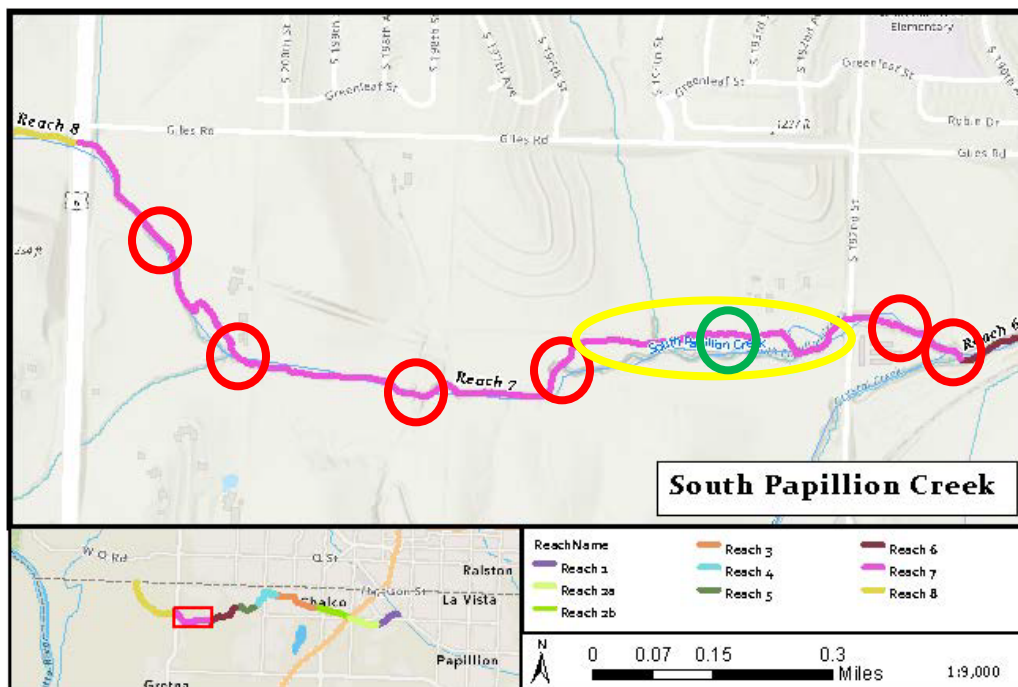
Figure 8-28: Reach 7 – South Papillion Creek

**Priority #2:** Grade control should be considered in the areas where there has been the most bed degradation: Reaches 7, 8 and 9.

Reach maps are provided to illustrate the potential locations for bed and bank stabilization practices (Figures 8-21-8-29).
